Evidence for the breakdown of an Angkorian hydraulic system, and its historical implications for understanding the Khmer Empire

Terry Lustig, Sarah Klassen, Damian Evans, Robert French, Ian Moffat

This paper examines the construction and design of a 7-km long embankment, probably built for King Jayavarman IV between 928 and 941 CE, as part of a new capital. We calculate that the capacities of the outlets were too small, and conclude that the embankment failed, probably within a decade of construction, so that the benefits of the reservoir stored by the embankment and the access road on top of it were lessened substantially. We explain how the design was sub-optimal for construction, and that while the layout had a high aesthetic impact, the processes for ensuring structural integrity were poor. Simple and inexpensive steps to secure the weir were not undertaken. We speculate that this early failure may have contributed to the decision to return the royal court and the capital of the Khmer Empire to the Angkor region, marking a critically important juncture in regional history.

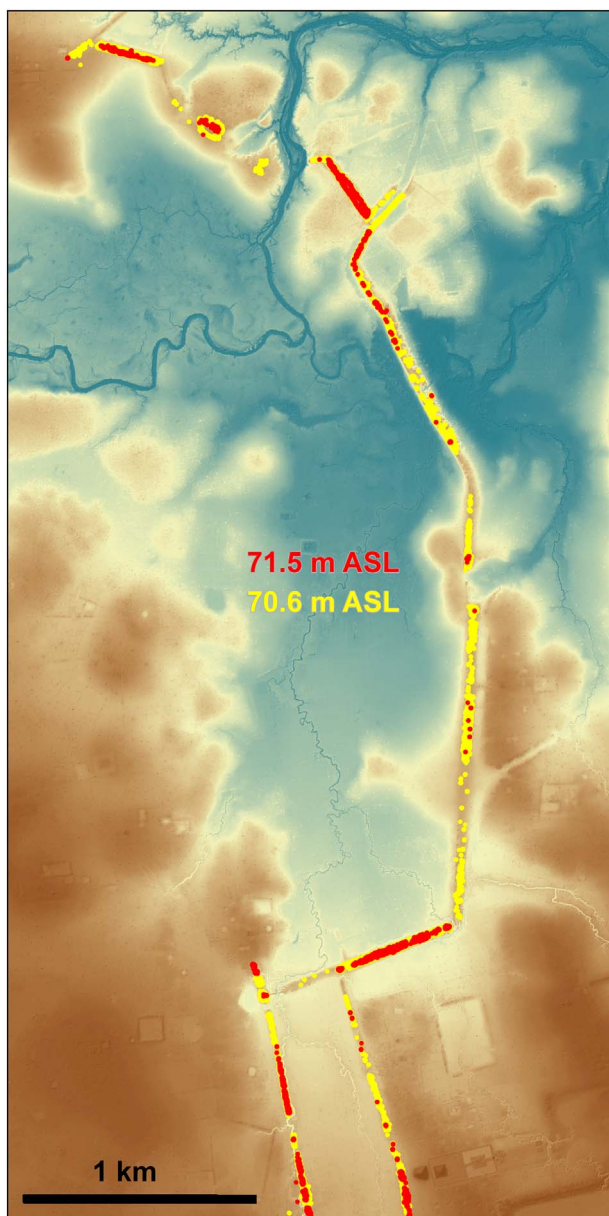
Fig. 8. Embankment showing where the crest is at or above 70.6 m ASL (yellow) and 71.5 m ASL (red), respectively.

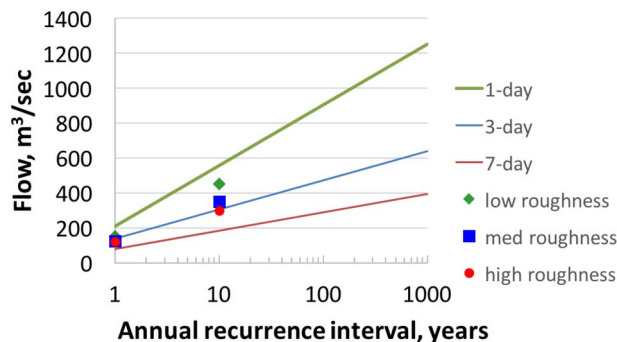
Fig. 18. Flood-frequency curve, derived from local and regional data. Markers indicate the results from the hydraulic modeling.

This scenario assumes simply that there has been a large and rare flood. The flood frequency derived by using the information from the villagers is plotted in Fig. 18 together with the results from the hydraulic modeling. The results from the hydraulic modeling were less than from the hydrological modeling for the 1-day flows, suggesting that the observed water levels may have been less than the actual peak. The maximum elevations reached in the reservoir are shown in Fig. 19 for the 3-day average modeling and Fig. 20 for the 1-day average modeling. The 3-day modeling indicated that the water level could
