Éric Maire, Stanislas Grabon, Jérôme Adrien, Pablo Lorenzino, Yuki Asanuma, et al.. Role of Hydrogen-Charging on Nucleation and Growth of Ductile Damage in Austenitic Stainless Steels. *Materials*, 2019, 12 (9), pp.1426. 10.3390/ma12091426 . hal-02271630

Role of Hydrogen-Charging on Nucleation and Growth of Ductile Damage in Austenitic Stainless Steels

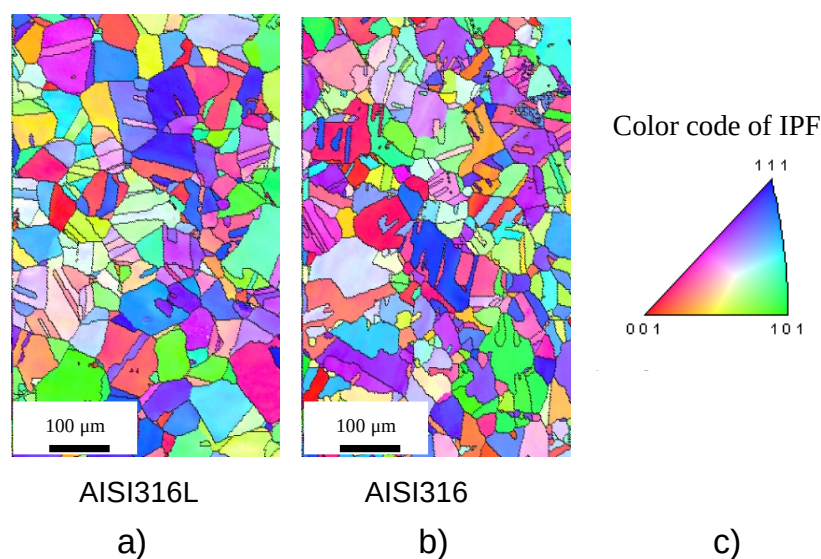
Figure 1. EBSD maps of the two different materials (a) non-charged AISI316L steel; (b) non-charged AISI316 steel; (c) inverse pole figure (IPF) coloring.

Figure 1 shows EBSD maps of the two studied alloys shown here to highlight the grain structure of the material. These were obtained by using a Schottky type FE-SEM (JEOL JSM-7001F) at an acceleration voltage of 15 kV. The grains have a similar size (around $100 \mu\text{m}$) and a similar amount of twins can be observed in both samples so the microstructure complies with our expectations for these very well known stainless steels. This value of the grain size is rather large compared to the sample diameter, but there are at least ten grains along the diameter so a total number of about 100 grains in a given section of the sample. This is a sufficient number of grains to insure that the mechanical behavior is not strongly influenced by plasticity gradient effects. The assessment of the texture would be interesting but is out of the scope of this paper.

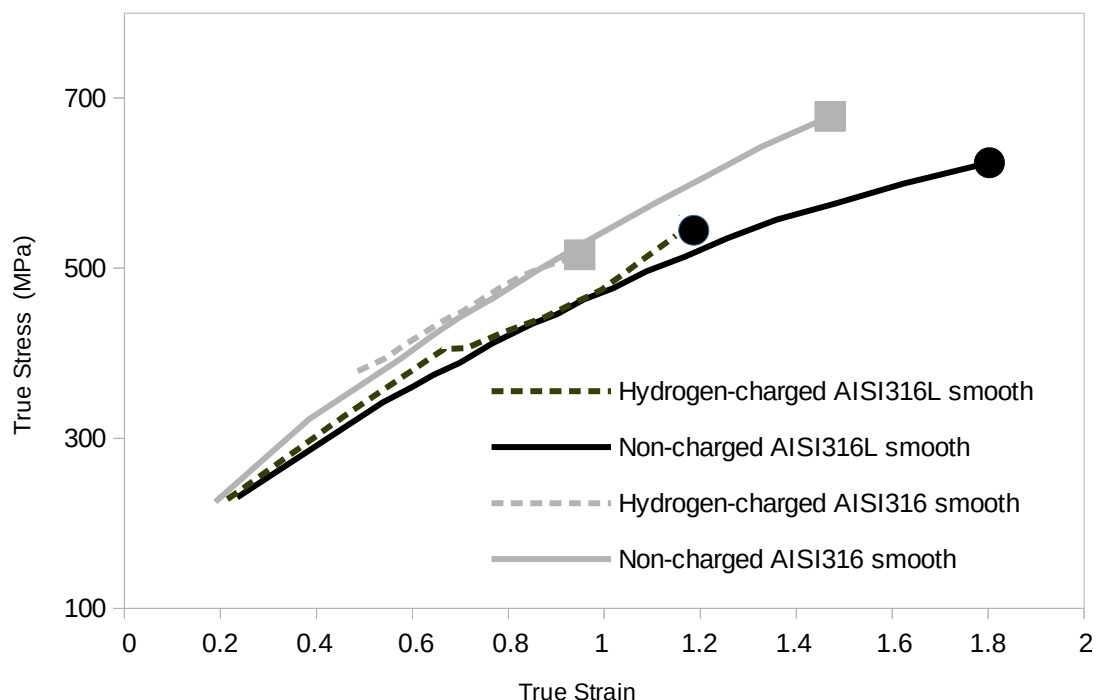
Figure 2. Tensile curve of the different samples (true stress vs. true strain).

where S_{min}^0 is the value of S_{min} in the initial tensile state. Figure 2 shows the true stress—true strain curves (the hardening curves) recorded during our experiments for all the samples tested. It should in principle start at zero true plastic strain, but, in our case, true strain and true stress were measured at each stop during the interrupted test, with a first step at ε close to 0.2. We have no precise measurement of the yield stress of these samples during the in situ tensile test.

The hardening curves are close together with AISI316 hardening a bit more, probably due to its higher C content. We have gathered the ductility values measured from these in situ tensile tests referred to as ε^f in Table 3. We also calculated in this table the decrease in ductility induced by hydrogen charging DDH, calculated as:

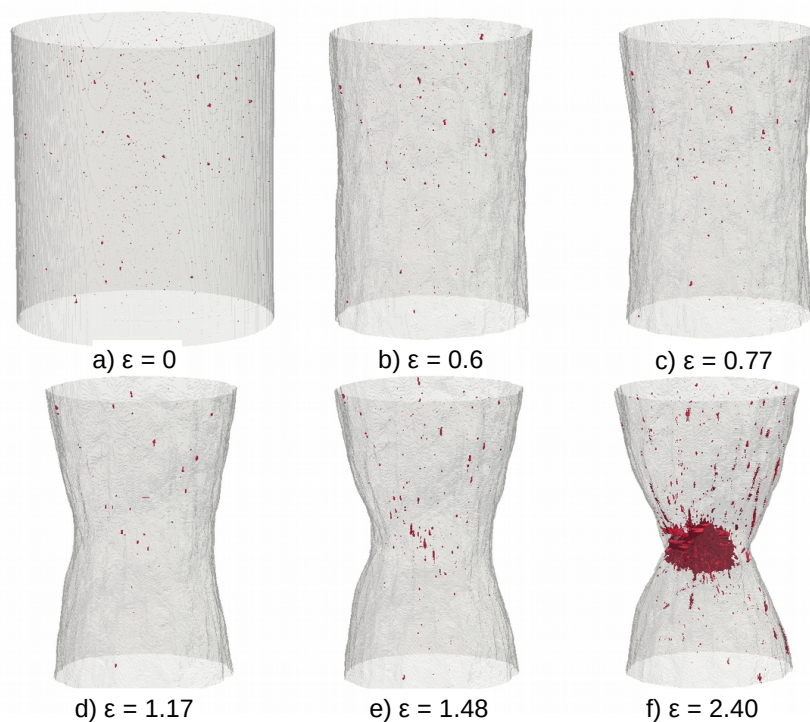
Figure 3. Damage evolution in the non-charged AISI316L sample observed as a volume rendering. The outer surface of the sample is transparent grey and the cavities are the dark red dots. Damage nucleates then grows and finally coalesce in the bottom right image (a) initial state; (b) true strain $\epsilon = 0.6$; (c) $\epsilon = 0.77$; (d) $\epsilon = 1.17$; (e) $\epsilon = 1.48$; (f) $\epsilon = 2.40$.

Figure 3 shows (as a selected representative example) a volume rendering of the evolution of the cavities in the non-charged AISI316L. It shows similar features compared to what was already observed in [17] on the same type of material. Voids, nucleate grow and coalesce during the severe plastic deformation of the sample, especially in the central region of the notch. This typical evolution is also observed in all the different tested samples and will be quantified further in a subsequent section.

By analyzing carefully volume series like the one shown in Figure 3 for every type of sample, qualitative differences were observed depending on the nature of the material and hydrogen charging. To highlight these differences, Figure 4 compares reconstructed slices of four typical samples in the

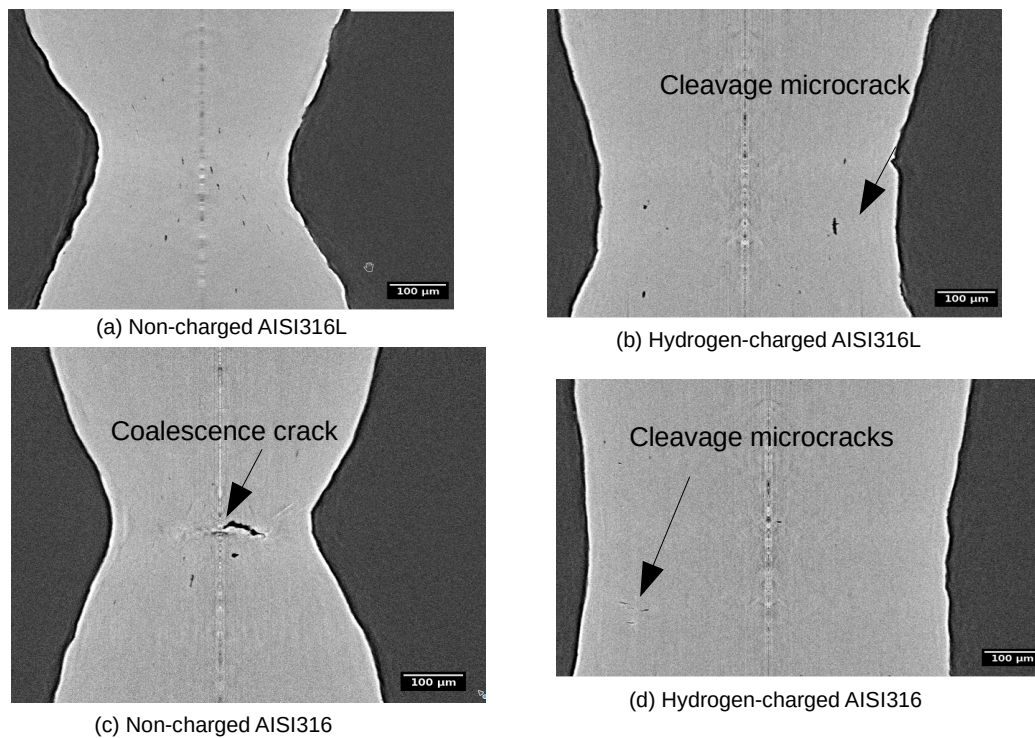
Figure 4. Reconstruction slices extracted parallel to the tensile axis in a central plane for the four samples in the ultimate state before fracture. AISI316 is clearly less deformed at fracture and contains local cleavage microcracks when hydrogen charged. The deformation in the different images are (a) $\epsilon = 2.40$ for non-charged AISI316L; (b) $\epsilon = 1.36$ for hydrogen-charged AISI316L; (c) $\epsilon = 1.92$ for non-charged AISI316; (d) $\epsilon = 0.95$ for hydrogen-charged AISI316.

last step before fracture. It is very clear from these images that the non-charged samples (left column) exhibit a much higher ductility, the section reduction and necking being much higher. Voids have then nucleated, grown and coalesced (see the big coalescence event observed for the non-charged AISI316 sample). This behavior is very typical of ductile metals. The right column shows the effect of hydrogen-charging on the final deformation stage. As already highlighted by Table 3, ductility was clearly reduced (necking is much less pronounced). Micro-cracks perpendicular to the tensile axis are observed in these reconstructions (as can be seen in Figure 5a) in the AISI316 sample but to a lesser extent in the AISI316L.

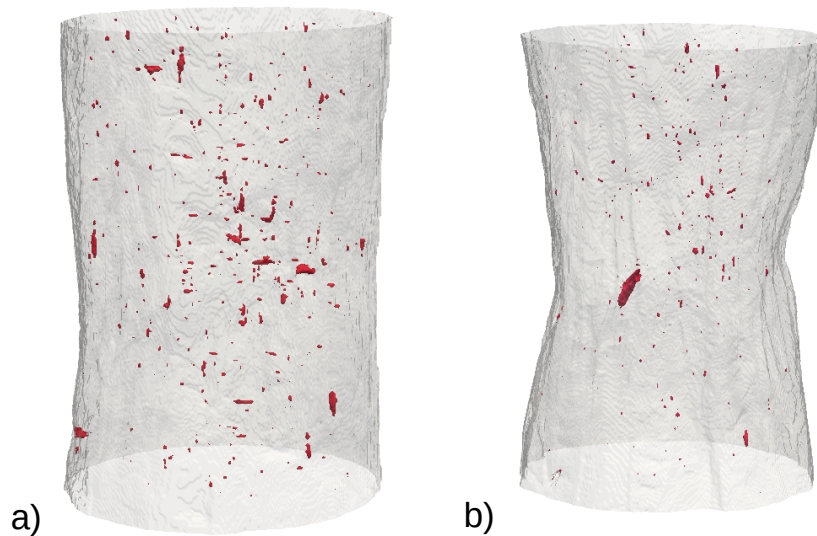
Figure 5. Volume rendering (a) hydrogen-charged AISI316 sample just before coalescence. The amount of penny shaped microcracks is very important. The deformation in the image is $\epsilon = 0.79$; (b) hydrogen-charged AISI316L sample just before coalescence. The morphology of the cavity is elongated along the tensile direction. The deformation in the image is $\epsilon = 1.15$.

Figure 5 compares 3D renderings of the hydrogen-charged AISI316 and AISI316L in the final stage just before coalescence. The figure clearly shows that the AISI316 exhibits many more microcracks than the AISI316L sample in which the voids are elongated along the tensile axis. In the AISI316, cracking from surface can be observed.

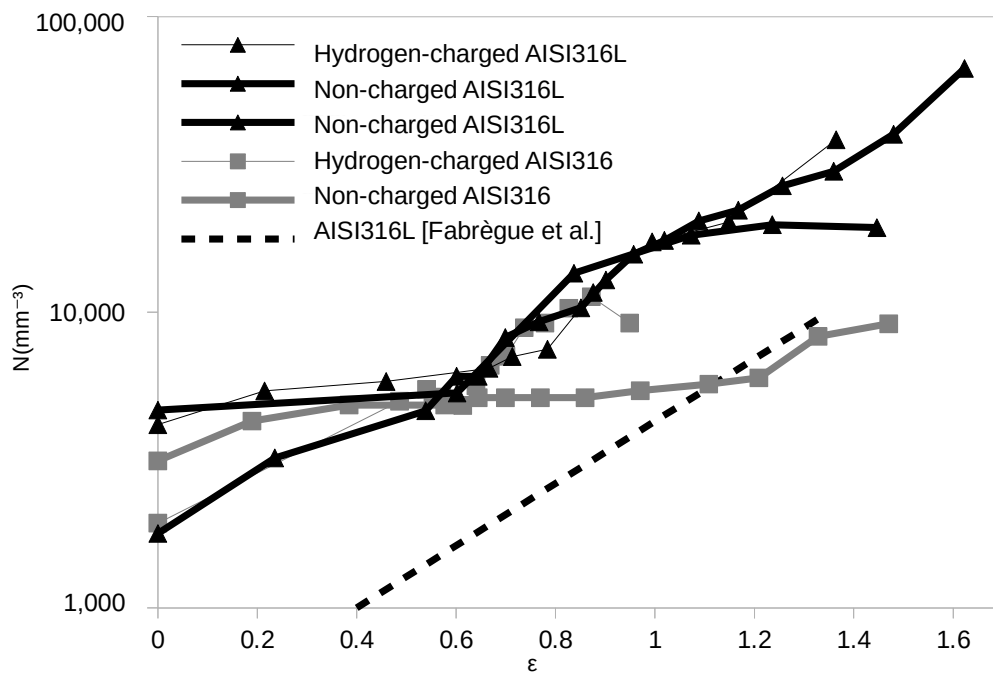
Figure 6. Nucleation quantified as the evolution of the density of cavities with strain. The nucleation in the non-charged AISI316L sample is anomalously small because of a small amount of nucleation in the necked region for this sample. From the behavior of the three other materials, it can be concluded that hydrogen charging has a weak effect on the nucleation kinetics. The measurements by Fabrègue et al. [17] are also shown as a dotted line. These were made using a larger voxel size (1.6 μm pixel size) which explains the lower level of nucleation detected, but the slope of the curve is in line with the measurements of the present paper.

Void nucleation was firstly quantified by calculating the number of cavities n_c in every cropped volume. The mean cavities density N per cubic mm was calculated by dividing n_c by the value of the analysed sub-volume. Figure 6 shows the evolution of the void density N as a function of the true strain for AISI316L and AISI316. Two samples were tested for the non-charged AISI316L; they are both plotted on the figure and they show a similar behavior. Nucleation being quite exponential with strain in steels (already observed in [15]), we have plotted the results in a logarithmic scale. Note first that the number of nucleated cavities is rather small in these samples. This is because of the homogeneous nature of these materials which present very few inclusions where damage can nucleate. It can be seen that, in the non-charged state, N increases very slowly in the AISI316 steel. We have noticed that, surprisingly, for this particular AISI316 sample, nucleation was anomalously small inside the neck and was mainly located at the periphery of the sample, where strain and triaxiality are not at their maximum. This is probably because when nucleation is very scarce, as is the case in these two materials, the random nature of the location of the nucleation site can lead to such surprising observations. We have then decided to reject this sample from the rest of the quantification. From the measurement of the three other materials, where nucleation was more substantial, it appears that hydrogen charging has only a weak effect on the nucleation kinetics, as can be measured by X-ray CT. The dotted curve included in the figure also shows the results that we previously obtained in [17] for a standard non-charged AISI316L sample (of different origin than the one used in this study). For these previous measurements, we were using synchrotron X-ray CT with a pixel size of $1.6 \mu\text{m}$ so detection capacity was smaller. This explains that the observed number of cavities was smaller in previous study. Despite these differences, we believe that it is comforting to see that the slope of the different curves are similar. The fact that N decreases at high strain for the hydrogen-charged AISI316 can be attributed to coalescence.

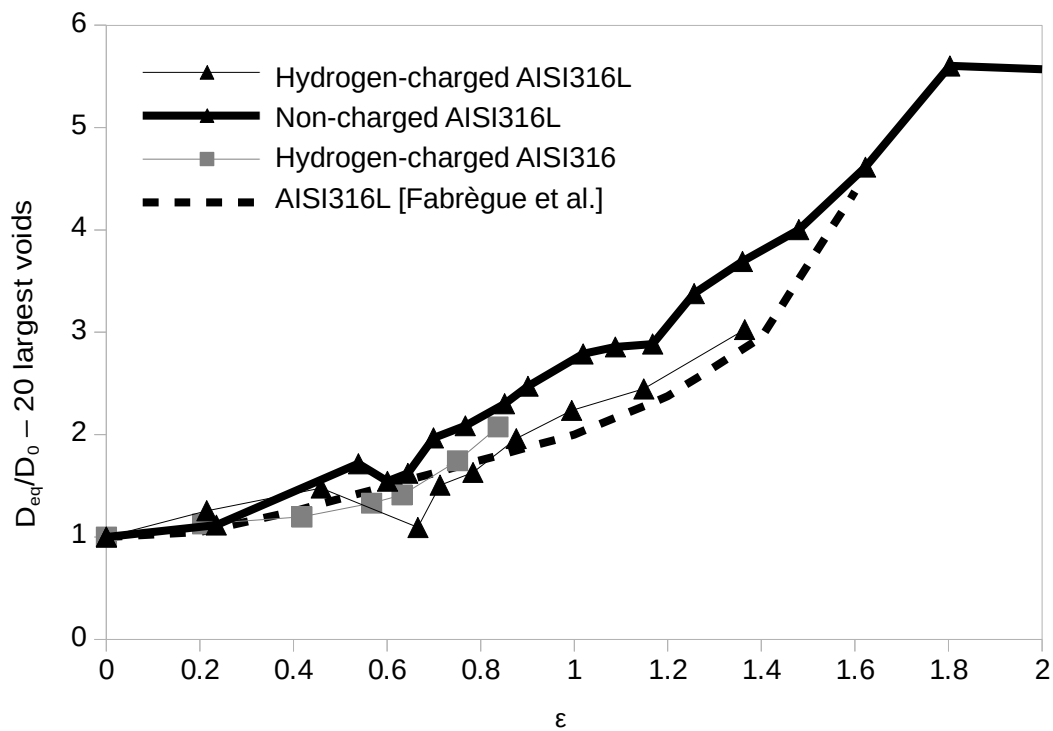
Figure 7. Growth of the average equivalent diameter of the 20 largest cavities with strain.

It has been shown in previous studies that growth could be easily estimated by quantifying the average value of the largest cavities assumed to remain the same from one strain step to the next [23]. Here, we have chosen to work with the 20 largest cavities in the cropped volume as a function of the true strain for the AISI316L non-charged, and for the two charged materials. For the sake of clarity, we have rationalized the values of D_{eq} by dividing it by its value at 0 strain D_0 . Previous measurement [17] is also shown as a dotted curve. In terms of growth, we clearly show again here that hydrogen charging has a weak effect of the growth rate of the cavities.

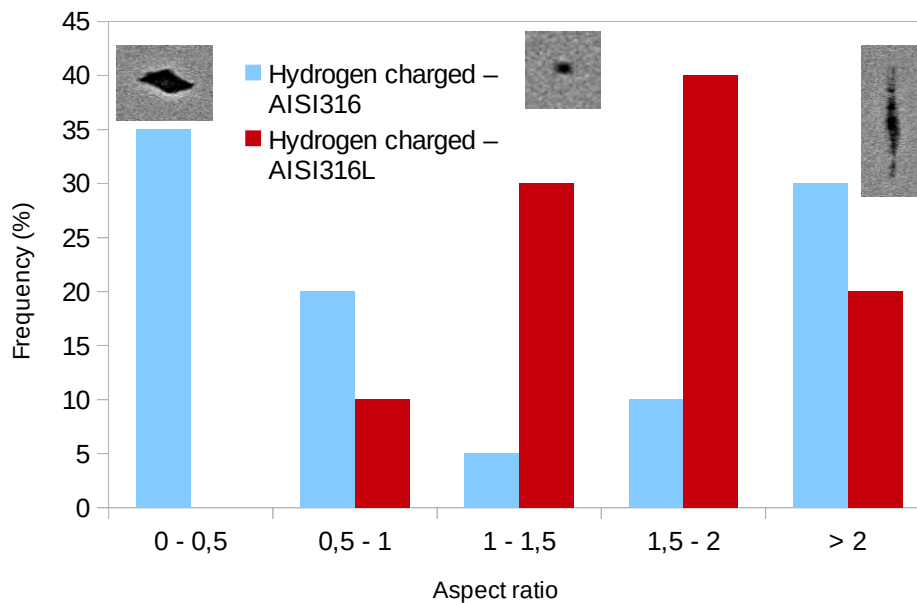
Figure 8. Histogram of the distribution of the aspect ratio of the 20 largest cavities in the two hydrogen charged materials in the state just before fracture.

The aspect ratio is smaller than one for cracks and higher when the cavities are elongated along the tensile direction. Figure 8 compares the histogram of the values of the aspect ratio for the 20 largest cavities, for the two charged materials. This comparison is performed for a similar deformation step close to fracture. This histogram confirms the visual impression in Figure 5 i.e., the cavities have a crack-like shape in the case of the AISI316 sample and much less for the AISI316L.

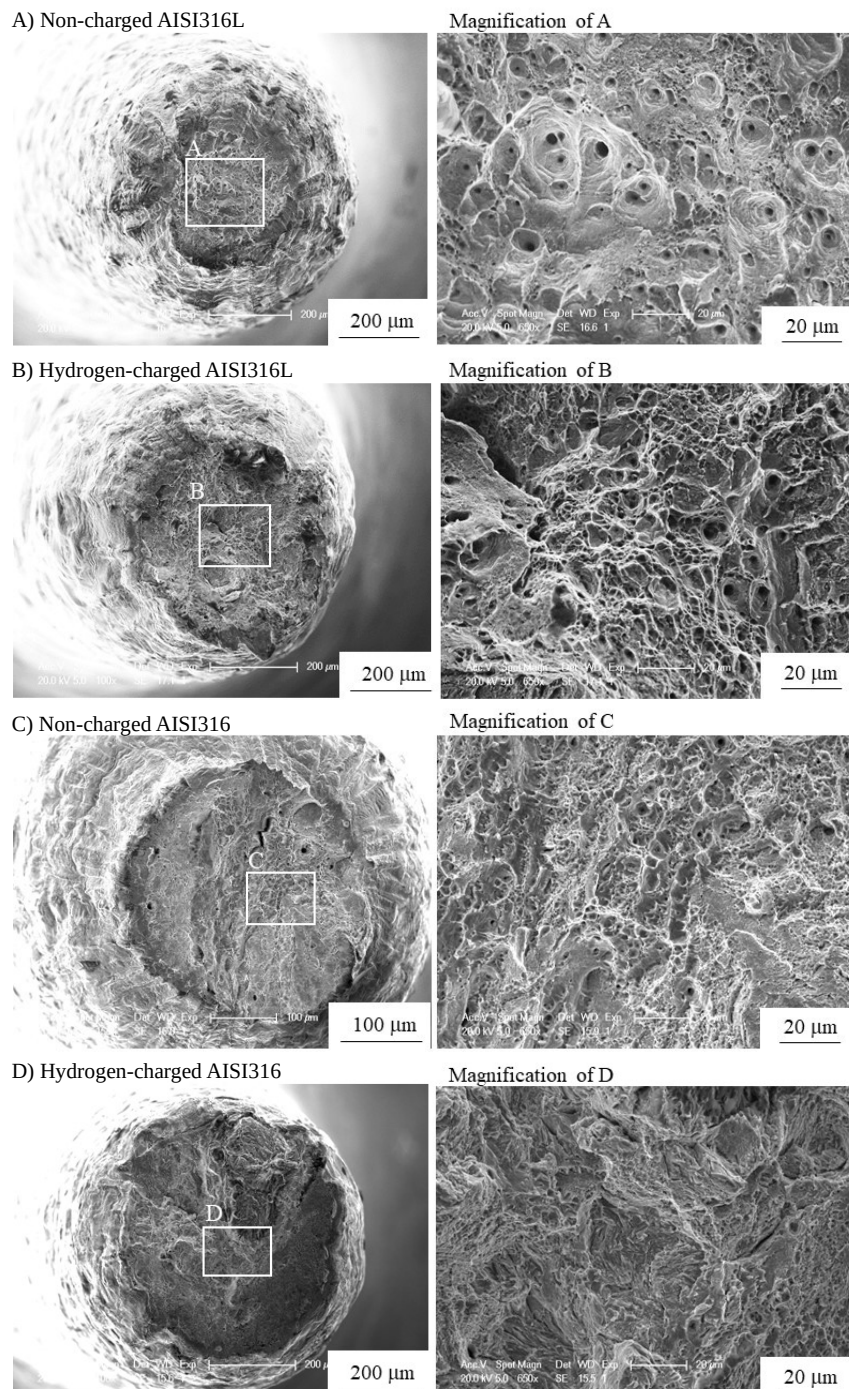
Figure 9. Fractography of non charged and hydrogen-charged samples.

It is presumed that the variation in the aspect ratio of voids in hydrogen charged specimens is dominated by void growth in AISI316L and is dominated by the mixture of micro crack propagation and/or void growth in AISI316. As mentioned above, the aspect ratio of 0–0.5 corresponds to micro cracking and that of 0.5–1.0 corresponds to a mixture of micro cracking and/or void growth. For the samples charged with hydrogen, in AISI316, micro cracking dominated the fracture process. By contrast, in AISI316L, the fracture process was dominated by void growth. As a verification of these fracture characteristics, Figure 9 shows the fracture surface of hydrogen charged and non charged specimens as observed using SEM. In non charged specimens, the ordinary void nucleation, growth and subsequent coalescence are the main processes of the fracture in both AISI316 and 316L. As a result, cup and cone fracture occurred. In hydrogen charged AISI316, fracture surface was predominately covered by so called “quasi cleavage” (QC) with some small and elongated dimples. It is noted that QC corresponds to the cavities with the aspect ratio of 0–0.5 in Figure 8. By contrast, in hydrogen charged AISI316L, fracture surface is covered by smaller dimples compared to the non charged case, and QC is rarely observed.

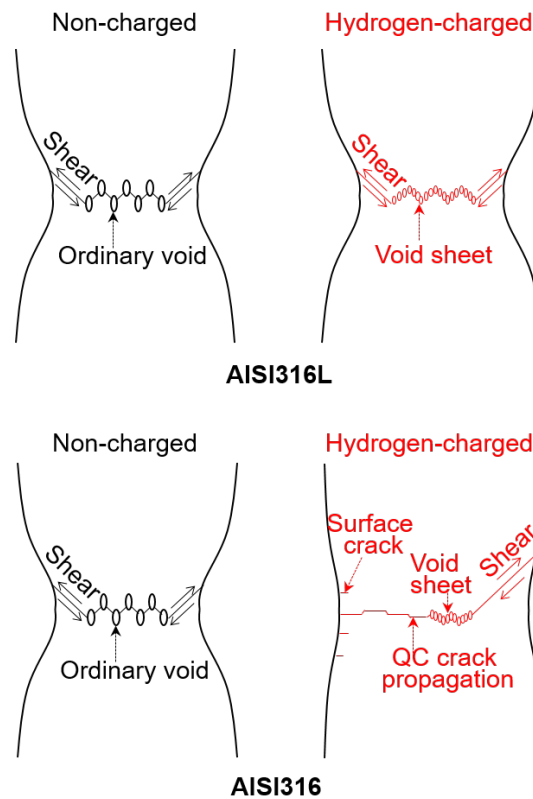
Figure 10. Schematic illustration of fracture mechanism in non-charged and hydrogen-charged AISI316 and 316L.

Some of the authors of this paper proposed that a combination of slip localization due to the presence of hydrogen and the phase transformation in the vicinity of the crack tip causes a successive crack propagation [1]. On the other hand, in hydrogen-charged AISI316L, the QC was not generated since the material has a high austenite stability. Therefore, voids nucleated in the central part where stress triaxiality was high, i.e., necked region, with a similar mechanism to non-charged specimen. Hydrogen made the voids easier to coalesce by local shear stress owing

to the slip localization, which resulted in void sheet formation [26]. The details in the tensile fracture mechanism of austenitic stainless steels charged with hydrogen have been comprehensively discussed in the literature [2]. The set of results presented above clearly visualize and verify the mechanism of the hydrogen-induced degradation.
