## Application of non destructive testing to the detection of aeronautical defects in composite structures

# APPLICATION OF NON DESTRUCTIVE TESTING TO THE DETECTIONS OF AERONAUTICAL DEFECTS IN COMPOSITE STRUCTURES

**ABSTRACT:** A study of two Non-destructive Testing methods (NDT) was carried out in specimens with different kinds of simulated defects. Ultrasonics test (US) and Infrared Thermography (IRT) were applied with the aim of evaluate the detectability and the accuracy of each method. These techniques acquired great importance in the aeronautics industry because they control the aerostructure without intervening in their physical and mechanical integrity. In the second part of the study, a comparison of both techniques was done with the purpose of analysing their limits and advantages. It appeared that detectability of defects was much better in a sample with flat-bottomed holes defects in the case of Ultrasonic Test. However it was found that Infrared Thermography is far more limited to the thickness of the specimen than the ultrasonic waves. On the other hand, defects were all revealed with IRT in a sandwich composite including Teflon inserts, which was not the case for U

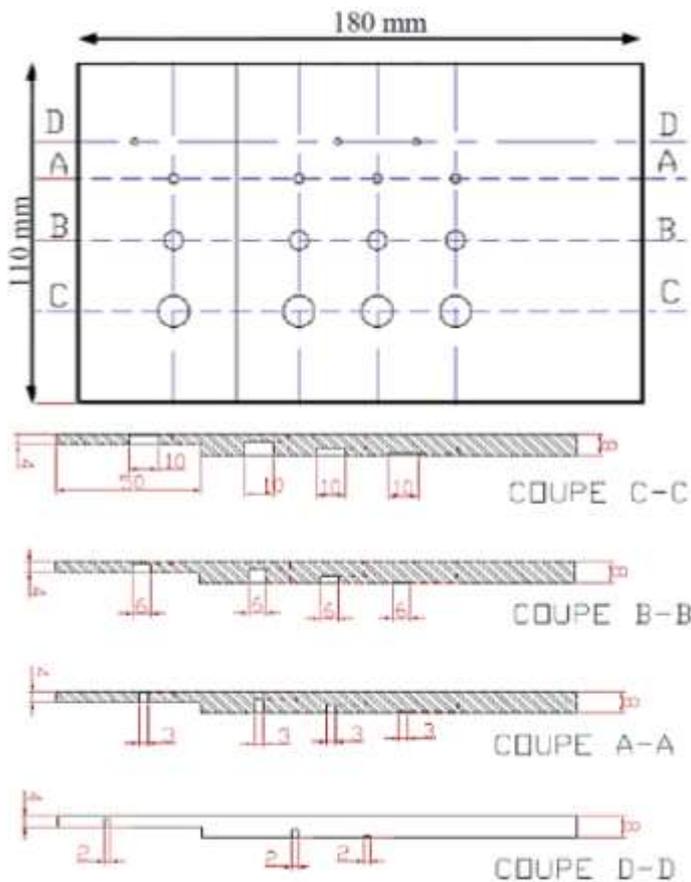
Figure 1. Manufacturing drawing of the specimen A

The specimen used to compare the detectability and accuracy between the IRT and the US is a carbon/epoxy laminated composite with flat bottomed holes defects and variable thickness. It is called specimen A (figure 1). This sample is divided in 2 sections. The first one is 4 mm width in 50 mm length. The second section is 130 mm length with 8 mm width. This sample contains 15 holes with diameters ranging from 2 mm to 10 mm. These holes have different deepness (from 0.52 mm until 7.5 mm). The aim of these holes is to simulate discontinuity on the specimen that is considered as a continuous medium.

Analyses of results are made taking into account two parameters: detectability and accuracy. 14 of the 15 holes were detected by this method. This is the 93% of them. The only defect that was not detected, is the one located at 1 mm deep and 2 mm of diameter. However, it is noticed that defects located near the contact surface (less than 1 mm) are difficultly distinguish from the signal input peak. On the other hand, the detected defects were measured on average, 1 mm larger or smaller than they really are. Defects located at 7.5 mm deep (3 and 6 mm diameter) were measured 1 mm smaller than their real size, and those located at 5,2 mm deep (2, 3 and 6 mm diameter) were measured at the correct dimension. 10 mm diameter defects were all measured 1 mm larger than their real size. Table 1 shows the measured dimension for each range of defects.

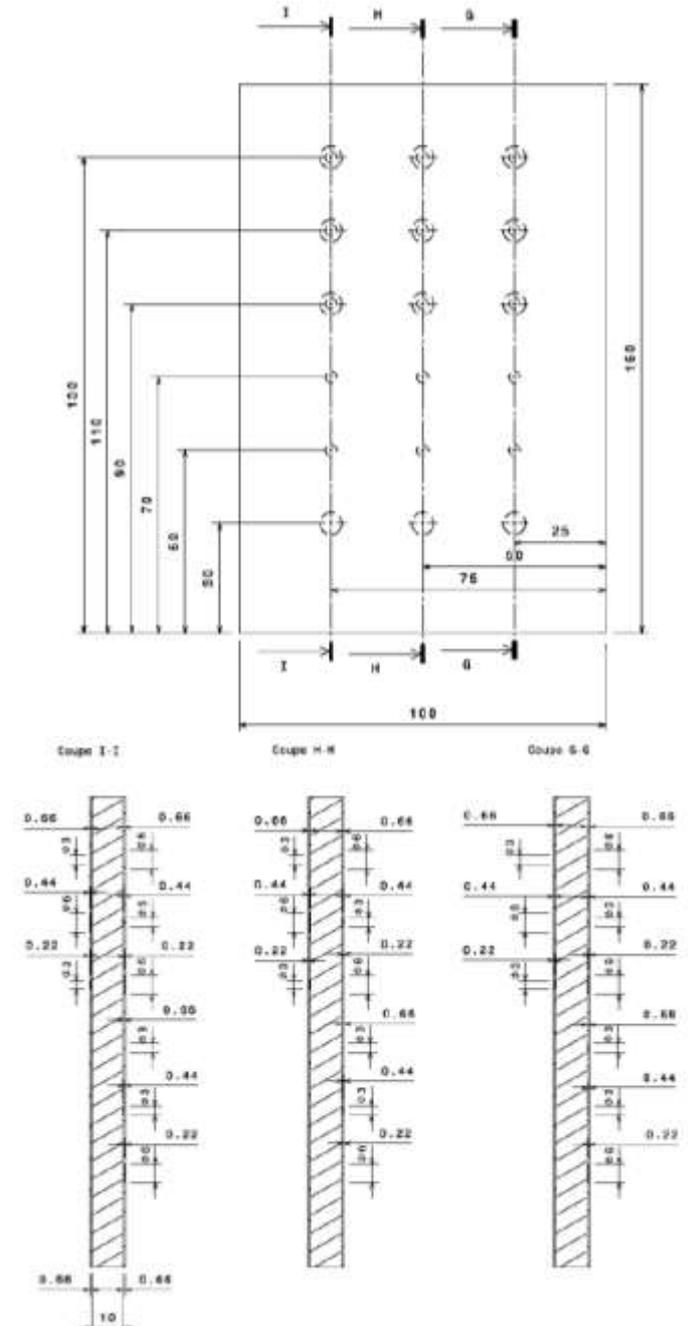
Figure 2. Manufacturing drawing of the specimen B

A second sample, called specimen B was also used. It was tested only in infrared thermography because of its materials properties. This specimen is a carbon-glass-epoxy skin with foam-core sandwich composite including Teflon inserts. The thickness of its skin is 0.66 mm. It has been demonstrated that the foam-core is a sound insulation, whereby, the ultrasonic waves can not penetrate this specimen to

be detected by the receiving transducer [5]. This specimen contains 18 defects. These simulated flaws are Teflon inserts ranging from 3 mm to 6 mm. They are located at the skin section. These inserts were placed during the stacking of the tissues so that they simulate as best as possible a delamination in the sample. The manufacturing drawing of this specimen is showed in figure 2.

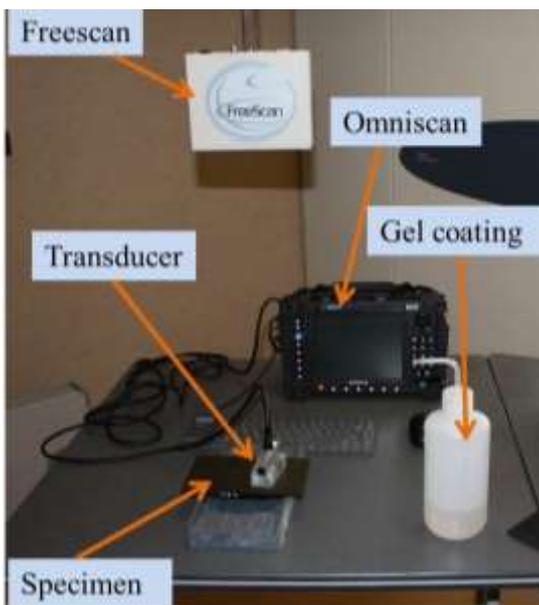
**Figure 3.** Ultrasonic measurement

In this study, a Omniscan 32: 128 PR is used with a 5L64-NW1 multi-elements transducer. The Omniscan is both, ultrasonic source and receiver at the same time. The frequency of the transducer is 5 MHz, which is the common frequency in aeronautics NDT [5]. For specimen A, the wave velocity is 2983 m s<sup>-1</sup>. This experiment was carried out by contact; therefore it is necessary to use a gel coating between the sample and the transducer. Ultrasonics testing enables two-dimensional mapping, accordingly, a freescan was also used as a coding system to detect the position of the transducer in regard to the specimen. Specimen A was placed in a support to hold it while the experiment was being carrying out. Figure 3 shows the ultrasonics device.

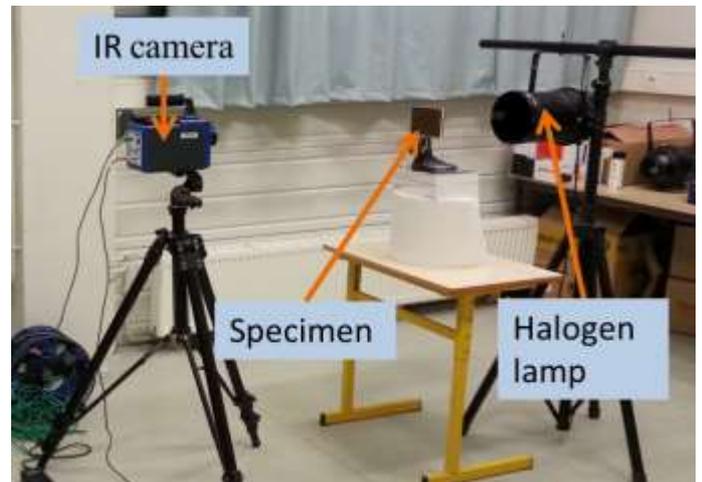
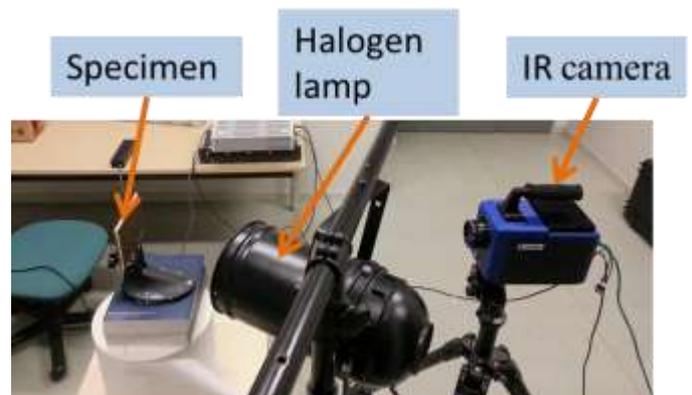
**Figure 4.** Infrared measurement

To heat the sample, a 1000 W halogen lamp is used in two configurations: transmission and reflection. Specimen A was tested only in transmission mode (figure 4a) and specimen was tested in both configurations (figure 4a and 4b). The infrared sensor was an IR camera whose thermal resolution was 20 mK. A 30 s and 50 Hz movie was recorded in which 15 s corresponds to the heating of the sample and the 15 last seconds to its cooling. The treatment of the movie was done with the ALTAIR software. The analysis of the movie is done in relative mode with the purpose of removing the ambient temperature.

For the carbon-glass-epoxy skin with foam-core sandwich composite, the use of infrared thermography is quite difficult since the foam is a thermal insulator. It is recommended to control the 2 skins of the sandwich separately and in reflection mode (figure 4b). Otherwise, the heat flux may not arrive to the detection surface.

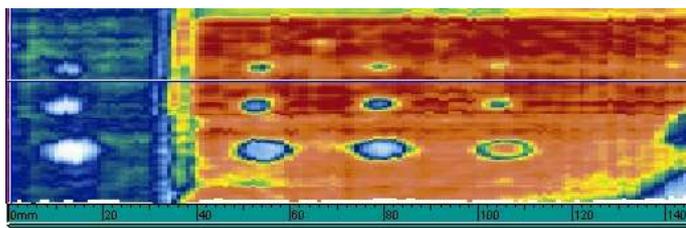
Figure 6. Lock-in thermography connection

Figure 6 shows the C-Scan mapping for this specimen in which measurements were done.

The C-Scan mapping in US shows that detectability is more affected by the diameter of defects rather than thickness. This detection becomes more difficult when the defect is close to the detecting

surface (less than 1 mm). In this case the defect echo is confused with the echo of the detection surface.

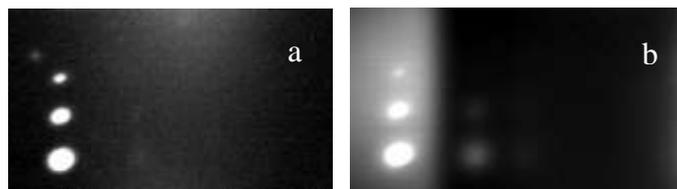
Figure 7. IRT mapping of specimen A

As in US testing, two parameters were taken into account to analyse the results: detectability and accuracy. A single picture must be selected from the recorded film. That selection depends on the quality of the image for each defect. In this study, for specimen A, 2 different images (figure 7) were selected to measure 2 ranges of defects located in two different sections of the specimen. These ranges of defects are located at 0.52 mm and 2.8 mm deep respectively and they are in the 4 mm section and 8 mm section of the sample. Figure 7 shows that only 6 from the 15 defects, were detected using classical IRT in transmission mode.

Defects at 0.52 mm deep were measured using image 7a and those at 2.8 mm deep using image 7b. It is noticed that heat saturation is generated after a short period of time. The 4 mm width section is rapidly saturated and in the 8 mm width section, no other defect is revealed with the increasing temperature.

visible beyond 2.8 mm in a carbon-epoxy laminated composite. However, by the use of lock-in IRT, the reach on thickness became to 5.2 mm. At any rate, diameter of defects also affects the detectability in IRT. Figure 7b and 8 shows that flaws located in the same range of deepness with different diameter are not all detected. The heat diffusivity inside the material does not let to see temperature difference in the surface of the sample.

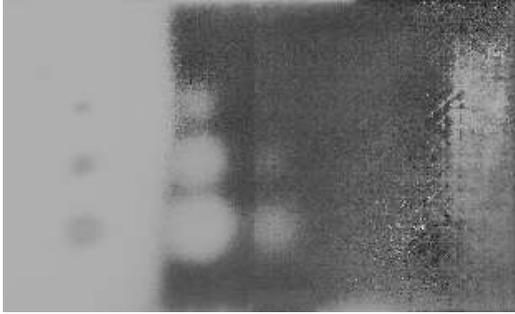
**Figure 8.** Lock-in IRT in specimen A

In lock-in IRT, the number of detected defects in specimen A increased. However, no measurement of their size was done because of the temperature difference. In addition to classical IRT, 3 mm diameter defect at 2.8 mm deep and 5.2 mm deep defects (6 and 10 mm diameter) were visible as shown in figure 8.

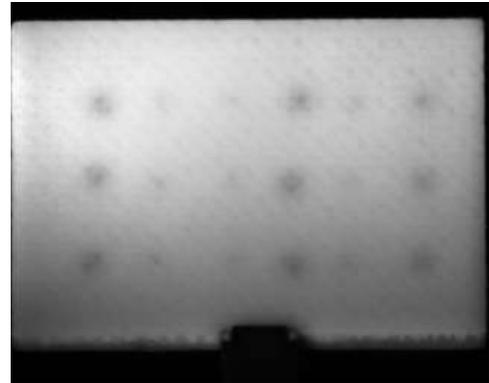
**Figure 9.** Lock-in IRT in specimen B

In the case of specimen B, lock-in IRT has similar results as in classical IRT. All defects were detected and they could be measured in diameter.

Best results were obtained at 0.1 Hz for both specimens tested in lock-in IRT. It was founded that the textured surface of specimen B was confounded with the defects in IRT mapping. Measurements were therefore less accurate than classical IRT in specimen A.

Defects located at the camera side, were easily distinguished; on the other hand, defects located on the opposite side of the camera, were difficultly detected. In addition, the dimension of the measurements was 2 or 3 mm larger that the real size of the defect. Table 3 shows the founded size for each range of defects.

Figure 9 shows the result on specimen B tested by lock-in thermography.

Péronnet E. [5] tested the same sample and found a gap between real size and measured size ranging from 1.5 mm to 3.5 mm. This information is in accordance regarding the experiments on the present study.
