# APPLICATION OF NON DESTRUCTIVE TESTING TO THE DETECTIONS OF AERONAUTICAL DEFECTS IN COMPOSITE STRUCTURES

**ABSTRACT:** A study of two Non-destructive Testing methods (NDT) was carried out in specimens with different kinds of simulated defects. Ultrasonics test (US) and Infrared Thermography (IRT) were applied with the aim of evaluate the detectability and the accuracy of each method. These techniques acquired great importance in the aeronautics industry because they control the aerostructure without intervening in their physical and mechanical integrity. In the second part of the study, a comparison of both techniques was done with the purpose of analysing their limits and advantages. It appeared that detectability of defects was much better in a sample with flat-bottomed holes defects in the case of Ultrasonic Test. However it was found that Infrared Thermography is far more limited to the thickness of the specimen than the ultrasonic waves. On the other hand, defects were all revealed with IRT in a sandwich composite including Teflon inserts, which was not the case for US.

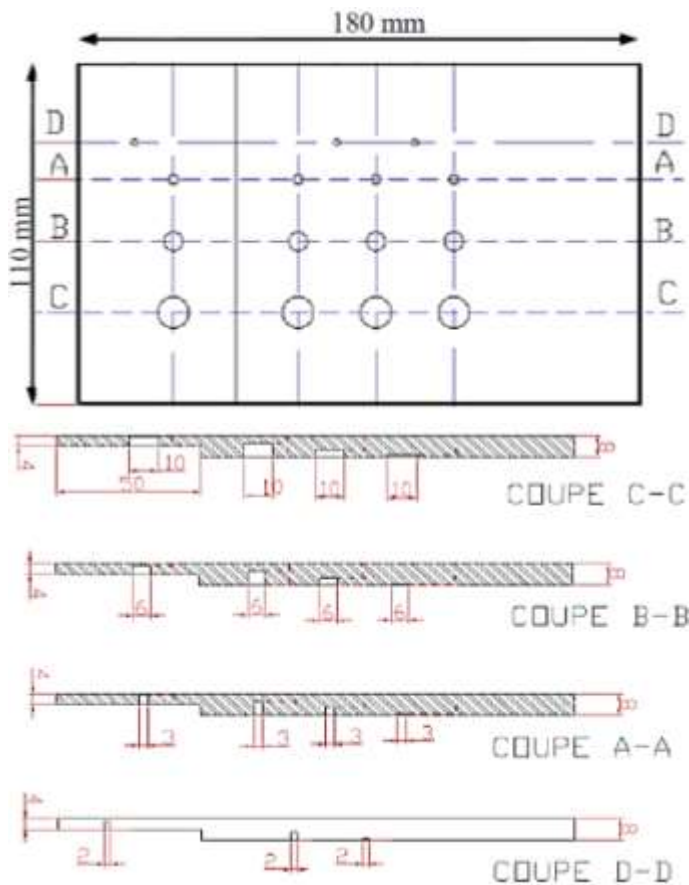
Figure 1. Manufacturing drawing of the specimen A

The specimen used to compare the detectability and accuracy between the IRT and the US is a carbon/epoxy laminated composite with flat bottomed holes defects and variable thickness. It is called specimen A (figure 1). This sample is divided in 2 sections. The first one is 4 mm width in 50 mm length. The second section is 130 mm length with 8 mm width. This sample contains 15 holes with diameters ranging from 2 mm to 10 mm. These holes have different deepness (from 0.52 mm until 7.5 mm). The aim of these holes is to simulate discontinuity on the specimen that is considered as a continuous medium.

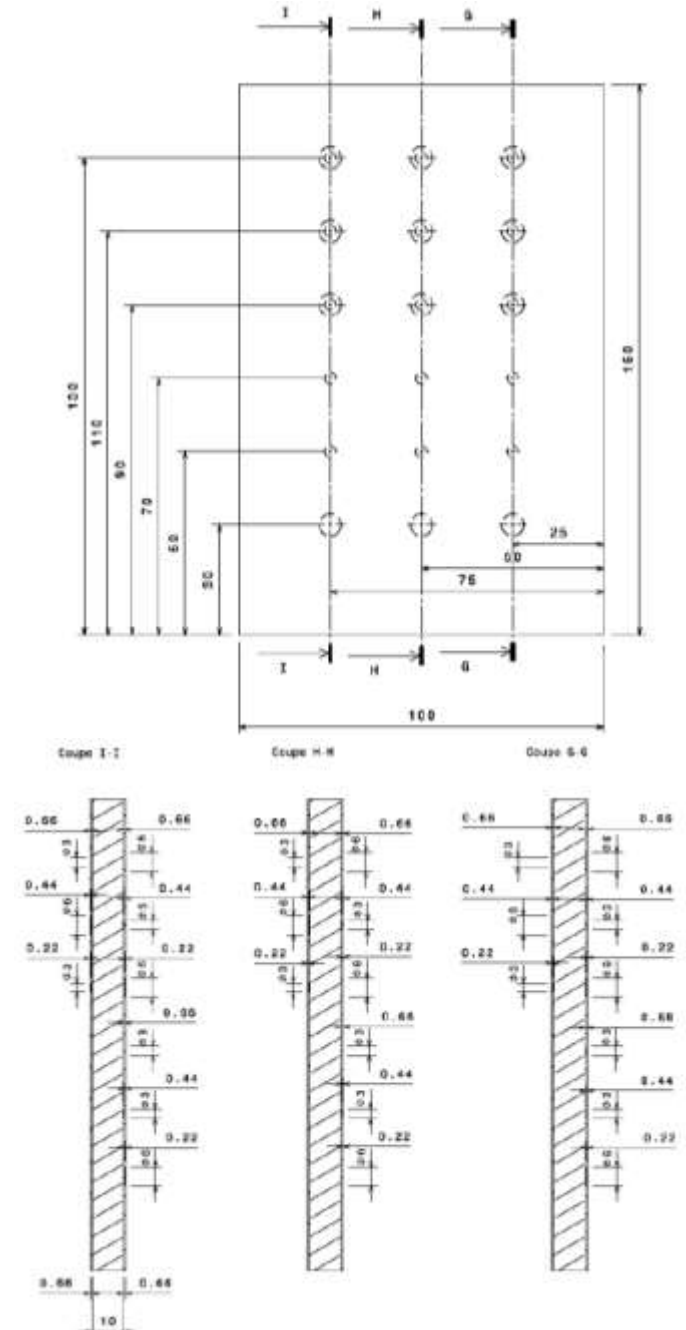
Figure 2. Manufacturing drawing of the specimen B

A second sample, called specimen B was also used. It was tested only in infrared thermography because of its materials properties. This specimen is a carbon-glass-epoxy skin with foam-core sandwich composite including Teflon inserts. The thickness of its skin is 0.66 mm. It has been demonstrated that the foam-core is a sound insulation, whereby, the ultrasonic waves can not penetrate this specimen to

be detected by the receiving transducer [5]. This specimen contains 18 defects. These simulated flaws are Teflon inserts ranging from 3 mm to 6 mm. They are located at the skin section. These inserts were placed during the stacking of the tissues so that they simulate as best as possible a delamination in the sample. The manufacturing drawing of this specimen is showed in figure 2.

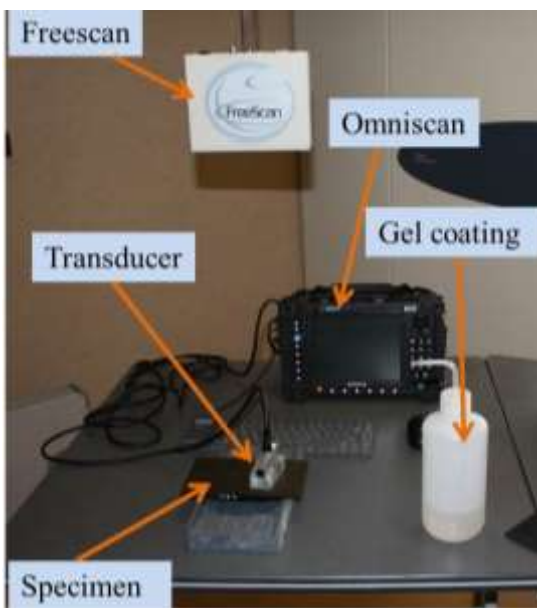
**Figure 3.** Ultrasonic measurement

In this study, a Omniscan 32: 128 PR is used with a 5L64-NW1 multi-elements transducer. The Omniscan is both, ultrasonic source and receiver at the same time. The frequency of the transducer is 5 MHz, which is the common frequency in aeronautics NDT [5]. For specimen A, the wave velocity is 2983 m s<sup>-1</sup>. This experiment was carried out by contact; therefore it is necessary to use a gel coating between the sample and the transducer. Ultrasonics testing enables two-dimensional mapping, accordingly, a freescan was also used as a coding system to detect the position of the transducer in regard to the specimen. Specimen A was placed in a support to hold it while the experiment was being carrying out. Figure 3 shows the ultrasonics device.

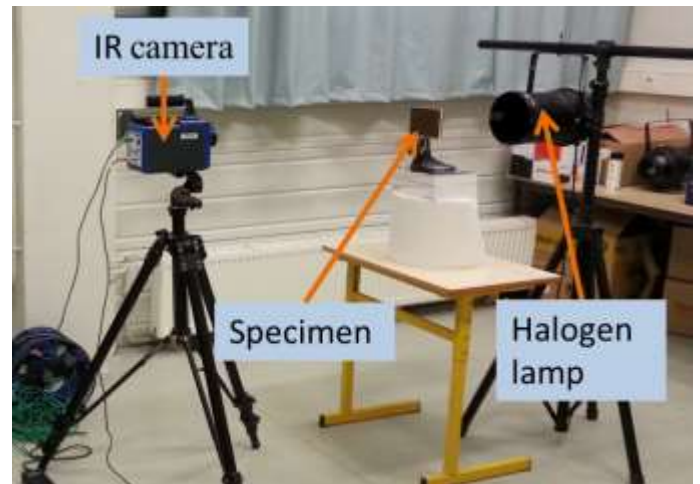
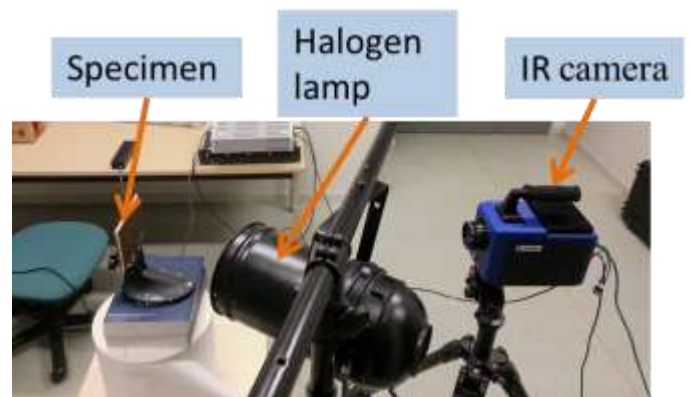
**Figure 4.** Infrared measurement

To heat the sample, a 1000 W halogen lamp is used in two configurations: transmission and reflection. Specimen A was tested only in transmission mode (figure 4a) and specimen was tested in both configurations (figure 4a and 4b). The infrared sensor was an IR camera whose thermal resolution was 20 mK. A 30 s and 50 Hz movie was recorded in which 15 s corresponds to the heating of the sample and the 15 last seconds to its cooling. The treatment of the movie was done with the ALTAIR software. The analysis of the movie is done in relative mode with the purpose of removing the ambient temperature.

a) Transmission mode

b) Reflection mode

For the carbon-glass-epoxy skin with foam-core sandwich composite, the use of infrared thermography is quite difficult since the foam is a thermal insulator. It is recommended to control the 2 skins of the sandwich separately and in reflection mode (figure 4b). Otherwise, the heat flux may not arrive to the detection surface.

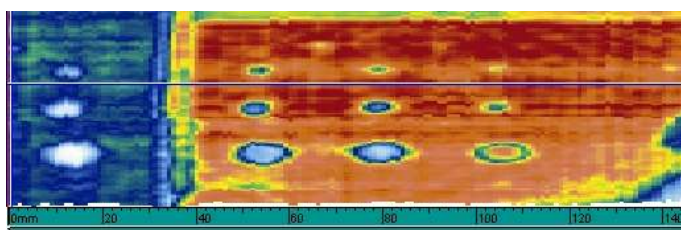
Figure 6. Lock-in thermography connection

Analyses of results are made taking into account two parameters: detectability and accuracy. 14 of the 15 holes were detected by this method. This is the 93% of them. The only defect that was not detected, is the one located at 1 mm deep and 2 mm of diameter. However, it is noticed that defects located near the contact surface (less than 1 mm) are difficultly distinguish from the signal input peak. On the other hand, the detected defects were measured on average, 1 mm larger or smaller than they really are. Defects located at 7.5 mm deep (3 and 6 mm diameter) were measured 1 mm smaller than their real size, and those located at 5,2 mm deep (2, 3 and 6 mm diameter) were measured at the correct dimension. 10 mm diameter defects were all measured 1 mm larger than their real size. Table 1 shows the measured dimension for each range of defects.

Figure 6 shows the C-Scan mapping for this specimen in which measurements were done.

The C-Scan mapping in US shows that detectability is more affected by the diameter of defects rather than thickness. This detection becomes more difficult when the defect is close to the detecting

surface (less than 1 mm). In this case the defect echo is confused with the echo of the detection surface.

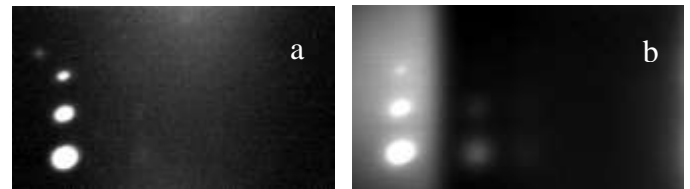
Figure 7. IRT mapping of specimen A

As in US testing, two parameters were taken into account to analyse the results: detectability and accuracy. A single picture must be selected from the recorded film. That selection depends on the quality of the image for each defect. In this study, for specimen A, 2 different images (figure 7) were selected to measure 2 ranges of defects located in two different sections of the specimen. These ranges of defects are located at 0.52 mm and 2.8 mm deep respectively and they are in the 4 mm section and 8 mm section of the sample. Figure 7 shows that only 6 from the 15 defects, were detected using classical IRT in transmission mode.

Defects at 0.52 mm deep were measured using image 7a and those at 2.8 mm deep using image 7b. It is noticed that heat saturation is generated after a short period of time. The 4 mm width section is rapidly saturated and in the 8 mm width section, no other defect is revealed with the increasing temperature.

visible beyond 2.8 mm in a carbon-epoxy laminated composite. However, by the use of lock-in IRT, the reach on thickness became to 5.2 mm. At any rate, diameter of defects also affects the detectability in IRT. Figure 7b and 8 shows that flaws located in the same range of deepness with different diameter are not all detected. The heat diffusivity inside the material does not let to see temperature difference in the surface of the sample.

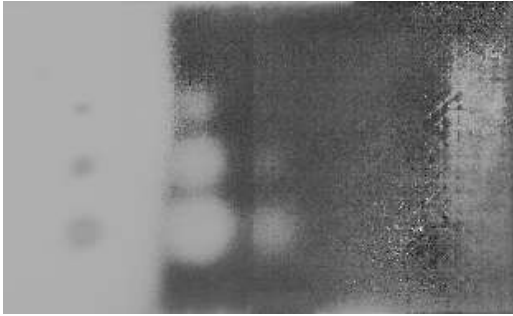
**Figure 8.** Lock-in IRT in specimen A

In lock-in IRT, the number of detected defects in specimen A increased. However, no measurement of their size was done because of the temperature difference. In addition to classical IRT, 3 mm diameter defect at 2.8 mm deep and 5.2 mm deep defects (6 and 10 mm diameter) were visible as shown in figure 8.

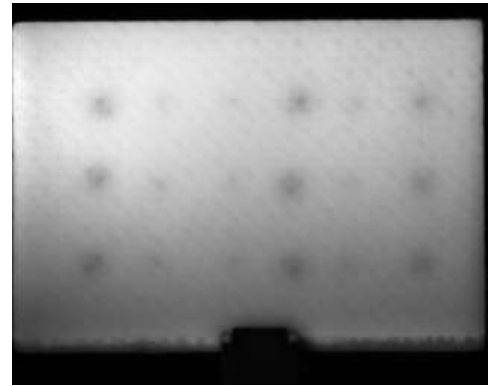
**Figure 9.** Lock-in IRT in specimen B

In the case of specimen B, lock-in IRT has similar results as in classical IRT. All defects were detected and they could be measured in diameter.

Best results were obtained at 0.1 Hz for both specimens tested in lock-in IRT. It was founded that the textured surface of specimen B was confounded with the defects in IRT mapping. Measurements were therefore less accurate than classical IRT in specimen A.

Defects located at the camera side, were easily distinguished; on the other hand, defects located on the opposite side of the camera, were difficultly detected. In addition, the dimension of the measurements was 2 or 3 mm larger that the real size of the defect. Table 3 shows the founded size for each range of defects.

Figure 9 shows the result on specimen B tested by lock-in thermography.
