Crack path in aeronautical titanium alloy under ultrasonic torsion loading

Alexander Nikitin, Claude Bathias, Thierry Palin-Luc, Andrey Shanyavskiy

Alexander Nikitin, Claude Bathias, Thierry Palin-Luc, Andrey Shanyavskiy. Crack path in aeronautical titanium alloy under ultrasonic torsion loading. *Frattura ed Integrità Strutturale / Fracture and Structural Integrity*, 2015, 10 (35), pp.213-222. hal-02353616

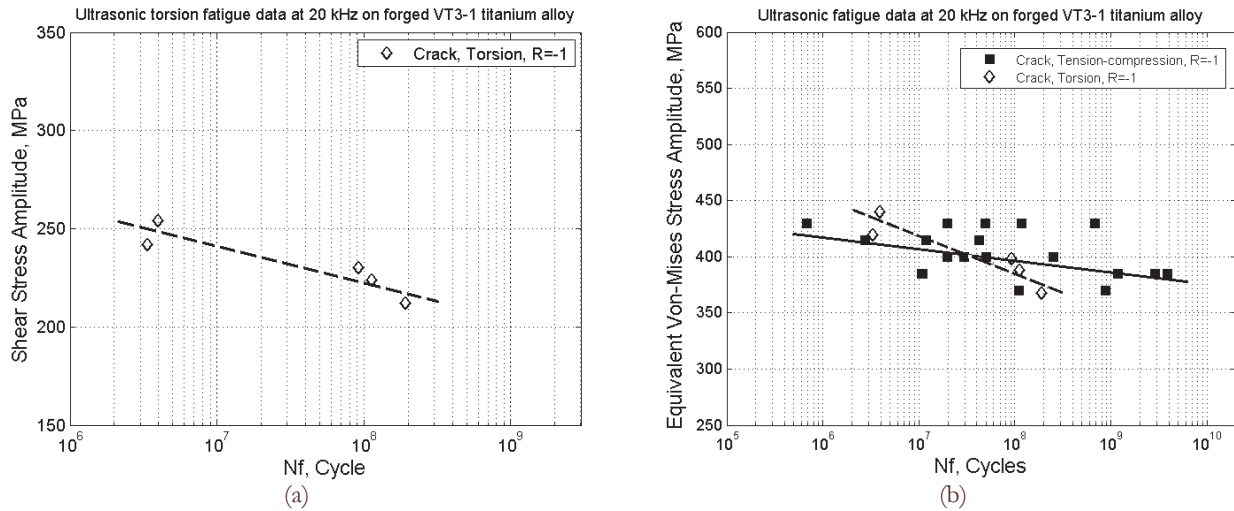
$\sigma = \sqrt{3} \cdot \tau$. It can be pointed out that points plotted in equivalent stress terms for forged VT3-1 show a good agreement and grouped near to 400 MPa that is about 40 % of UTS. This result is similar to typical results on titanium alloys in the HCF range.

Figure 4: Results of fatigue tests on forged VT3-1 titanium alloy (a) torsion data in terms of shear stress amplitude and (b) tension compression R=-1 and torsion data in terms of equivalent normal stress amplitude.

The torsion results cover a range of fatigue life from about 10⁶ to 10⁸ cycles. Based on previous results obtained on forged VT3-1 under fully reversed tension loading, the crack initiation mechanisms could be quite different at such fatigue life for forged alloy [16]. Besides a changing from surface to subsurface crack initiation mode, it has been reported about micro-structural fatigue life controlling mechanisms. In the case of torsion loading, a transition from surface to subsurface initiation after longer fatigue life was also found. However, this transition appears at fatigue life of about two order of magnitude longer. Detailed analysis on fatigue crack initiation mechanisms under torsion loading will be provided in the section 'Discussion'.

The results of fatigue tests on both forged (Fig.4a) and extruded (Fig.5a) titanium alloy shows that fatigue failure under pure torsion loading may occur well beyond 10^6 cycles. In spite of limited fatigue data on forged VT3-1 it is possible to plot a curve fitting the results. This curve will have an important slope in the VHCF range. Decreasing in fatigue strength with increasing number of loading cycles is more pronounced for torsion mode compared to results of axial tension-compressing tests [16] that is presented on Fig.4b. In order to compare the results of torsion and axial tests, the following equation was used to recalculate the shear stress amplitude into equivalent (Von Mises) normal stress

First of all, the comparison of SN-curves for push-pull and torsion loadings (Fig.4 and 5) shows a more important slope of SN-curve in the case of torsion loading. This tendency keeps being the same as for forged, as well for extruded titanium alloy in spite of small difference of SN-curves for these alloys under push-pull fatigue. This means that VT3-1 titanium is more sensitive to shear stress than to normal one. This is typical for ductile metals. However, long crack propagation is observed in planes of maximum normal stress which is typical for more brittle material. Therefore, at the very first stage of fatigue crack initiation, when a crack length is about the same order than the grain size the fatigue behavior of titanium is similar to ductile material and fatigue damage accumulation is due to sliding process. In the case of two-phase $\alpha + \beta$ titanium alloy a higher capacity to accommodate plastic sliding has a hexagonal alpha-phase. Thus, the fatigue resistance of titanium alloy to torsion loading may be related to features of alpha-platelets. In the case of surface torsion crack it can be observed macroscopically at surface in one of two maximum shear stress planes: along or perpendicularly to specimen’s axis. Fig.8b shows an example of first torsion crack growth stage along an axis.

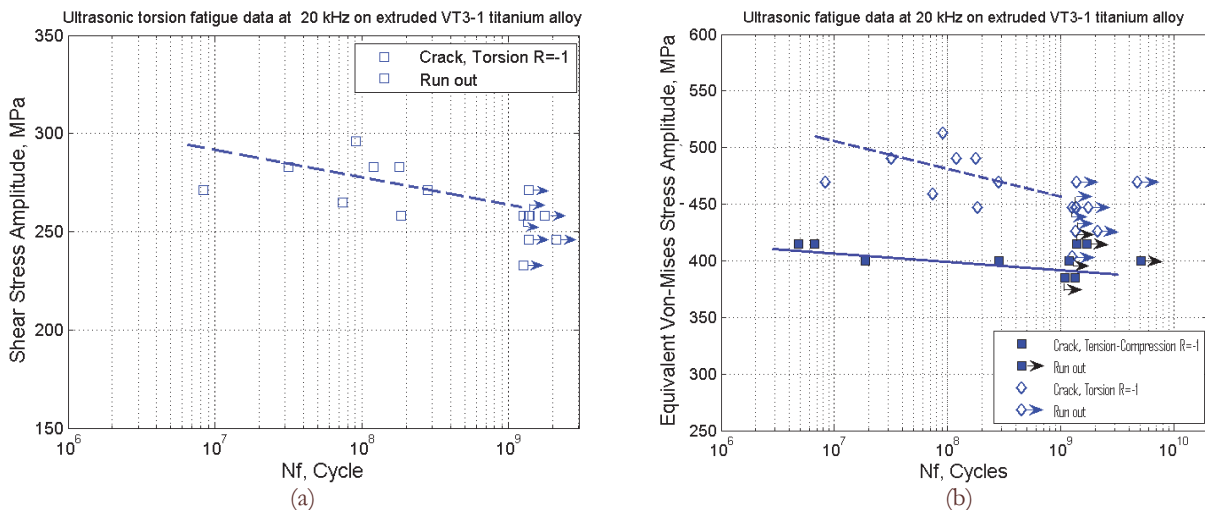
Figure 5: Results of fatigue tests on extruded VT3-1 titanium alloy (a) torsion data in terms of shear stress amplitude and (b) tension compression R=-1 and torsion data in terms of Von Mises equivalent stress amplitude.

Like for the forged alloy, the SN curve in torsion for the extruded VT3-1 titanium alloy exhibits a significant slope in VHCF regime, Fig.5a. Since the fatigue tests were stopped around 10⁹ cycles, most of the cracks were observed in the fatigue life range below 10⁹ cycles. As already was done for the forged alloy, the results of torsion tests on extruded VT3-1

titanium alloy were compared with previous results [17] obtained on the material but under fully reversed tension, Fig. 5b. In terms of Von Mises equivalent stress amplitude, like for the forged alloy, the slope of the SN-curve is more important under torsion than under tension-compression. However, unlike the forged alloy, fatigue strength of extruded titanium is higher (about 50 MPa) in torsion than in tension-compression. This shows that the Von Mises equivalent stress is not suitable to describe the VHCF strength of this alloy. In order to try to explain such mechanical behavior the analysis of the fracture surface was carried out both by optical microscopy and SEM. Unlike tension-compression, where only subsurface crack were observed, in case of torsion load a transition from surface to subsurface crack initiation was found. Comparison of results on forged and extruded titanium alloy (Fig.4 and Fig.5) shows that fatigue strength of extruded titanium alloy is higher compared to the forged one that is in good agreement with mechanical properties of materials (Tab.2).
