# Microstructural evolutions of Sn-3.0Ag-0.5Cu solder joints during thermal cycling

J.B. Libot<sup>a,b,\*</sup>, J. Alexis<sup>a</sup>, O. Dalverny<sup>a</sup>, L. Arnaud<sup>a</sup>, P. Milesi<sup>b</sup>, F. Dulondel<sup>b</sup>

<sup>a</sup> University of Toulouse, INP/ENIT, LGP, 47, Avenue d'Azereix, F-65013 Tarbes, France

<sup>b</sup> SAFRAN Electronics & Defense, 21, Avenue du Gros Chêne, F-95610 Eragny-sur-Oise, France

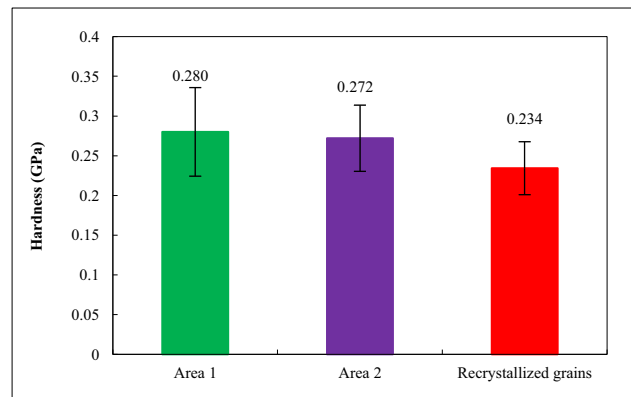
**Fig. 16.** (a) Cross-section of a WLP900 as-reflowed solder ball exhibiting interlaced and macrograins morphologies. (b) Associated hardness results. (c) Cross-section of a WLP900 damaged solder ball. (d) Hardness in the recrystallized region and in the center of the ball.

macrograins hardness does not exhibit large differences according to the crystallographic orientation. Concerning the damaged WLP900 solder joint, the measured hardness in the recrystallized zone is lower than in the rest of the ball. The macrograins still exhibit a similar hardness value regardless of the crystallographic orientation, though it is a lower value than the one measured after reflow since the Ag<sub>3</sub>Sn have grown due to thermal-induced coarsening. It is also not surprising to find a lower hardness level in the damaged area as recrystallization generated stress-free grains whose residual stresses are even more relaxed after cracking. Measuring the hardness of SAC305 solder joints throughout thermal cycling can constitute a good indicator to assess solder damage. Viscoplastic strains generated during thermal cycling would indeed create strain-hardened sub-grains in the damage regions which would eventually get rid of the accumulated dislocations through the recrystallization process and therefore exhibit a lower hardness. Further measurements are needed to have a better understanding on the evolution of the mechanical properties in the high strain regions.
