A Experimental Research On The Anti-erosion Material For Hydraulic Machinery

Lu Jinling, Zhang Xin, Zhang Jie, Feng Jianjun, Xingqi Luo. A Experimental Research On The Anti-erosion Material For Hydraulic Machinery. International Symposium on Transport Phenomena and Dynamics of Rotating Machinery, Dec 2017, Maui, United States. hal-02369358

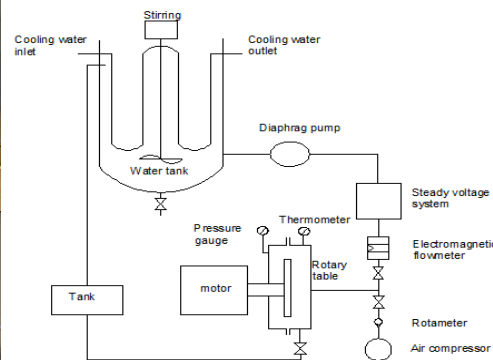
Figure 1. Rotary spray erosion testbed

As the Fig. 1(a) and (b) show, the testbed consists of adjustable speed motor, diaphragm pump, mixed water tank, steady voltage system, air compressor, refrigeration system and rotary table room. In the testbed, with the help of diaphragm pump, the flow with sands went through steady voltage system into rotary table room, and impact rotary table surface by using nozzles where the velocity could be set. Furthermore, rotary table was driven by motor and in high speed, it made the rotating centre pressure decrease and formed pressure gradient, and created opportunity for cavitation. Flow pattern at the back of the hole was damaged owing to cavitation hole. The area in low pressure produced gas nucleus and the gas nucleus were broken in the high pressure area, which lead the phenomenon of cavitation damage. Moreover, the flow with sands in high speed impacted material surface through nozzles and lead wear damage. Cavitation and wear could affect each other and formed erosion. Eventually, the flow with sands returned to mixed water tank.

To keep the temperature of the water in the mixed water tank below 50 degree centigrade, so the cooling system used to absorb energy from rotary table was been set. Besides, the impacting velocity and impacting angle were regulated by changing flow and rotational speed of the rotary table. Other functions could be achieved on the control cabinet. Fig. 2(a) and (b) show the diagram of rotary table. Eight test materials were installed in the rotary table. In present paper, same materials were installed at the opposite angle, so four kinds of materials could be tested at the same time.

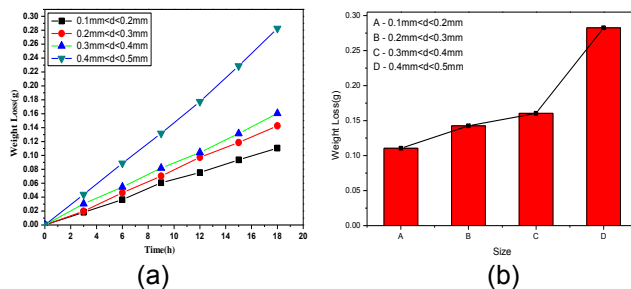
Figure 5. The variation curves of the weight loss of specimen under different sand particle sizes

Aluminum bronze used in marine propellers was considered as study object to investigate the influence of sand particle diameter on erosion. Fig. 5(a) shows that the accumulative weight loss of aluminum bronze changed with the test time under different sand particle sizes. The accumulative weight loss of erosion was proportional to the increase of time, and the larger of the particle size, the greater of the weight loss. The weight loss of materials had a big difference between the biggest particle size (from 0.4 mm to 0.5 mm) and other particle sizes at the beginning of the test.

As Fig. 5(b), when the sand particle size was less than 0.4 mm, the increasing of accumulative weight loss of erosion was relatively slow. However, when the sand particle size was exceeded than 0.4 mm, the accumulative weight loss of erosion increased suddenly.

4 When the particle size of sands were in the range of 0.5 mm, The damage of the material surface became seriously with the increasing particle size of sands. The material weight loss had a clear difference when the particle size of the sands from 0.4 mm to 0.5 mm.

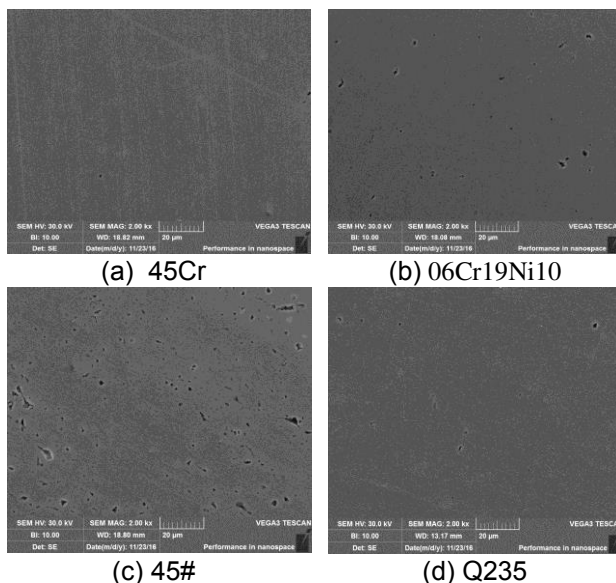
Figure 6. Original specimen appearance

To analyze easily, the original surface topographies of four materials which were not been tested after polishing were shown in Fig. 6. After polishing, the surfaces of the materials were relatively smooth without obvious scratches. Due to the defects of Q235, there were many pores in the surface of the material, but the influence of these pores was relatively small on test results, so it could be ignored.

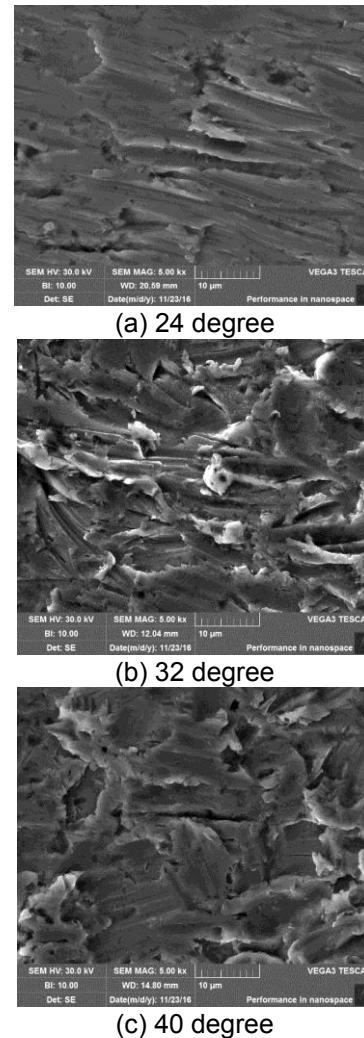
Figure 7. SEM images with erosion angle 24degree, 32 degree, 40 degree .(5000x)

The Q235 was chosen as the study object, Fig. 7 shows the surface topography after 10 hours of erosion under 24 degree, 32 degree and 40 degree, respectively. The surface damage of the material mainly concentrated in the back of the cavitation hole, and the surface appeared furrow, fish scales lip, small cracks and small pit.

When the impacting angle was small, the interaction between cavitation and wear was mainly micro cutting and the second was the effect of cavitation damage. The velocity of the sands in the process of movement was constituted by horizontal component and vertical component. The vertical component determined the sand into the material surface depth. The horizontal component completed the micro-cutting on the material surface [12,13]. It formed a lamellar deformation layer after many times of impacting on the material surface. Subsequently, the layer at the edge cracked and formed some concaves and convex lips. Eventually it leded the surface micro volume shedding. When impacting angle was large, the wear loss was mainly decided by sand kinetic energy, the influences

vertical impact and cavitation effect of the flow with sands on the material destroyed structure of the surface layer, causing fatigue spalling and leaving the pitting on the surface of the material. When the impacting angle was 24 degree, the surface of material were mainly large lips and also appeared small amount of cavitation pits and furrows. Direction of the furrow was neat, and depth was shallow. When the impacting angle was 32 degree, the cutting of sands made the surface plastic deformation seriously. At same time, the direction of lips and furrow are more chaos, and lip flanging was more serious. When the impacting angle was 40 degree, material surface damage was mainly based on vertical impact and cavitation damage, furrow trip was short and the lips appeared as small patches.

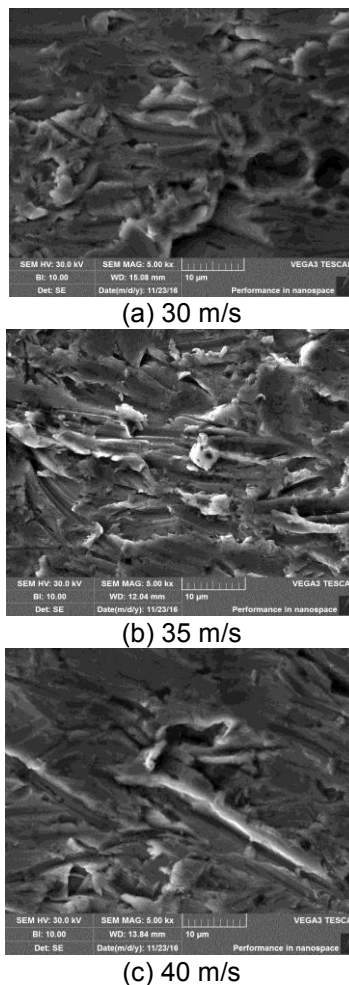
Figure 8. SEM images of erosion velocity 30 m/s 35 m/s, 40 m/s .(5000x)

Also, Q235 was chose as the study object. Fig. 8 shows the surface morphology after 10 hours of erosion under 30 m/s, 35 m/s and 40 m/s.

In the erosion test, , the wear scar of the material surface was shallow and deep with the increasing of the impacting velocity, and the wear degree was also gradually increased . When the impacting velocity was 30 m/s, wear scar on the surface caused by sand were short and disorderly, the damage concentrated mainly in the surface layer. When the impacting velocity was

35 m/s, the surface cutting degree of the sand particles increased continually, and the furrow wear marks became longer and the wear direction was gradually neat. When the impacting velocity was 40 m/s, the cutting marks on the surface of the material were further increased and the furrow wear was deepened, and the damage of cavitation was further promoted.
