A Experimental Research On The Anti-erosion Material For Hydraulic Machinery

Lu Jinling, Zhang Xin, Zhang Jie, Feng Jianjun, Xingqi Luo

Lu Jinling, Zhang Xin, Zhang Jie, Feng Jianjun, Xingqi Luo. A Experimental Research On The Anti-erosion Material For Hydraulic Machinery. International Symposium on Transport Phenomena and Dynamics of Rotating Machinery, Dec 2017, Maui, United States. hal-02369358

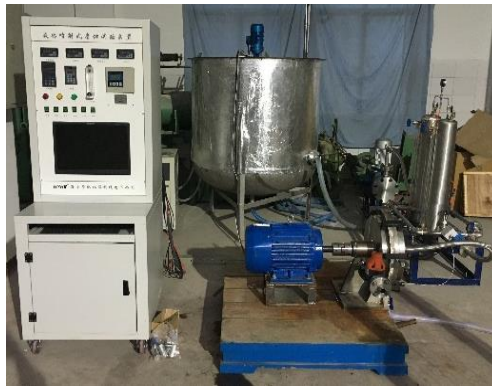
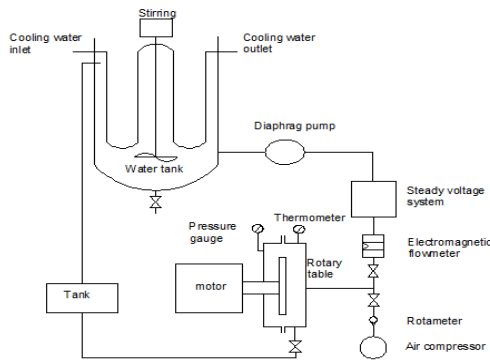
Figure 1. Rotary spray erosion testbed

As the Fig. 1(a) and (b) show, the testbed consists of adjustable speed motor, diaphragm pump, mixed water tank, steady voltage system, air compressor, refrigeration system and rotary table room. In the testbed, with the help of diaphragm pump, the flow with sands went through steady voltage system into rotary table room, and impact rotary table surface by using nozzles where the velocity could be set. Furthermore, rotary table was driven by motor and in high speed, it made the rotating centre pressure decrease and formed pressure gradient, and created opportunity for cavitation. Flow pattern at the back of the hole was damaged owing to cavitation hole. The area in low pressure produced gas nucleus and the gas nucleus were broken in the high pressure area, which lead the phenomenon of cavitation damage. Moreover, the flow with sands in high speed impacted material surface through nozzles and lead wear damage. Cavitation and wear could affect each other and formed erosion. Eventually, the flow with sands returned to mixed water tank.

To keep the temperature of the water in the mixed water tank below 50 degree centigrade, so the cooling system used to absorb energy from rotary table was been set. Besides, the impacting velocity and impacting angle were regulated by changing flow and rotational speed of the rotary table. Other functions could be achieved on the control cabinet. Fig. 2(a) and (b) show the diagram of rotary table. Eight test materials were installed in the rotary table. In present paper, same materials were installed at the opposite angle, so four kinds of materials could be tested at the same time.

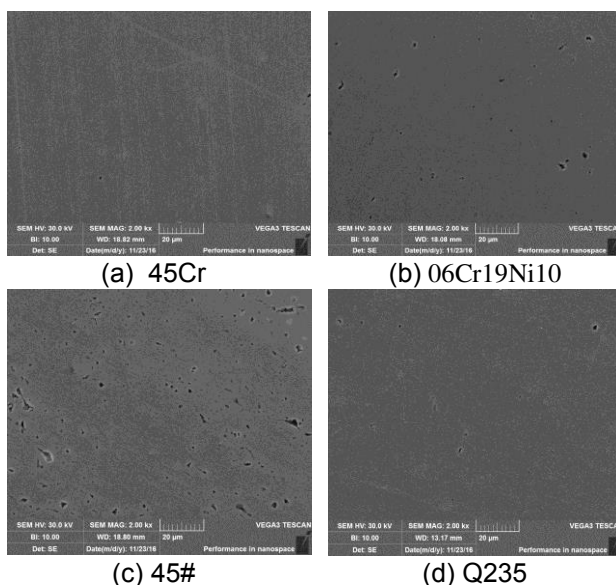
Figure 6. Original specimen appearance

To analyze easily, the original surface topographies of four materials which were not been tested after polishing were shown in Fig. 6. After polishing, the surfaces of the materials were relatively smooth without obvious scratches. Due to the defects of Q235, there were many pores in the surface of the material, but the influence of these pores was relatively small on test results, so it could be ignored.

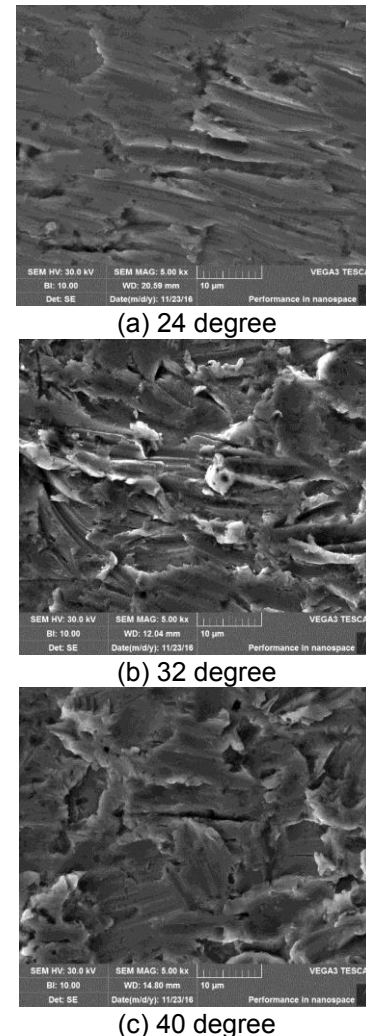
Figure 7. SEM images with erosion angle 24degree, 32 degree, 40 degree .(5000x)

The Q235 was chosen as the study object, Fig. 7 shows the surface topography after 10 hours of erosion under 24 degree, 32 degree and 40 degree, respectively. The surface damage of the material mainly concentrated in the back of the cavitation hole, and the surface appeared furrow, fish scales lip, small cracks and small pit.

When the impacting angle was small, the interaction between cavitation and wear was mainly micro cutting and the second was the effect of cavitation damage. The velocity of the sands in the process of movement was constituted by horizontal component and vertical component. The vertical component determined the sand into the material surface depth. The horizontal component completed the micro-cutting on the material surface [12,13]. It formed a lamellar deformation layer after many times of impacting on the material surface. Subsequently, the layer at the edge cracked and formed some concaves and convex lips. Eventually it leded the surface micro volume shedding. When impacting angle was large, the wear loss was mainly decided by sand kinetic energy, the influences

vertical impact and cavitation effect of the flow with sands on the material destroyed structure of the surface layer, causing fatigue spalling and leaving the pitting on the surface of the material. When the impacting angle was 24 degree, the surface of material were mainly large lips and also appeared small amount of cavitation pits and furrows. Direction of the furrow was neat, and depth was shallow. When the impacting angle was 32 degree, the cutting of sands made the surface plastic deformation seriously. At same time, the direction of lips and furrow are more chaos, and lip flanging was more serious. When the impacting angle was 40 degree, material surface damage was mainly based on vertical impact and cavitation damage, furrow trip was short and the lips appeared as small patches.

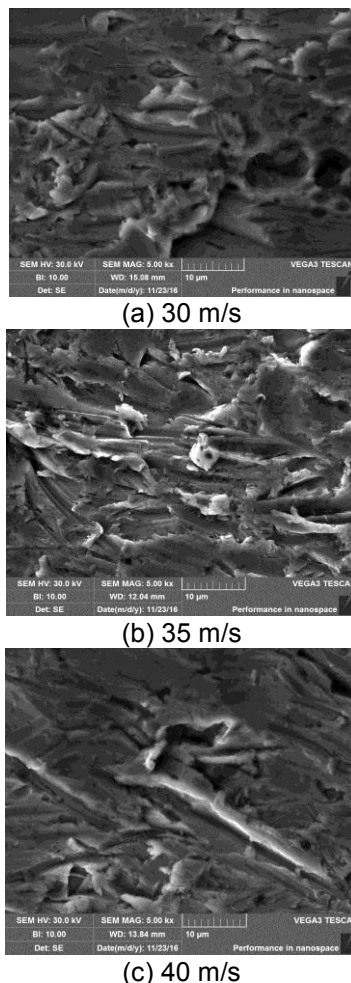
Figure 8. SEM images of erosion velocity 30 m/s 35 m/s, 40 m/s .(5000x)

Also, Q235 was chose as the study object. Fig. 8 shows the surface morphology after 10 hours of erosion under 30 m/s, 35 m/s and 40 m/s.

In the erosion test, , the wear scar of the material surface was shallow and deep with the increasing of the impacting velocity, and the wear degree was also gradually increased . When the impacting velocity was 30 m/s, wear scar on the surface caused by sand were short and disorderly, the damage concentrated mainly in the surface layer. When the impacting velocity was

35 m/s, the surface cutting degree of the sand particles increased continually, and the furrow wear marks became longer and the wear direction was gradually neat. When the impacting velocity was 40 m/s, the cutting marks on the surface of the material were further increased and the furrow wear was deepened, and the damage of cavitation was further promoted.
