Electrostatic Discharge Tests for JUICE Photovoltaic Assembly

Abstract—In the framework of JUICE Photovoltaic Assembly, development and testing activities have been carried out in order to verify the effectiveness of grounding networks solution against ESDs occurrence in charging environment. During prequalification phase, dedicated coupons have been manufactured and submitted to environmental test campaigns, including ESD characterization. As the PVA design has progressed, a new ESD coupon with more representative technologies has been then manufactured and tested for electrons charging, so to compare results and assess new design and materials. This paper firstly describes the coupons manufactured for ESD testing, then an overview on ESD characterizations performed is provided. Lastly, relevant conclusions and comparisons between the results are discussed.

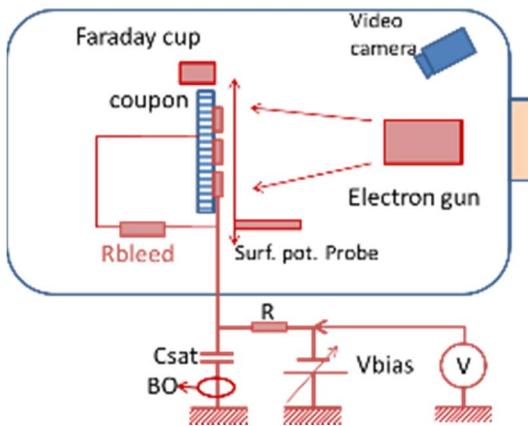
Aim of the primary arcs tests were to highlight which materials of the coupon were more subjected to charging and to identify locations where Inverted Potential Gradient (IPG) was established. In Figure 3, a schematic of the set-up used by ONERA is presented.

Figure 3 Set-up in JONAS facility with electron source

For the electrons irradiation test, the goal was to create a set-up representative for Jovian environment: for this reason the electron current density on the coupon was chosen equal to 12 nA/cm^2 , a conservative value which was however derived from worst case requirement conservatively marginated. Coupon was biased to -5 kV and electron beam set to 5.5 keV, to maximize the secondary electron emission yield and establish IPG on coverglasses.

The same set-up presented in Figure 3 has been used by ONERA, biasing the coupon substrate to - 5 kV and irradiating the coupon surface with a 5.5 keV electron beam, with current density of 12 nA/cm². The lateral sides of the coupon have been shielded with Al foil in order to prevent ESDs to occur only on honeycomb's edges.

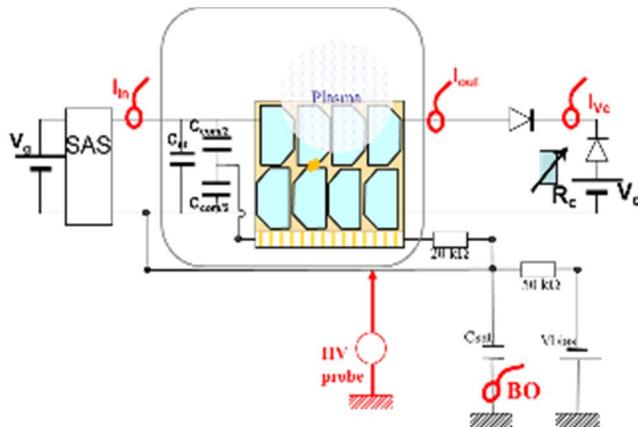
Following step, after primary arcs testing, consisted in biasing the strings in order to check the current-voltage combination needed to trigger secondary arcs on the coupon. The set-up illustrated in Figure 5 was used: by means of a Solar Array Simulator, strings were biased in order to achieve different voltage-current combinations, covering different mission phases of JUICE; current was set to progressively increasing values, starting from very low values (20 mA) up to 0.5 A. Capacitance values were chosen to correctly represent the presence of the remaining strings on the complete solar array. Test was performed in

plasma environment because of the higher ESDs rate deriving by the use of this charging source.

Figure 5 – Schematics of test set-up for secondary arcs test

As well known by literature [1], no secondary arcs are expected for voltages-currents settings lower than 150 V-0.5 V, in the case of 0.5 mm inter-string gaps: indeed, this was experimentally confirmed on both A1 and A2 coupons, where no secondary arc was detected and observed for JUICE typical current parameters. As purely scientific characterization, it was decided to cover the ITO coated coverglasses with kapton foil and to force a secondary arc in the string gap: it was eventually triggered only at maximum voltage and current (150 V, 0.5 A) a Non Sustained Arc (duration equal or shorter than primary discharge), that did not result in any impact on the dark IV curve of both strings. It is important to remark that these high current and voltage parameters are not applicable to JUICE mission and in this final test grounding network was indeed prevented from operating nominally.

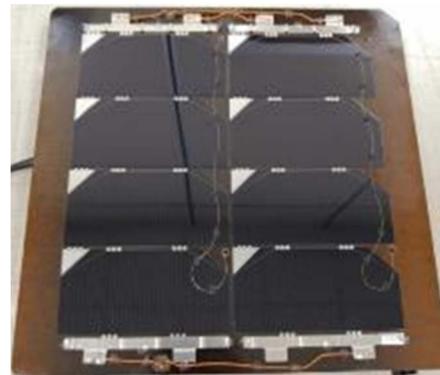
As the development phase of JUICE PVA progressed, some of the key technologies have been modified or newly designed. On the PVA, the focus of a major improvement has been the grounding network that connects the coverglasses to the rear side: instead of conductive adhesive patches, a metallic wire running on the coverglasses has been preferred [2], so to increase reliability and effectiveness of electrical grounding. Also on the substrate rear side, solar array prime contractor Airbus D&S Netherlands, has chosen a design in which black kapton is applied on the carbon fiber skin [3]. Pictures of the front and rear side of this coupon are presented on Figure 8. Because of these major changes and other minor design modifications, ESD test has been repeated to validate such technologies for electric charging behavior.

Figure 7 - ESD validation coupon's front side

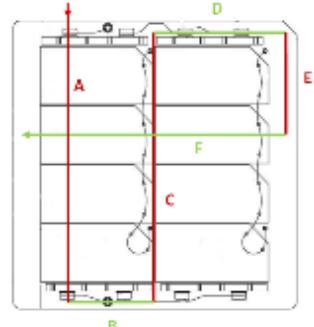
Figure 10 - Schematics of voltage probe scanning path on front side

Voltage probe scanning has been performed following a x-y path indicated in Figure 10 and the associated results in terms of measured voltage are plotted in Figure 11; it can be recognized, on paths A, C and F, that the voltage measured in proximity of the ITO coated coverglasses is in fact equal to -5 kV, demonstrating that no IPG is established on coverglasses or on the grounding network. On path C, small fluctuations that are visible are due to the kapton left exposed on the 3 crop-corners between the two different strings. ESDs are concentrated in correspondence of the two feedthrough holes through which the grounding metallic wire is routed to the rear side: this is explained by the presence of small bushings, that are made of dielectric material, close to the metallic grounding wire. It is worth to mention that, after 4 hours irradiation, ESDs rate decreased by a factor of 5, maintaining a decreasing trend, due to the vaporization of sharp tips that were the location of the cathodic spots.

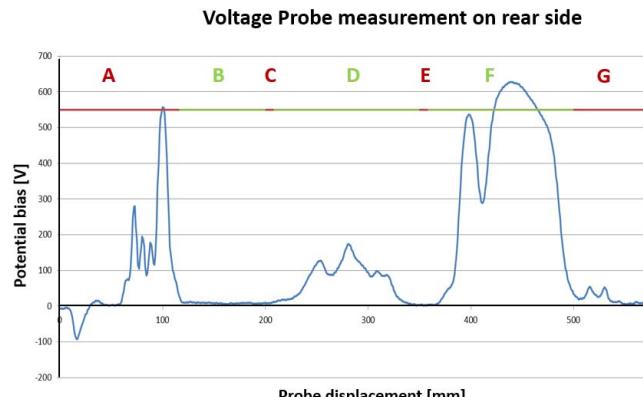
Similar tests have been repeated by irradiating the coupon rear side again with an electron flux equal to 12 nA/cm^2 . Figure 12 shows the path followed by the voltage probe after irradiation step, while the actual reading is presented in Figure 13. The signal plotted corresponds to the potential bias, where 0 V is the reference ground of the substrate's core. It can be observed that potential is varying significantly: in correspondence of conductive surfaces it is uniform and close to ground, as expected, while IPG occurs in presence of the unavoidable dielectric insulators that are needed for the PVA to nominally operate.

Figure 13 – Voltage probe measurement on rear side
