Mechanical and microstructural analysis on hydrogen-related fracture in a martensitic steel

Akinobu Shibata, Yazid Madi, Kazuho Okada, Nobuhiro Tsuji, Jacques Besson

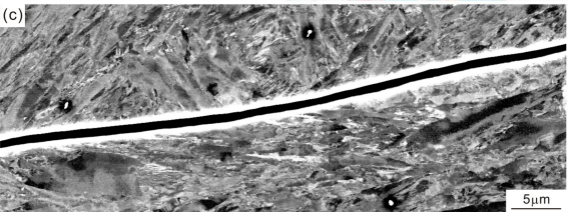
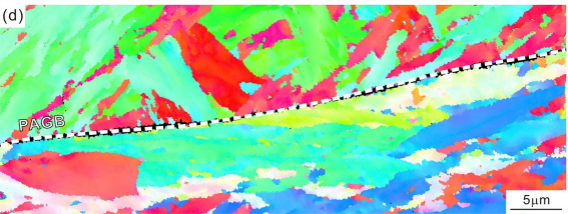
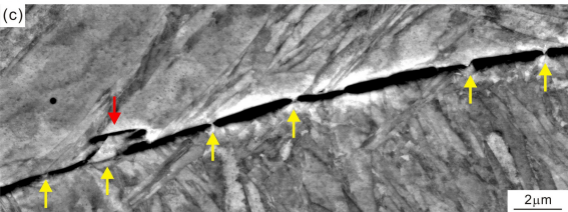
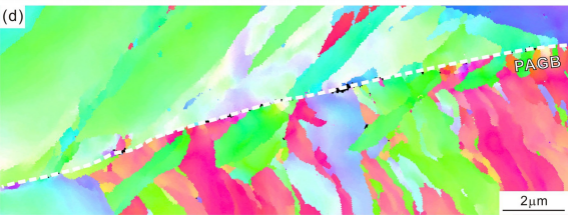
Figure 11 (a, c) SEM / BSE images and (b, d) EBSD orientation maps taken at a region ahead of the main crack in the hydrogen-charged CT specimen ($H_D = 4.00$ wt. ppm) after the unloading compliance test. The observed area of (c, d) is white rectangle indicated in (a). The black solid lines, white broken lines, red arrow and yellow arrows indicate the positions of micro-cracks, prior austenite grain boundaries, micro-cracks deviated from the prior austenite grain boundary and small un-cracked ligaments, respectively.

An SEM / BSE image and an EBSD orientation map of an area about 100 μm ahead of the main crack in the hydrogen-charged CT specimen ($H_D = 4.00$ wt. ppm) are shown in **Figures 11 (a, b)**. The black and white broken lines represent the positions of micro-cracks and prior austenite grain boundaries, respectively. As well as the case of the uncharged CT specimen, the hydrogen-related micro-cracks apparently propagated along the prior austenite grain boundaries. However, the high magnification SEM / BSE image and the EBSD orientation map of **Figures 11 (c, d)** revealed that the small un-cracked ligaments existed on the prior austenite grain boundary (yellow arrows). Moreover, the micro-crack partly deviated from the prior austenite grain boundary at the position indicated by red arrow. Hydrogen-related crack propagations not exactly on but in the vicinity of prior austenite grain boundaries have been reported previously [20-22]. We confirmed the similar tendency in the other hydrogen-charged CT specimens ($H_D = 0.42 \sim 1.01$ wt. ppm). Based on the observation results, we found that the hydrogen-related micro-cracks propagated discontinuously in a stepwise manner on a microscopic scale, although the cracks were rather continuous macroscopically.

One of the important findings in the present paper is that the stable crack propagations were confirmed in the hydrogen-related intergranular fracture of the high strength martensitic steel. To date, stable crack propagations in hydrogen embrittlement have been recognized in austenitic stainless steels [33, 34, 36, 37], ferrite – pearlite steels [31], and tempered Cr-Mo / Ni-Cr-Mo steels [38], whose sensitivities to hydrogen embrittlement are not as high. As shown in **Figure 4**, sensitivity to hydrogen embrittlement of the martensitic steel used in the present study was notably high and hydrogen-charged specimens exhibited premature fracture within the elastic strain regime during the slow strain rate tensile tests. Nevertheless, we found that the hydrogen-related intergranular cracks propagated in a stable manner as shown in the $J - \Delta a$ resistance curves of **Figure 6 (b)**. This leads to an important suggestion that hydrogen-related intergranular fracture essentially involves a stable crack propagation process, even though macroscopic premature fracture occurs. The SEM / SE images of **Figure 9** indicate that the macroscopic crack propagations were rather continuous when H_D was large. As shown in the SEM / BSE image and the EBSD orientation map of **Figures 11 (c, d)**, however, there

were many small un-cracked ligaments on the prior austenite grain boundary and a part of the micro-crack existed slightly away from the prior austenite grain boundary. The microstructure observation results indicate that the hydrogen-related crack propagated in a stepwise manner on a microscopic scale. In addition to crack blunting by plastic deformation and to sub-cracks formation, discontinuous crack propagation would result in stable crack propagation with increment of J -integral. Therefore, we infer that the microscopic discontinuous crack propagation could be the possible reason for the stable crack propagation in the hydrogen-related intergranular fracture.
