Fatigue of improved polyamide mooring ropes for floating wind turbines

Abstract. This paper describes a study of the fatigue characterization of polyamide mooring ropes for floating wind turbines. Under some conditions polyester ropes, which are favoured for offshore oil and gas platform station-keeping, are too stiff for wind turbine moorings, and polyamide may be a suitable alternative. While early studies on fatigue of braided nylon ropes showed very short lifetimes some recent results have indicated that it is possible to significantly enhance lifetime by modifying rope construction and improving fibre coatings. In this paper yarn-on-yarn abrasion testing is used first to evaluate a new yarn coating. Significant lifetime enhancement was noted, so fatigue testing of ropes was then performed. Results confirm that excellent fatigue lifetimes can be achieved, superior to those for steel chain. Finally, failed yarn and rope samples were examined by microscopy, in order to improve understanding of the fatigue mechanisms leading to failure.

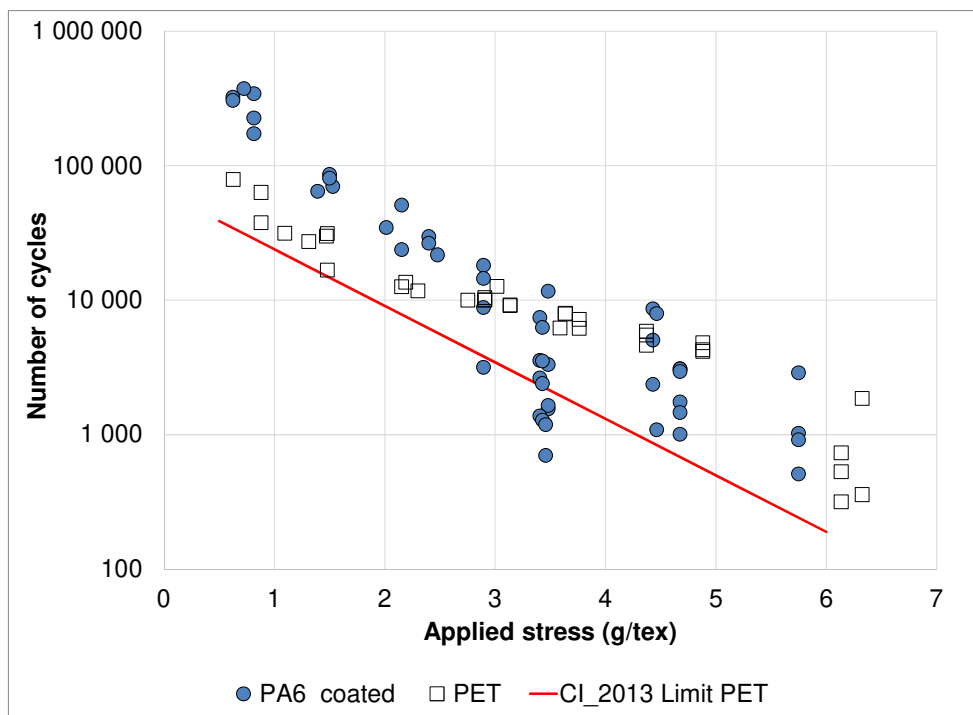
A set of yarn-on-yarn abrasion tests was also performed on a 220 tex polyester fibre yarn with a marine finish, currently used in offshore mooring line applications. Figure 4 shows the comparison

between the polyester and the nylon. These tests were all performed on the same test machine, in natural seawater, following the same test procedure. It is apparent that the yarn-on-yarn abrasion lifetimes of the coated nylon yarn are similar to those of this polyester yarn.

Figure 4. Comparison between YoY abrasion test results for nylon 6 and polyester (PET) yarns

The main conclusion from these test results is that addition of this special marine coating to yarns results in an increase in lifetime by one or two decades; the coating enables mean lifetimes of this yarn to pass from below to above the CI limit and to achieve similar performance to those of a polyester yarn with marine finish. Given this promising improvement, a set of rope specimens was then prepared from these coated yarns.

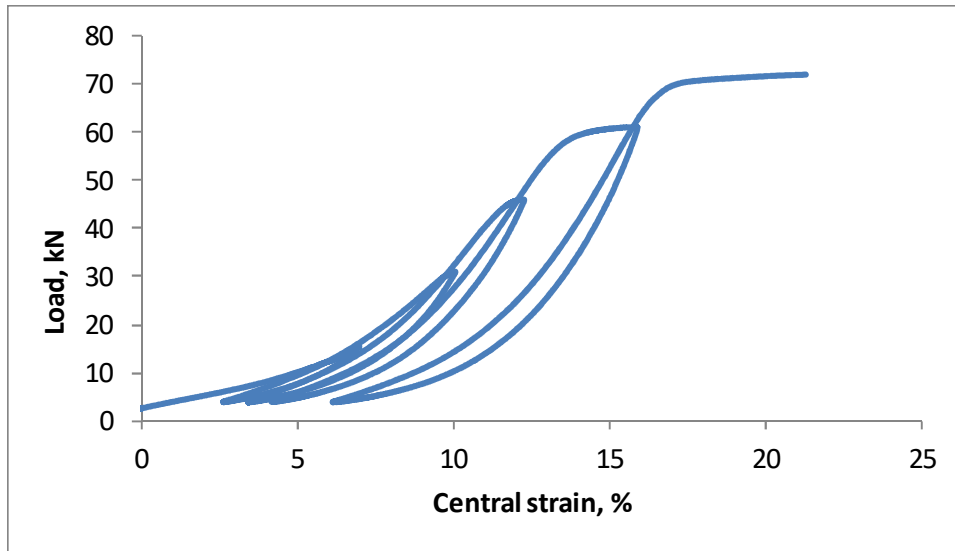
Figure 5. Example of force-strain plot for wet quasi-static test to failure.

Test consisted of load-unload cycles to 20, 40, 60 and 80% of nominal break load then ramp to fail.

Wet and dry break tests were performed first, to check nominal reference strength values. On one wet sample the strain to failure was measured by fixing an (expendable) wire transducer gauge to the central section between splices. Table 2 shows the results from these six tests. Figure 5 shows the load-strain plot for the wet break test. This rope sample was subjected to unloading cycles at 20, 40, 60 and 80% of the nominal break load. The other samples were loaded directly to failure at a rate of 20% break load/minute. The load-strain response is very non-linear as has been noted in previous studies.

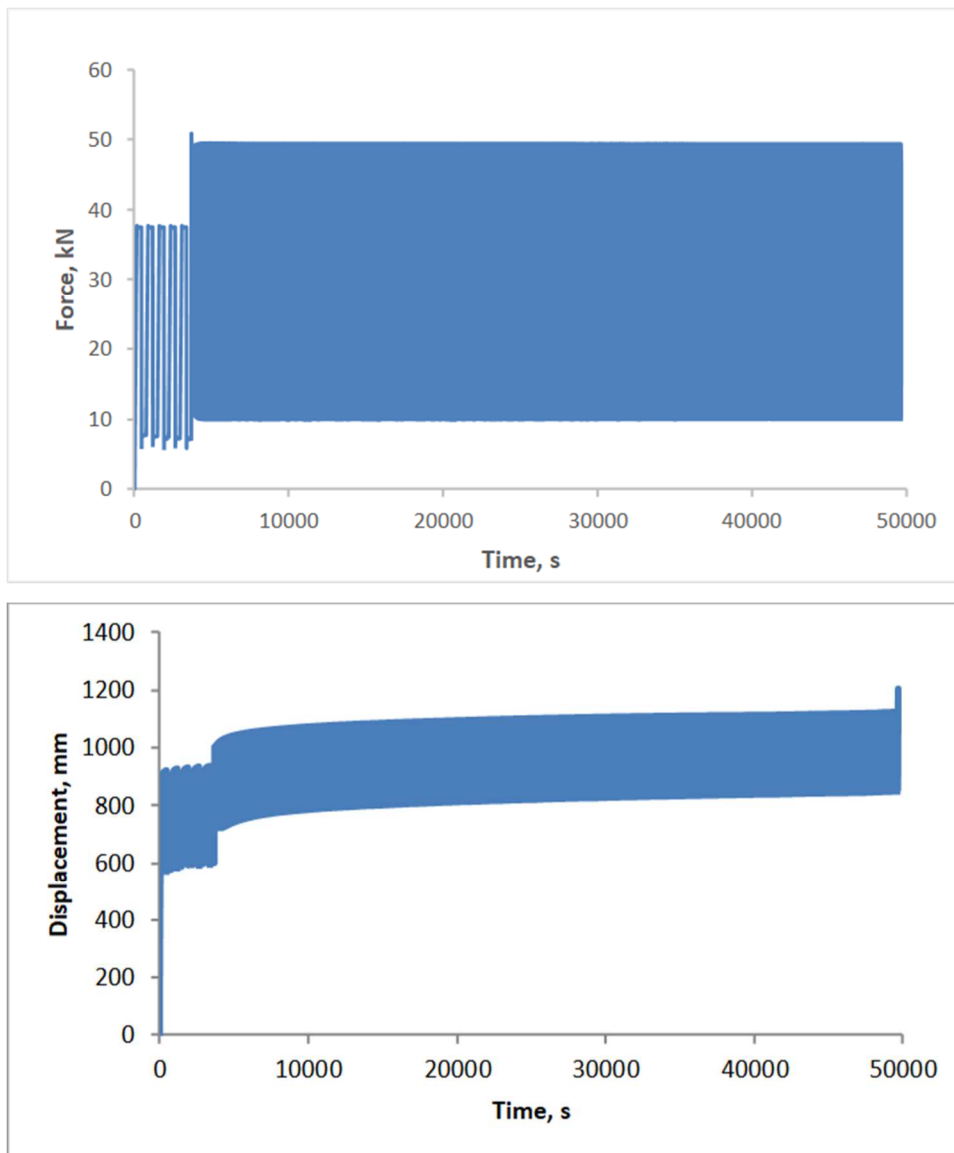
[Figure 6](#) shows examples of the load-time and piston displacement-time recordings for a fatigue test which involved 5 bedding-in cycles to 37.5 kN followed by 4612 cycles between 10 and 50 kN to failure.

Figure 6. Examples of a) force-time and b) piston displacement versus time raw data from a cyclic rope test to failure after 4612 cycles.

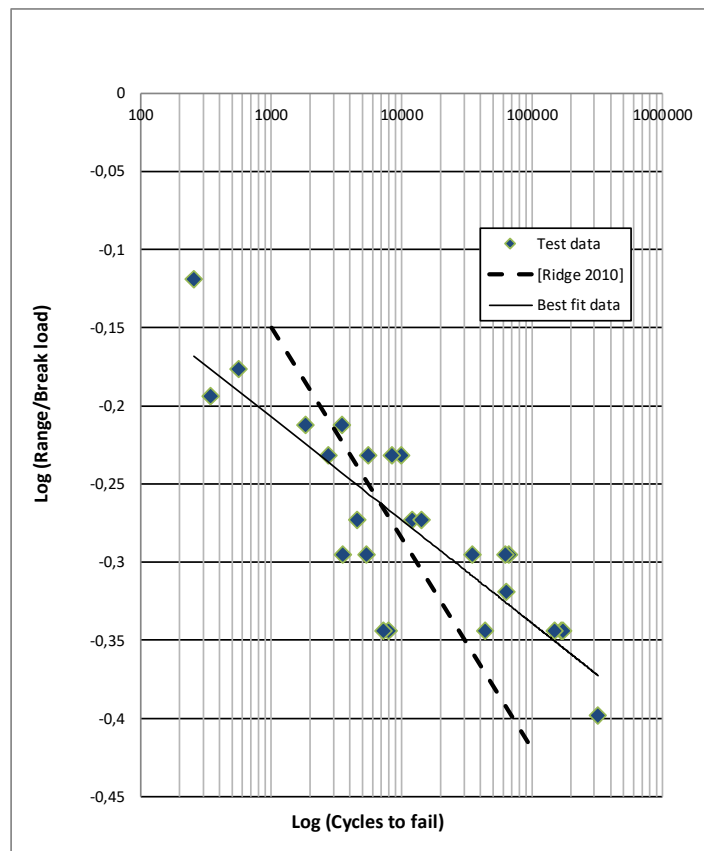
The fatigue data points are shown in an alternative presentation format in Figure 9, in order to compare directly with the data published by Ridge et al. (2010). Here the load range is normalized by the wet break load (75 kN) and plotted on a log scale.

Figure 9. Fatigue test results for rope samples and comparison with published data from Ridge et al. (2010) shown as dashed line.

The dashed line in **Figure 9** shows the trend line for results from Ridge et al. (2010) on their improved polyamide rope for long term mooring of wave energy converters. The results for the rope from the present study, from a different rope manufacturer to that of Ridge et al. (2010), are grouped around those previous results.
