## **Fatigue of improved polyamide mooring ropes for floating wind turbines**

Yoan Chevillotte, Yann Marco, Guilhem Bles, Karel Devos, Mathieu Keryer, et al.. Fatigue of improved polyamide mooring ropes for floating wind turbines. *Ocean Engineering*, 2020, 199, pp.107011-1 - 107011-9. <10.1016/j.oceaneng.2020.107011>. <hal-02493828>

# Fatigue of improved polyamide mooring ropes for floating wind turbines

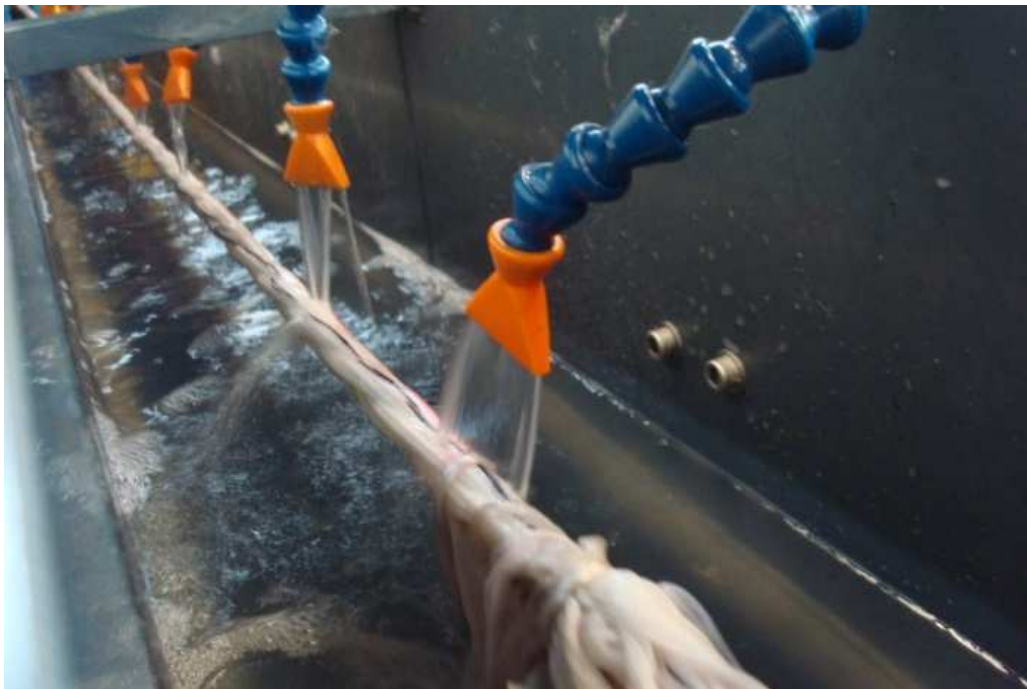
It is well known that polyamides are sensitive to water, and moisture has been shown to affect the long term behaviour of polyamide 6 fibres (ISO18692, 2007; Miri, 2009; Hunt, 1980; Humeau, 2018) so it is essential to perform tests in the wet state. Before each test, the rope sample was fully immersed in tap water for 4 hours on the testing machine without load. It was then continuously sprayed with tap water throughout the test as shown in Figure 2.

**Figure. 2.** Rope during a fatigue test

Unless noted otherwise, the fatigue test results presented here were obtained with a mean-load of 40% of nominal break load, and at a cycling frequency of 0.1 Hz. Sinusoidal load amplitude was applied around this mean value. Before each test, a pre-cycling “bedding in” protocol was applied. This consisted of five load-unload cycles up to 50% of nominal break load, with each loading and unloading ramp lasting 2.5 minutes and hold periods of 5 minutes at 10 and 50%.

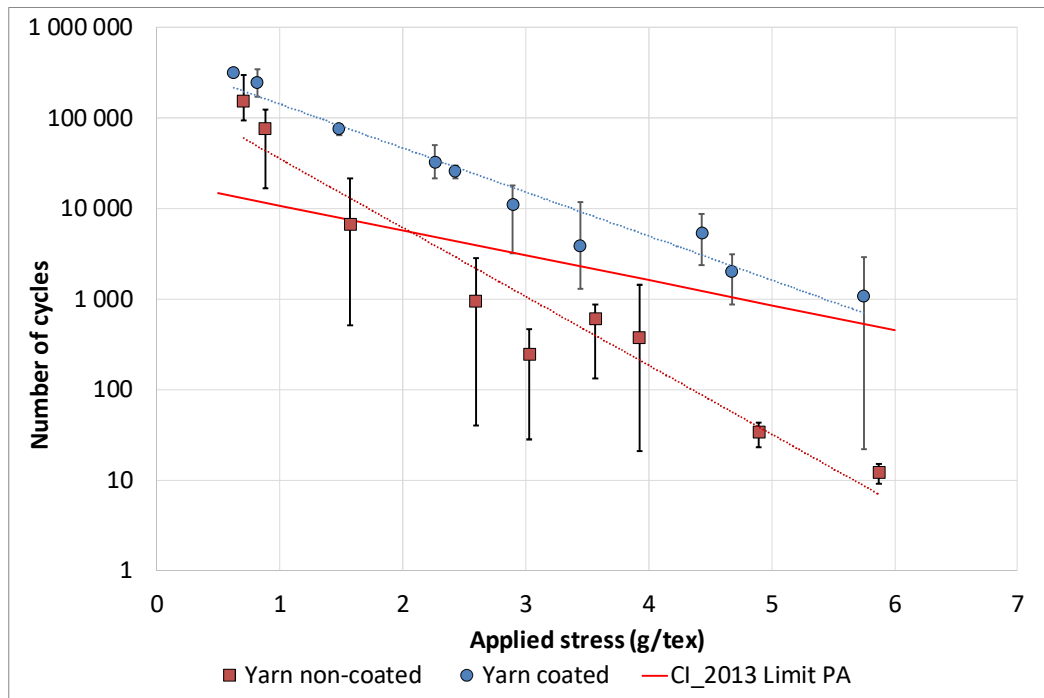
Yarn on yarn abrasion tests were performed up to failure, which occurred in the inter-wrapped section of the yarn in all cases reported on Figure 3. On this curve, each point represents 3 to 8 test repeats at each applied stress level, defined in grams/tex, depending on the scatter. The error bars represent the minimum and maximum numbers of cycles found at each load. The dashed lines show a linear best fit on the semi-log scale. The continuous red line corresponds to values in a Cordage Institute guidance document (Flory, 2013), which recommends a minimum lifetime for each load level for offshore hawsers.

**Figure 3.** Yarn on yarn results for uncoated and coated polyamide 6 yarns.

Cycles to failure are significantly higher for coated yarn samples and there is more scatter in results for uncoated yarns. There is a minimum performance criterion (number of cycles versus applied tension) defined for polyamide yarns for offshore use in hawsers, given by the CI document (Flory, 2013), which is represented as a red line on Figure 3. **The coating enables the mean test values at all applied stresses to satisfy this criterion, though the criterion is only satisfied for all individual test lifetimes below an applied stress of 3g/tex.**

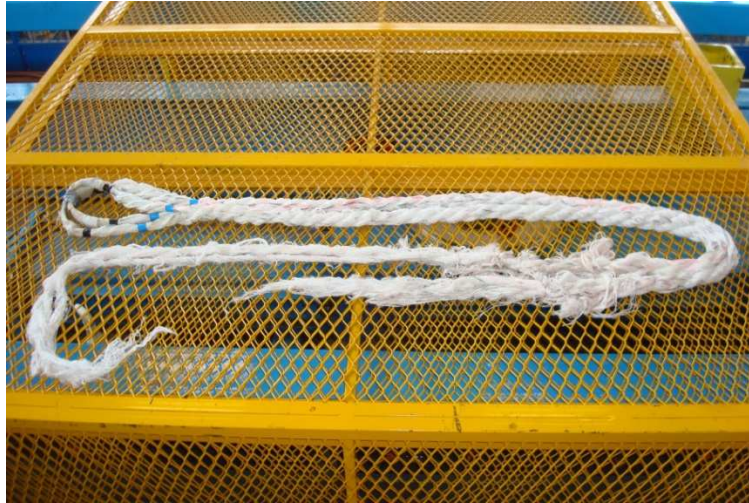
**Figure 8.** Failed sample after test, showing two broken parts superposed.

Results are shown first in the traditional S-N format in Figure 7, with cycles to failure plotted versus maximum load (Figure 7a) and load range (Figure 7b), both **normalized by the nominal dry break load (75 kN)**. For all tests reported here failure occurred in the central section of the rope, initiating near the transition between the end of a splice and the central section, with complete separation of the specimen into two parts. A small number of samples failed in the eye splice region at the sample end, and these have been removed from the data set. Figure 8 shows an example of a broken specimen.

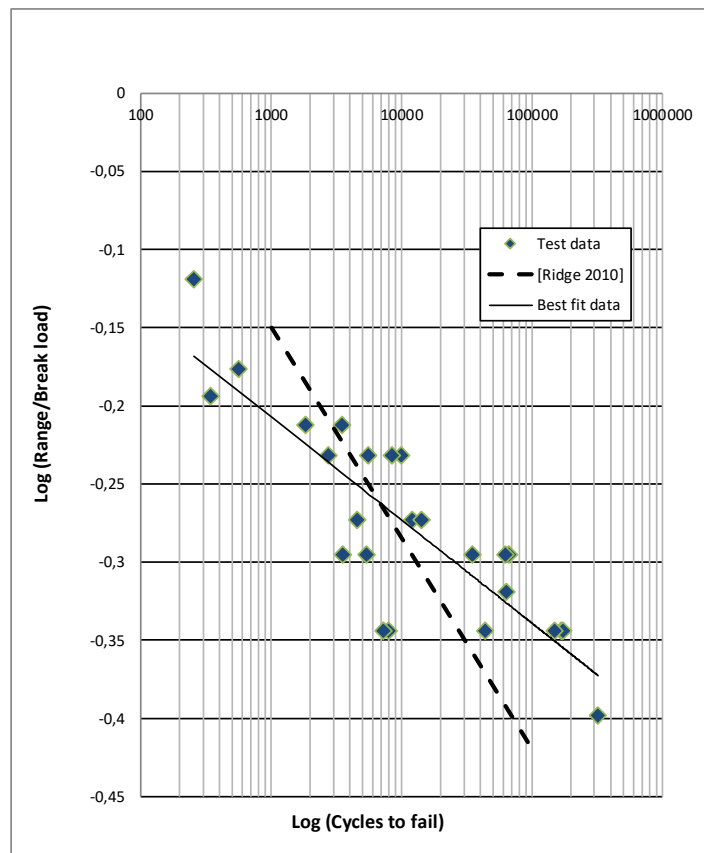
The fatigue data points are shown in an alternative presentation format in Figure 9, in order to compare directly with the data published by Ridge et al. (2010). Here the load range is normalized by the wet break load (75 kN) and plotted on a log scale.

**Figure 9.** Fatigue test results for rope samples and comparison with published data from Ridge et al. (2010) shown as dashed line.

The dashed line in **Figure 9** shows the trend line for results from Ridge et al. (2010) on their improved polyamide rope for long term mooring of wave energy converters. The results for the rope from the present study, from a different rope manufacturer to that of Ridge et al. (2010), are grouped around those previous results.

A more detailed analysis of the results from the present tests shown in Figure 9 revealed two populations, as shown in Figure 10. Indeed, when the results are plotted according to their batches, it is apparent that the final batch provides significantly higher fatigue lives and lower variability than the initial batch. The reasons for this difference are currently being investigated.

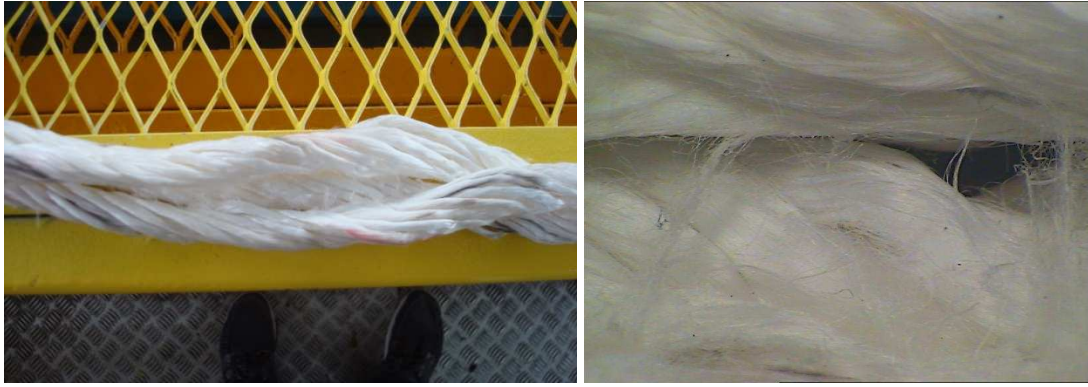
The results discussed by Mandell (1987) suggest that two failure mechanisms dominate cyclic response of nylon ropes. At high loads, creep rupture is the main failure mode, while at low loads abrasion can cause failure, either external abrasion on bollards or internal abrasion between fibres. However, it should be noted that there is not a distinct cut-off between these two mechanisms, both may occur if loading amplitude (and hence relative internal movement within the rope elements) is sufficient. As coatings are improved, one would also expect the abrasion mechanism to be shifted to higher numbers of cycles. Most samples were taken from broken ropes at 200mm from the final failure zone, **in order to detect damage but without the final high energy failure mechanisms.** Additional observations on samples from tests interrupted before final failure, and from areas of failed samples away from the break region, revealed significant areas of abrasion in the contact areas between the rope strands, Figure 13. The outer surfaces of the strands are intact but the inner surfaces in contact reveal broken fibres.

**Figure 13.** Example of internal abrasion in rope sample (coated)
