Swelling behavior of compacted bentonite with the presence of rock fracture

Xia Bian, Yu Jun Cui, Ling-Ling Zeng, Xiao-Zhao Li

Xia Bian, Yu Jun Cui, Ling-Ling Zeng, Xiao-Zhao Li. Swelling behavior of compacted bentonite with the presence of rock fracture. *Engineering Geology*, 2019, 254, pp25-33. 10.1016/j.enggeo.2019.04.004 . hal-02499259

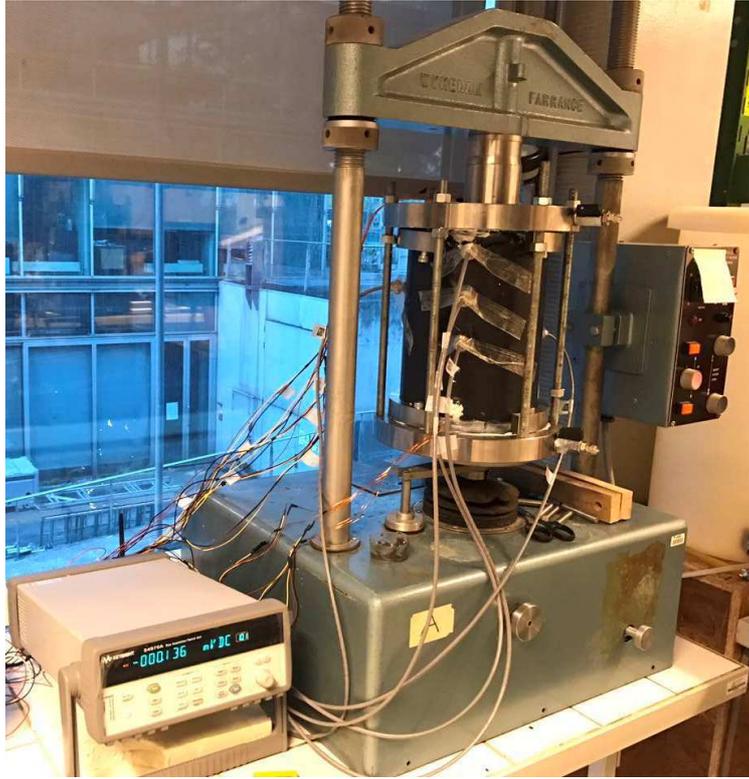
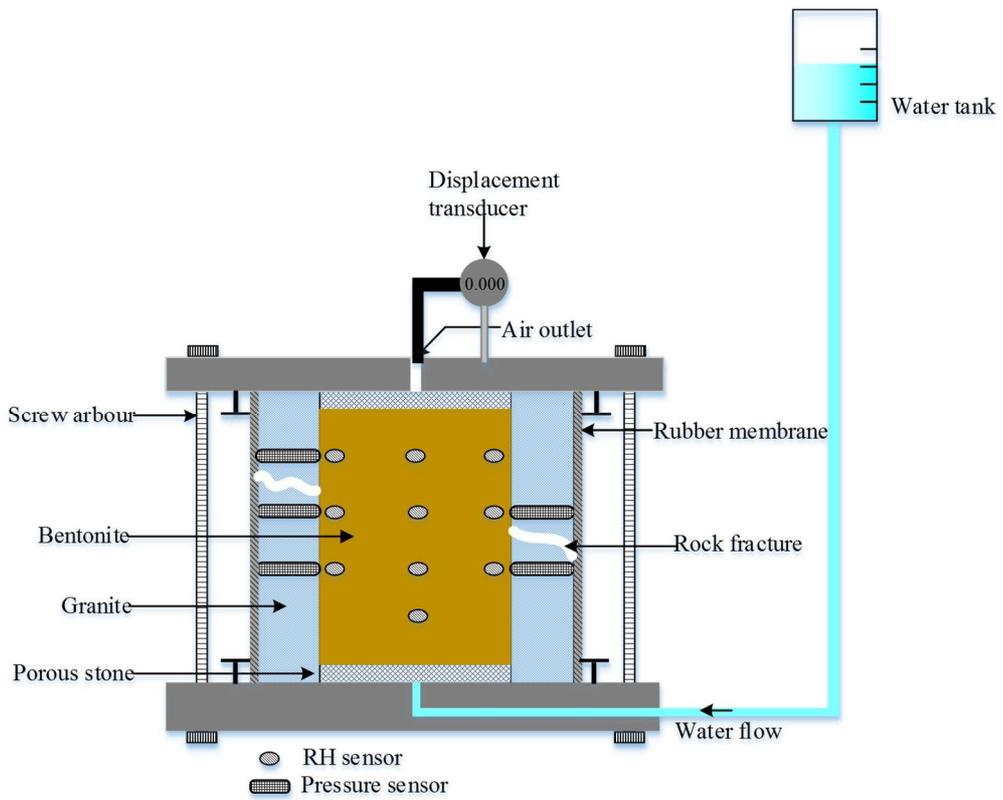
Fig. 1 Experimental setup, (a) photo, (b) schematic layout

97 The basic scheme of the infiltration test is presented in Fig. 1. The experimental setup
98 consisted of three parts: (i) the main body which was made of a hollow fractured Beishan
99 granite cylinder and the compacted bentonite inside; (ii) the water supply system for water
100 infiltration into the bentonite; and (iii) the monitoring system that compassed all the sensors
101 (pressure sensors and relative humidity sensors) and the data logger linked to a computer.

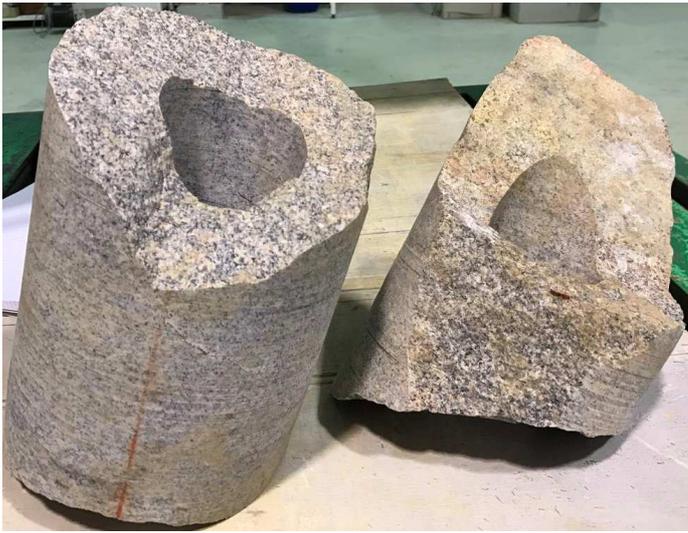
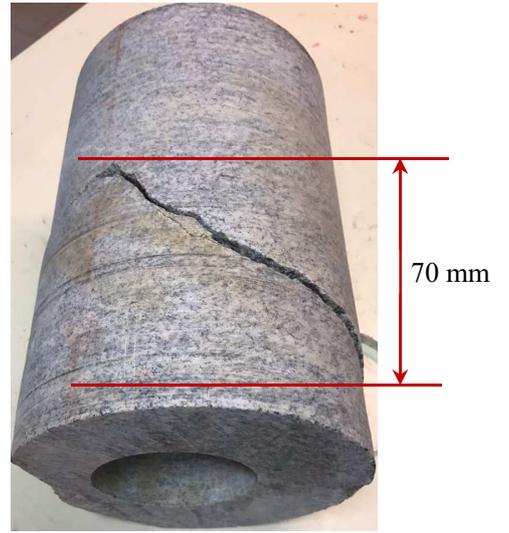
Fig. 2 Beishan Granite samples, (a) separated samples, (b) assembled sample

103 The hollow rock cylinder consisted of two parts of granite samples with a natural fracture. As
104 shown in Fig. 2, when the two parts of granite were put together, a well-defined natural
105 fracture was formed with a width ranging from 0.1 to 5.6 mm. The height of the assembled
106 rock cylinder was 282 mm. The inner diameter of the cylinder ranged from 82 to 84 mm
107 (average diameter of 82.5 mm). Note that the hollow part was not centered in the rock sample,

108 with the wall thickness of rock varying from 32 to 58 mm, due to the fact that the hollow
109 cylinder granite was directly drilled from the Beishan site and it was hard task to handle the
110 drilling tools in the field conditions. The hollow rock cylinder was placed on a stainless steel
111 plate (base plate) with a porous stone on it, where the interface between the rock and the base
112 plate was sealed by elastic rubber to prevent water leakage. After the sample was compacted
113 inside the rock cylinder, a porous stone and a stainless steel plate were installed on its top. Six
114 screw arbors were used to fix the rock cylinder vertically, while two pieces of stainless steel
115 bars with screws were attached to the top and base plates to prevent the radial movements. In
116 addition, the rock was covered by a rubber membrane to prevent water evaporation though the
117 rock.

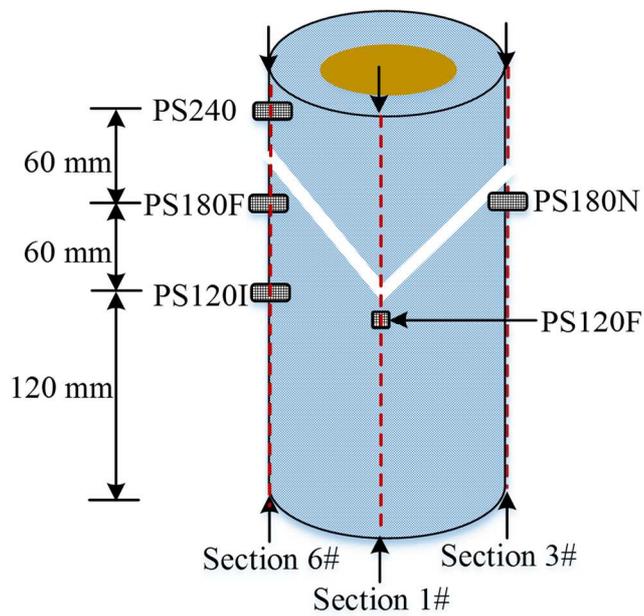
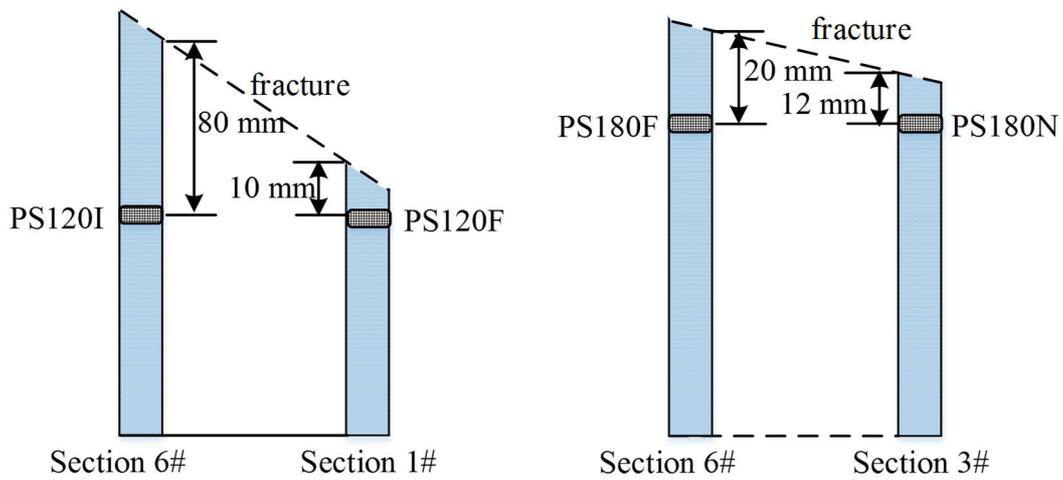
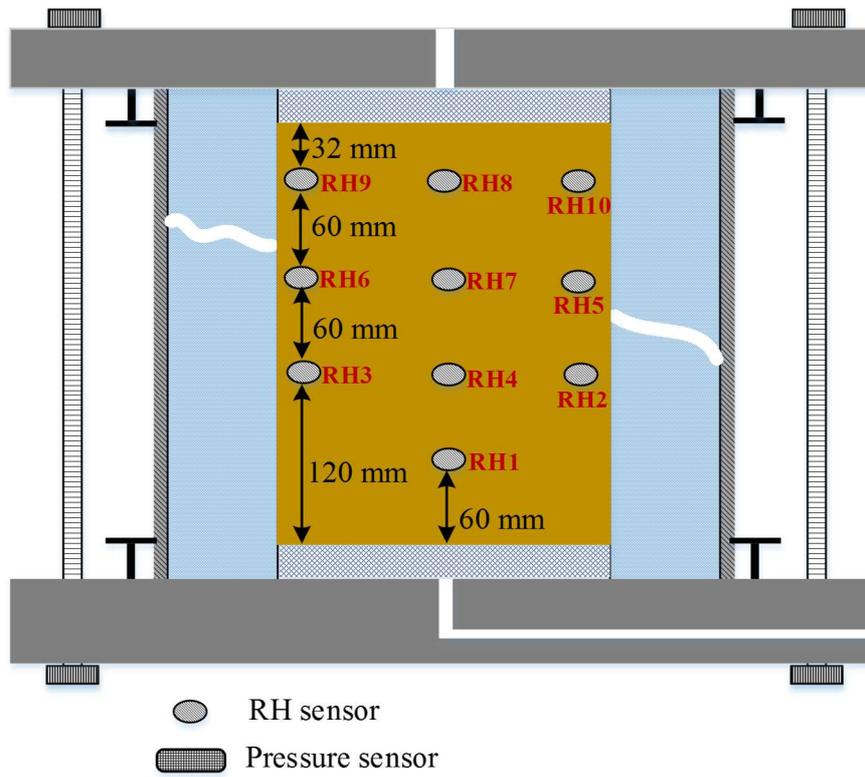
Fig. 3 Positions of different sensors

(a) Locations of pressure sensors

(b) Relative distances of pressure sensors to the fracture

(c) Location of RH sensors

126 There were five total pressure sensors and ten relative humidity sensors installed to monitor
127 the swelling behavior of compacted bentonite with the presence of rock fracture, as shown in
128 Fig. 3. Miniature pressure sensors protected by a stainless steel shell were installed through
129 the ports in the wall of the rock cylinder. Fig. 3(a) shows that five pressure sensors were
130 installed along three different sections. Along section 6#, three pressure sensors were placed

131 at 120 mm, 180 mm and 240 mm, namely PS120I, PS180F and PS240, respectively. In
132 addition, PS120F was installed at 120 mm along section 1# and PS180N was installed at 180
133 mm along section 3#. Hence, there were two sensors installed at 120 mm and 180 mm along
134 different sections, with different relative distances to the fracture. As shown in Fig. 3(b), the
135 vertical distances to the fracture for sensor PS120F and PS120I were 10 mm and 80 mm,
136 respectively. Sensors PS180N and PS180F were situated at about 12 mm and 20 mm below
137 the fracture, respectively.

138 Fig. 3(c) depicts that ten relative humidity (RH) sensors were installed every 60 mm along the
139 sample (60, 120, 180 and 240 mm). To avoid the disturbance of rock cylinder, all the RH
140 sensors were directly placed inside the compacted bentonite at the predetermined height. At
141 each height, one RH sensor was installed at the center of the sample. For the height of 120,
142 180 and 240 mm, the two other RH sensors were installed near the interface between rock and
143 bentonite. A digital displacement transducer was installed at the top plate to monitor the
144 vertical movement of the system during the infiltration test.

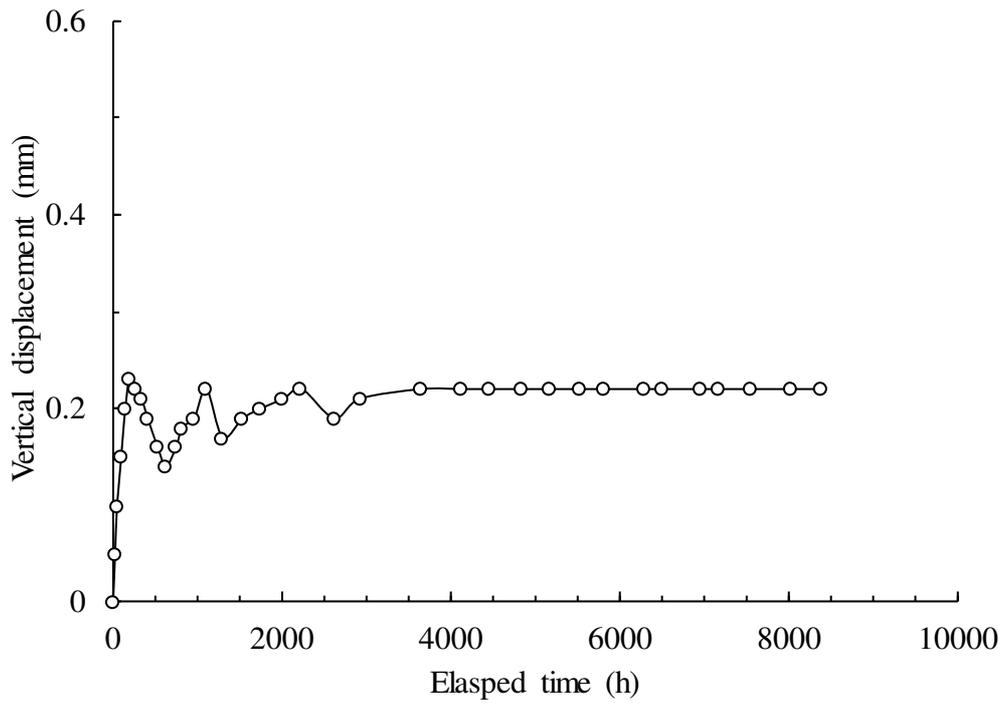
Fig. 4 Vertical displacement of the top plate

182 After the whole system was assembled, a 24-hour period was waited to ensure the glue
183 sealing the rock and plate interface, and fixing the position of pressure sensors. Water
184 infiltration was then performed from the bottom of the compacted bentonite. The swelling
185 pressures at different heights were recorded during hydration as well as the relative humidity
186 measured through RH sensors. Meanwhile, the vertical displacement of the top plate was also
187 monitored by the displacement transducer. As shown in Fig. 4, the axial movement of top
188 plate increased rapidly with time and reached a peak value of 0.23 mm after about 7 days of
189 hydration, corresponding to 0.09% of the sample height which was negligible. Thereby, the
190 test can be regarded as in constant volume condition during hydration.

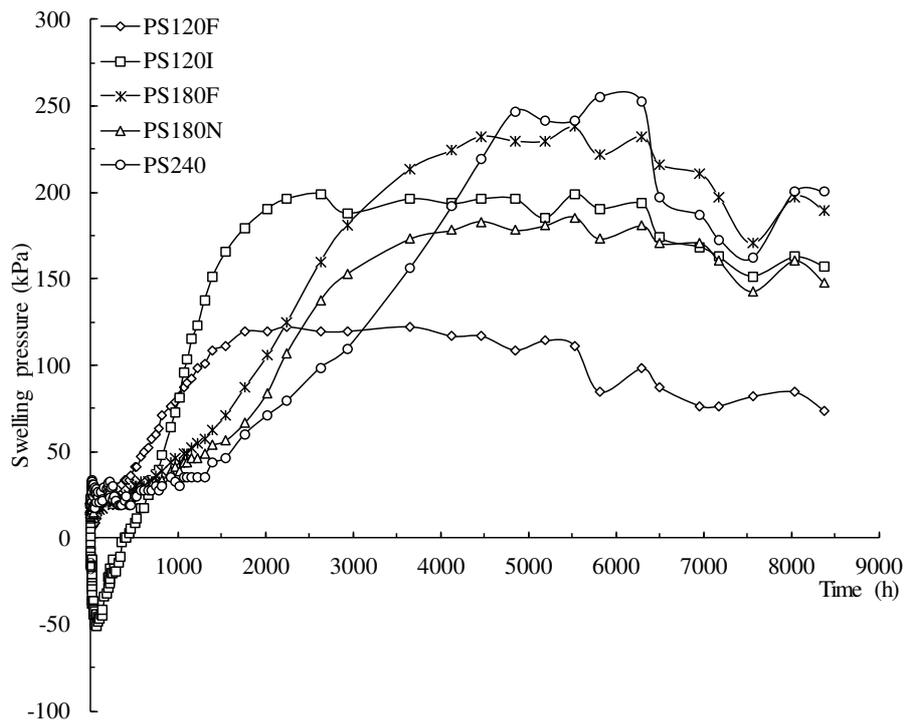
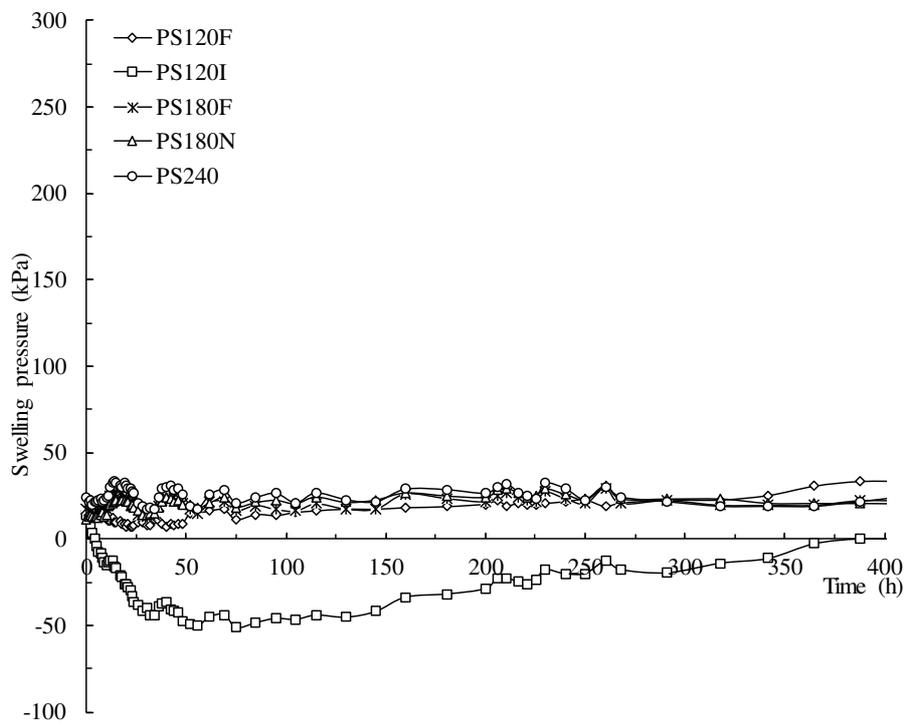
Fig. 5 Evolution of swelling pressure over time, (a) swelling pressure, (b) swelling pressure in the first 400 hours

193 Fig. 5 shows the evolutions of swelling pressure with time. The initial value of all five
194 pressure sensors varied from 11 to 24 kPa, which indicated the good contact between the
195 pressure sensors and the compacted bentonite. With water infiltration, a quick increase of
196 swelling pressure followed by stabilization was observed at different heights. A gradually
197 slight decrease in swelling pressure was identified from 6500 hours. This trend was in
198 agreement with the evolution of swelling pressure from the mock-up test by Saba et al. (2014).
199 As water migrated upwards from water inlet, the first quick increase stage recorded by the

200 sensors at different heights were quite different, with the highest increase rate at 120 mm.
201 This increase rate gradually decreased from 180 mm to 240 mm. At the same height, the
202 increase rate changed with the relative distance to rock fracture, with lower increase rate for
203 the position closer to the fracture.

204 Note that, the evolution of swelling pressure at the same height was directly affected by the
205 presence of rock fracture. For sensor PS120I, a sudden decrease in swelling pressure was
206 observed after water infiltration until about 75 hours (see Fig. 5b). This sudden drop might
207 relate to the experimental design as discussed in latter section. After the first 75 hours, the
208 swelling pressure exhibited a quick linear increase up to 1200 hours. Afterwards, the swelling
209 pressure slowly increased and reached a peak value of 196 kPa, followed by a slight decrease
210 to a final value at about 157 kPa. At the same height but close to the fracture, the evolution of
211 swelling pressure measured by sensor PS120F showed a similar pattern as that of sensor
212 PS120I, except for the first sudden drop. However, the peak and final value of swelling
213 pressure recorded by sensor PS120F were about 110 and 73.7 kPa, respectively, which were

214 significant lower than that measured by PS120I. This difference can be attributed to the
215 influence of rock fracture. At 180 mm, the swelling pressure increased at similar initial rate
216 for sensor PS180N and PS180F up to 1400 hours, which was lower than that at 120 mm. After
217 1400 hours, the difference in swelling pressure between sensor PS180N and PS180F occurred
218 and increased to about 42 kPa at 8300 hours. Again, this difference resulted from different
219 distances of sensors from the rock fracture, that is: the position of sensor PS180N was about 8
220 mm closer to the fracture than that of sensor PS180F. Fig. 6 shows the relationship between
221 peak and final swelling pressure and the distance to the fracture at 120 and 180 mm. It is clear
222 that with the presence of rock fracture, the relative position to the fracture showed significant

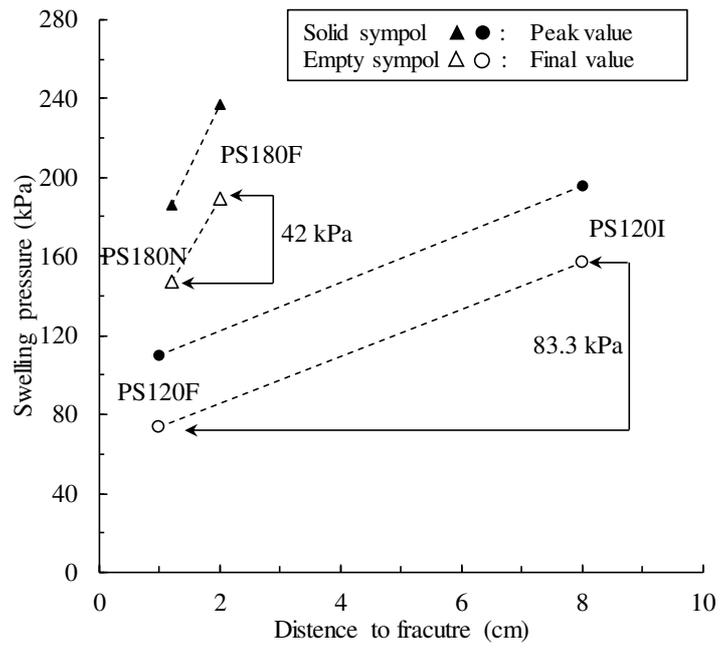
Fig. 6 Relationship between peak and final swelling pressure and distance to fracture

223 effect on the peak and final swelling pressure. At 120 mm, the difference in distance to the
224 fracture for sensor PS120F and PS120I was 70 mm, which led to a difference in swelling
225 pressure of 86 kPa (peak value) and 83.3 kPa (final value). For the case at 180 mm, the
226 differences in swelling pressure of 51 kPa (peak value) and 42 kPa (final value) were mainly
227 due to the 8 mm difference in distance to the fracture between sensor PS180N and PS180F. It
228 can also be observed that, greater relative distance to the fracture at the same height resulted
229 in higher difference in swelling pressure.

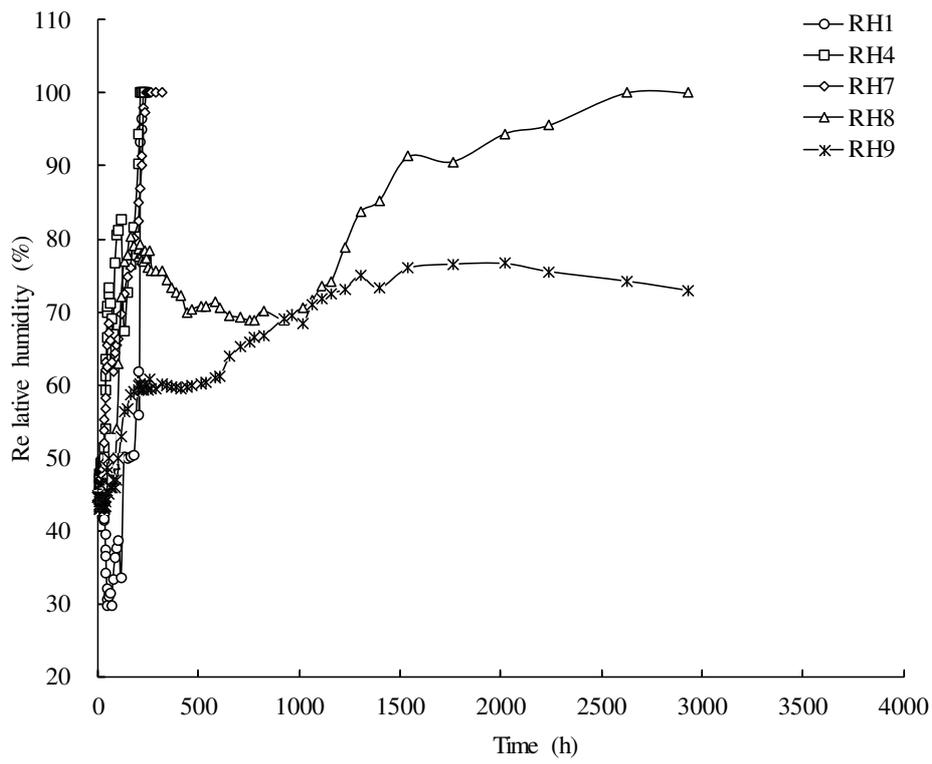
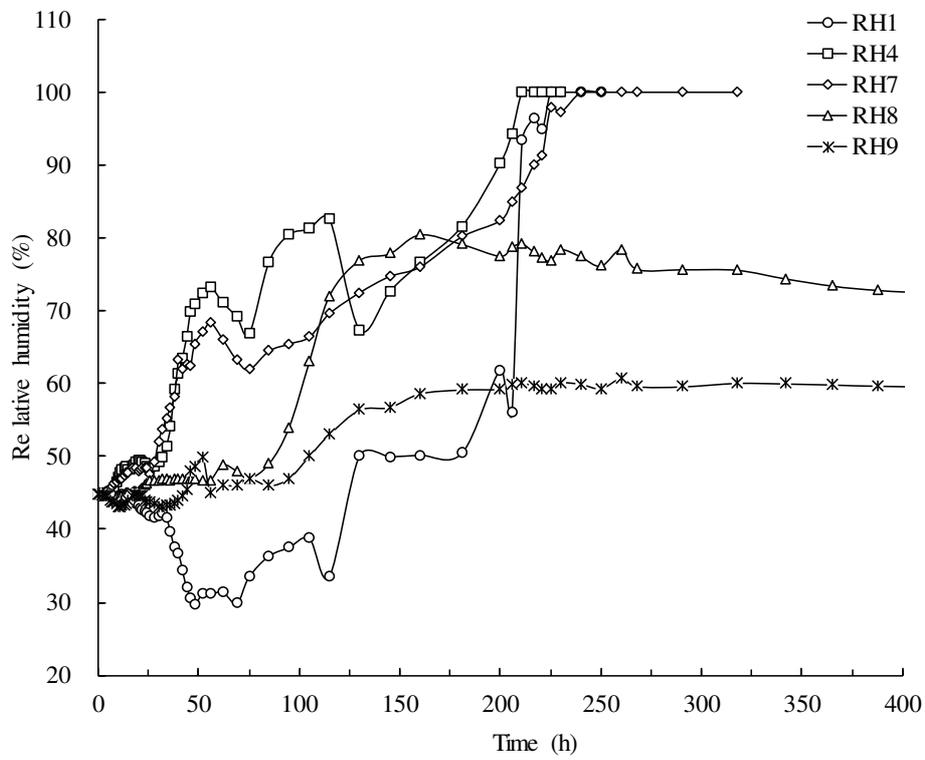
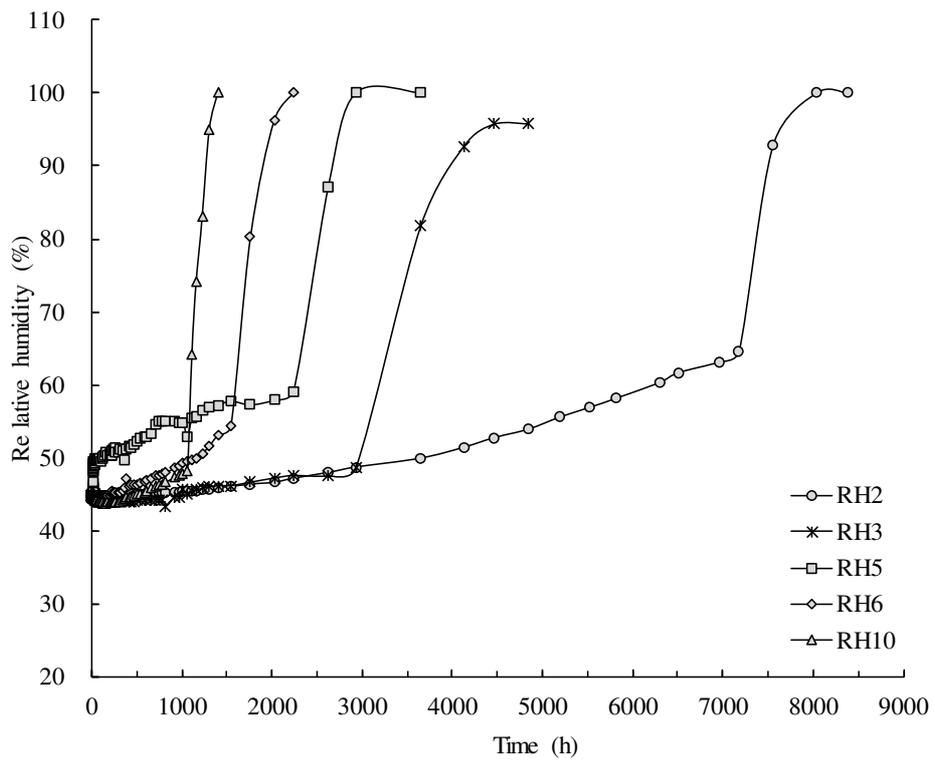
Fig. 7 Evolution of relative humidity during water infiltration, (a) recordings from sensors RH1, RH4, RH7, RH8 and RH9, (b) recordings from sensor RH1, RH4, RH7, RH8 and RH9 in the first 400 hours, (c) recordings from sensor RH2, RH3, RH5, RH6 and RH10

231 During the test, the changes in relative humidity (RH) at different positions are presented in
232 Fig. 7. The initial RH values were about $44\pm 1\%$, corresponding to the initial water content of
233 10.6%. On the whole, the RH value increased with time after water was introduced (for
234 sensors located in the center of the sample, as shown in Fig. 7a). At 60 mm, the RH value
235 showed a decrease trend up to 70 hours, and increased rapidly to 99% at 200 hours. This
236 sudden decrease in RH at lower position can explain the sudden decrease in swelling pressure
237 mentioned previously. As shown in Fig. 7b, the RH value at 120 mm, 180mm and 240 mm
238 started to increase after about 40 hours, 50 hours and 100 hours respectively, indicating the
239 gradual migration of water from the water inlet upwards (from bottom to top). Similar
240 observations have also been reported by Wang et al. (2013a) from the mock-up test on the

241 compacted bentonite and sand mixture. Unlike the results reported by Wang et al. (2013a), the
242 changes in relative humidity at different heights showed discontinues pattern with sudden
243 increase followed by a plateau. This behavior is mainly due to the fact that the air in the
244 porous stone and the water inlet tube did not been fully evacuated before the water injection.
245 Hence, the trapped air bubble might result in the discontinues of water infiltration. This

246 behavior can be confirmed by the variation of recordings of sensors near the rock/bentonite
247 interface as shown in Fig. 7c. As water infiltration continued, RH sensors located close to the
248 bentonite/rock interface at heights of 120 mm, 180 mm and 240 mm showed a delay response
249 in recording of relative humidity. Comparisons between Fig. 7(b) and 7(c) showed that at the
250 same height, the detection times of sensors near the rock/bentonite interface were about
251 dozens of times longer than that in the middle of the bentonite. At longer time, a sudden
252 increase in relative humidity for sensors near the rock/bentonite interface was also observed.
253 This phenomenon is thought to be due to that the air bubble was mainly distributed near
254 bentonite/rock interface, resulting in difficulty of upward water migration from the position
255 close to bentonite/rock interface. However, water could move from the center of the sample to

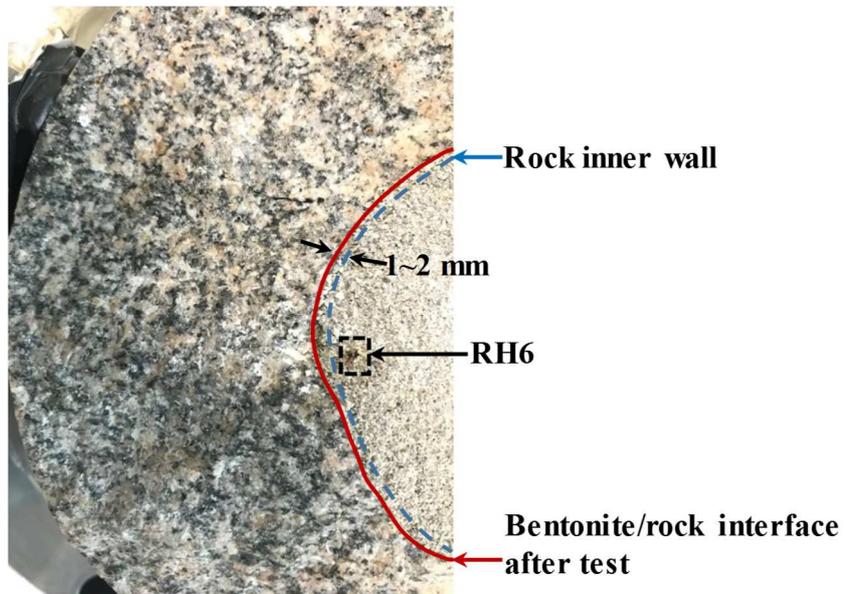
Fig. 8 Intrusion of bentonite into the fracture

260 The aim of the presented experimental test was to study the influence of rock fracture on the
261 swelling behavior of compacted bentonite. Fig. 8 shows a photo of rock fracture after
262 dismantling. The dash line depicts the rock inner wall, while the solid line represents the
263 bentonite/rock interface after test. Sensor RH6 can be also observed in the figure. It appears
264 clearly that after 349-day hydration, the bentonite/rock interface enlarged about 1-2 mm. This
265 confirms the intrusion of bentonite into the rock fracture under the effect of swelling pressure
266 of bentonite behind. Hence, it is logically to expect that the loss of swelling pressure with the
267 presence of rock fracture (see Fig. 6) was mainly due to the decrease in local dry density in
268 the vicinity of the fracture when certain amount of bentonite filling the fracture. This behavior

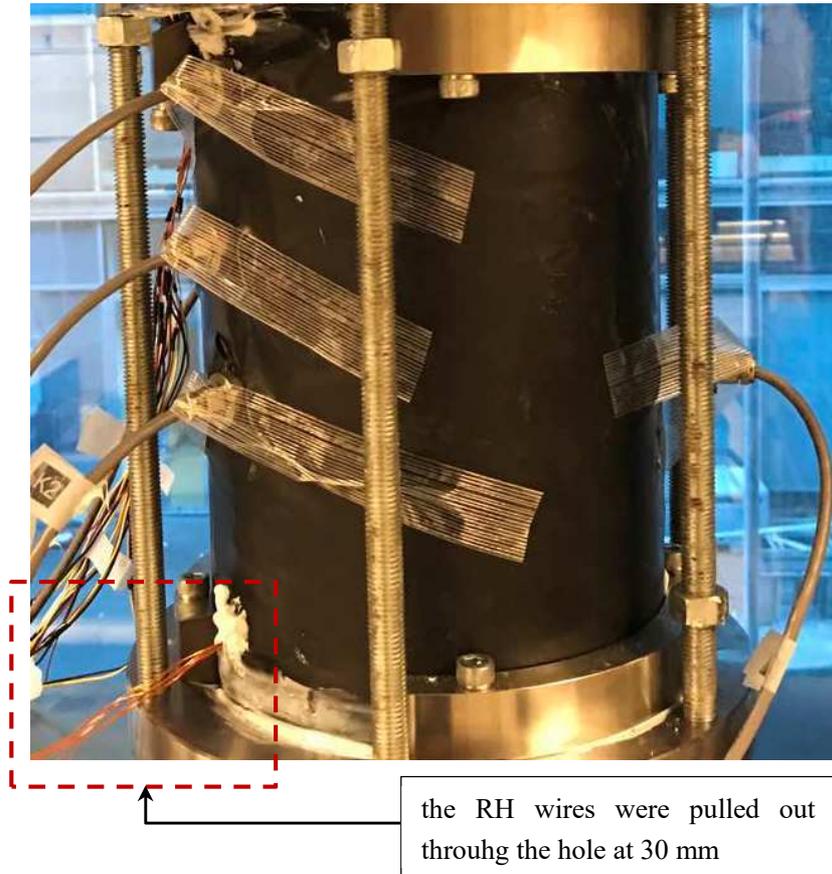
Fig. 9 Detail of RH wires at the hole of 30 mm

301 Regarding the sudden decrease of swelling pressure for sensor PS120I, it can be explained by
302 combining the results of swelling pressure sensors and RH sensors. As shown in Fig. 7, the
303 RH value at 60 mm decreased until about 70 hours. This decrease possibly resulted from the
304 experimental design where the connection wires of RH sensor at position lower than 180 mm
305 were pulled out of the sample through the hole located at 30 mm (as shown in Fig. 9).
306 Although the hole was sealed by the elastic rubber after the wire pulled out, some air can still
307 flow into the sample through the hole, which may lead to the first decrease in RH value at 60
308 mm after water injection. In addition, because there were lots of wires going through the hole
309 at 30 mm, this may result in local inhomogeneous distribution of soil around this area. After
310 water infiltration, the soil around the hole at 30 mm tended to swell and reorganize.

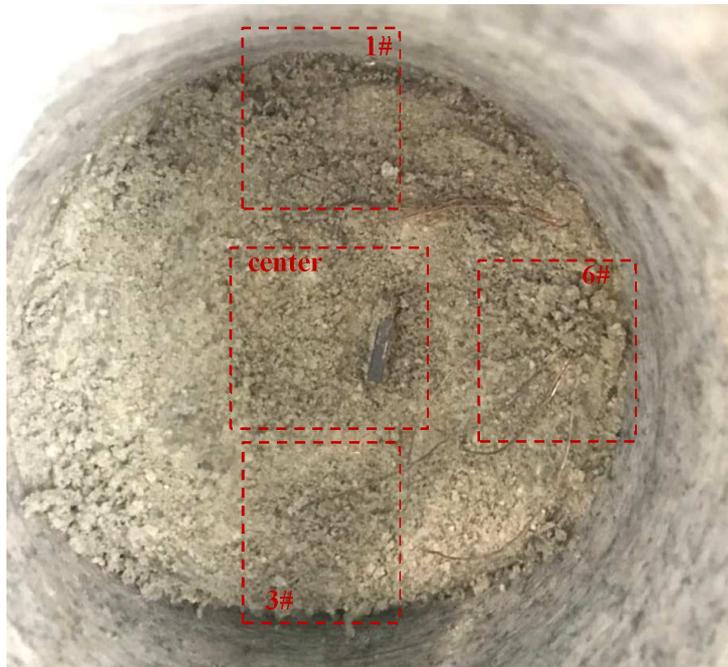
Fig. 10 After-infiltration sample at 60 mm

311 Meanwhile, air might go inside the sample through the hole at 30 mm. All these factors might
312 result in the local soil redistribution or local soil collapse around the area near 30 mm hole.
313 This, in turn, led to the decrease in swelling pressure of sensor PS120I along section 6# at the
314 beginning of the test. Fig. 10 shows a photo of sample at 60 mm after sample dismantled. It

315 can be observed that the converged wires of RH sensor around 60 mm along section 6#
316 significantly disturbed the soil around that position. The sample at different sections were
317 taken and the dry density of after-infiltration sample at 60 mm were determined as shown in
318 Fig. 11. It is clear that the dry density of after-infiltration sample along section 6# (near 30
319 mm hole) was the lowest, which confirmed that the looser state of soil was caused by the
320 wires of RH sensors and explained the sudden decrease in swelling pressure for sensor
321 PS120I.

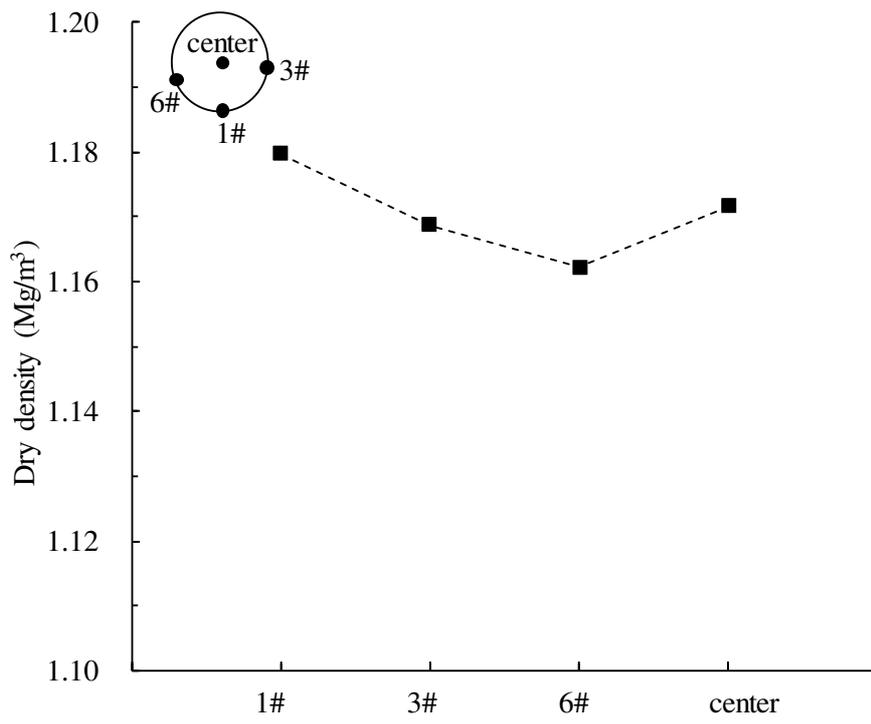
Fig. 11 Variation of dry density of after-infiltration sample at 60 mm
