Decay processes in buildings close to the sea induced by marine aerosol: Salt depositions inside construction materials

H. Morillas, F.F. Mendonça Filho, Hannelore Derluyn, M. Maguregui, David Grégoire, Juan Manuel Madariaga

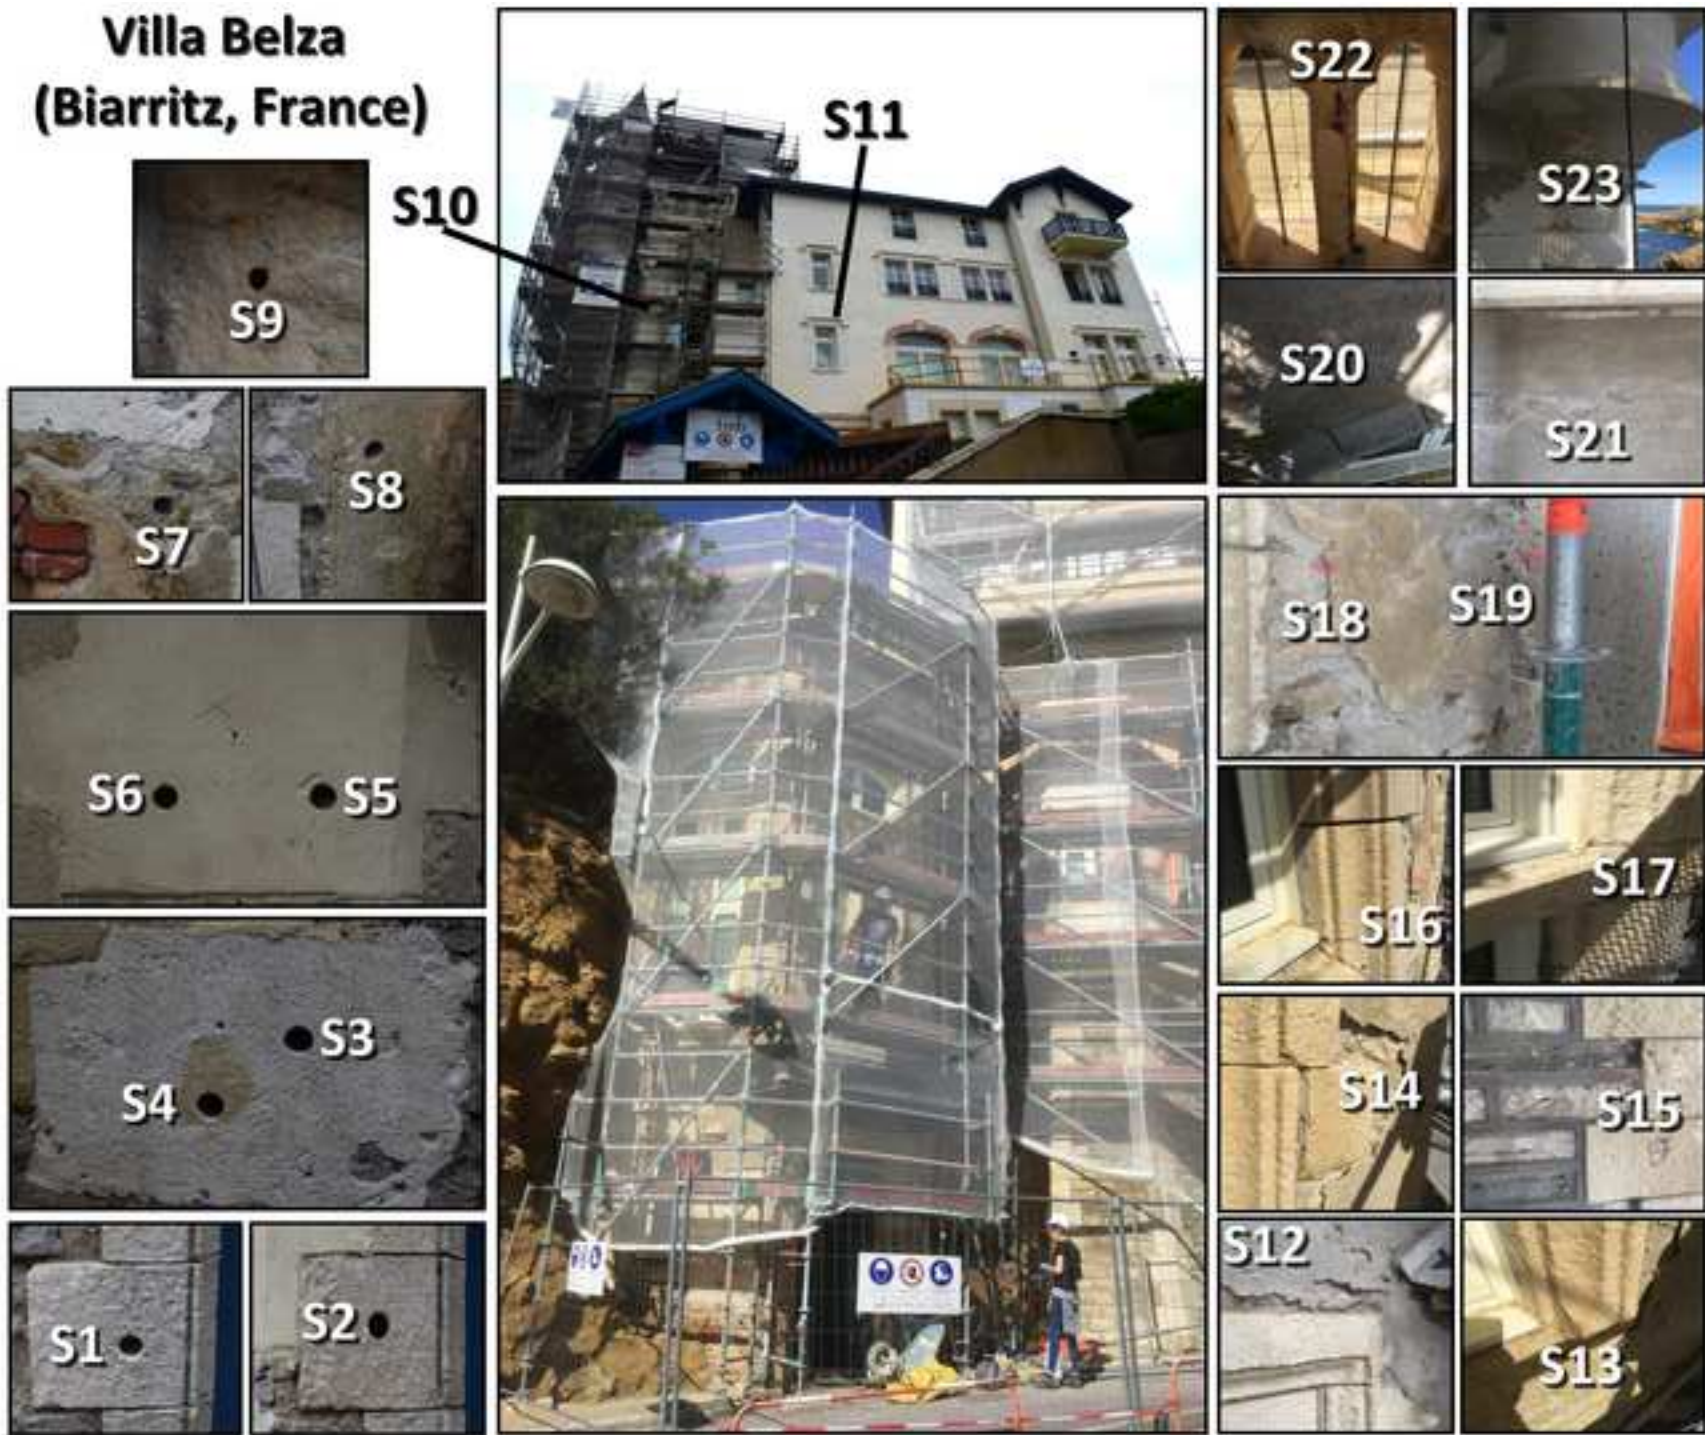
Figure 1
[Click here to download high resolution image](#)

Villa Belza (Biarritz, France)

102 This study has been carried out on the façades from a building called the Villa Belza,
103 which was built from 1880 until 1895. The construction is located at the coast of
104 Biarritz, France, with direct exposition to sea spray (see Figure S1 from Supplementary
105 Material and Table 1). The study has been performed in the façade opposite to the

106 orientation of the sea, since it was not possible to extract samples from the opposite
107 façade oriented directly to the sea. 23 samples of different kinds of materials
108 (limestones, sandstone, cement and joint and rendering mortars) were collected at
109 different heights (see Figure 1) in order to observe possible differences in the
110 deterioration processes of building materials along the façade.

156 To determine the nature of the main colonizers in the greenish patina visible in some
157 samples (e.g., S8 sample in Figure 1) from Villa Belza, Phase Contrast microscope
158 (PCM) was used. Micro-photographs of the colonized samples were obtained with a
159 Nikon DN100 camera coupled to a Nikon SMZ800 stereoscopic microscope and
160 microphotographs were captured with a Nikon DS Fi1 DS-Fi1 digital microscope
161 camera on a Nikon Eclipse 80i PCM provided with 20 \times , 40 \times , 60 \times and 100 \times objective
162 lenses.

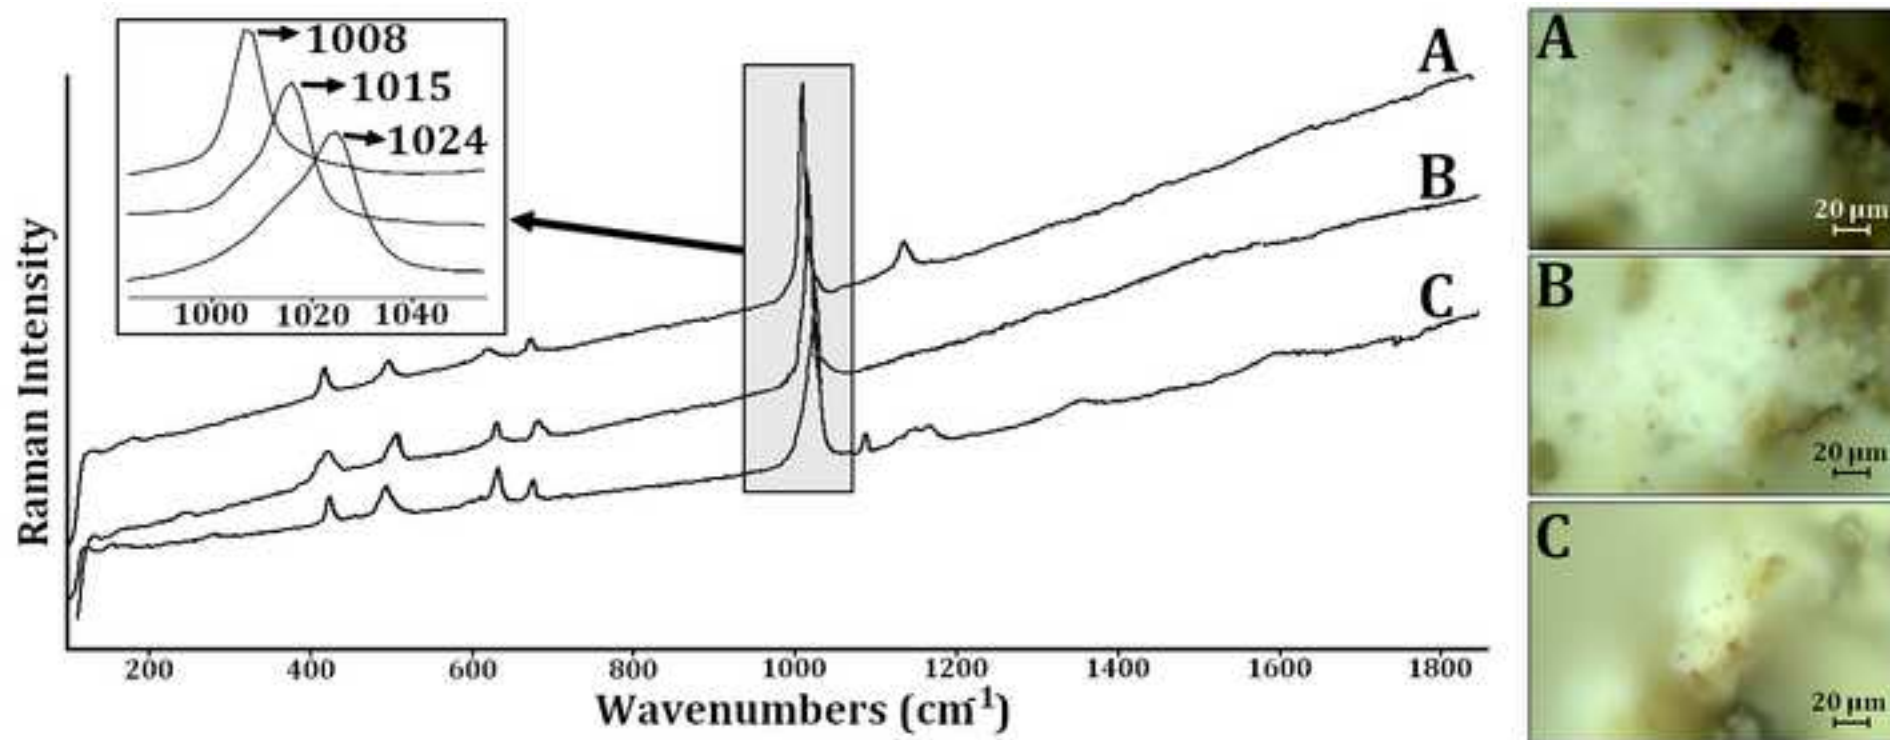
Figure 3
[Click here to download high resolution image](#)

276 In most of the studied samples (S1, S2, S9, S10, S11, S12, S13, S14 and S20) different
277 kind of calcium sulfates were detected (see Figure 3), such as gypsum (main Raman
278 bands at 414, 493, 616, 670, 1008 and 1132 cm^{-1}) (see Figure 3A), bassanite
279 ($\text{CaSO}_4 \cdot \frac{1}{2}\text{H}_2\text{O}$, main Raman bands at 430, 488, 627, 668 and 1015 cm^{-1}) (see Figure
280 3B) and anhydrite (CaSO_4 , main Raman bands at 422, 492, 631, 673, 1024 and 1166
281 cm^{-1}) (see Figure 3C). In this last case, the additional band at 1086 cm^{-1} that belongs to
282 calcite (see Figure 3C) was also registered. The identification of calcium sulfate
283 crystallization with different hydration waters is related with the dehydration process of
284 the gypsum previously formed in the different building materials (sandstone, limestone
285 and joint and rendering mortar) from Villa Belza construction. These transformations

286 start when water evaporation processes take place under some specific reactions
287 described elsewhere (**Morillas et al., 2013**). Hydration and dehydration cycles promote
288 an increase and decrease in the size of the crystals formed in the pores of the building
289 materials, which can lead to possible cracks and loss of material.

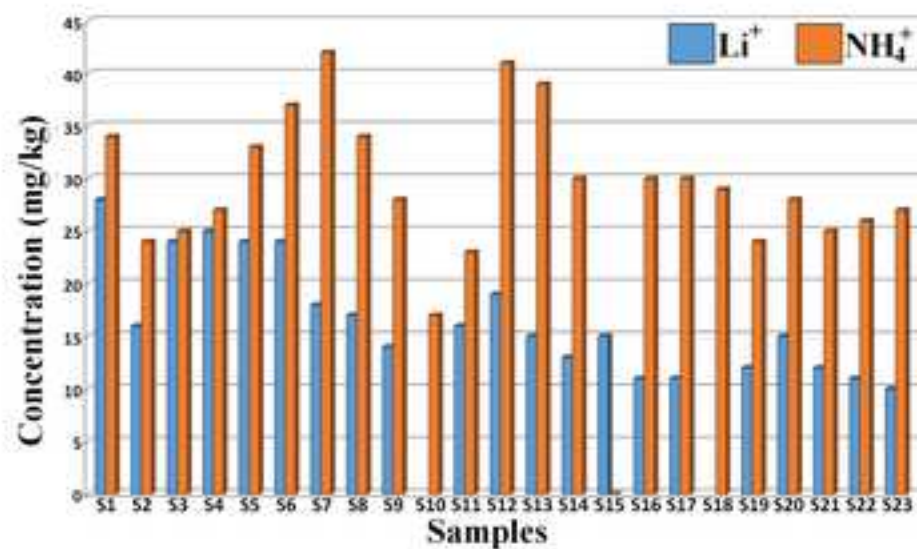
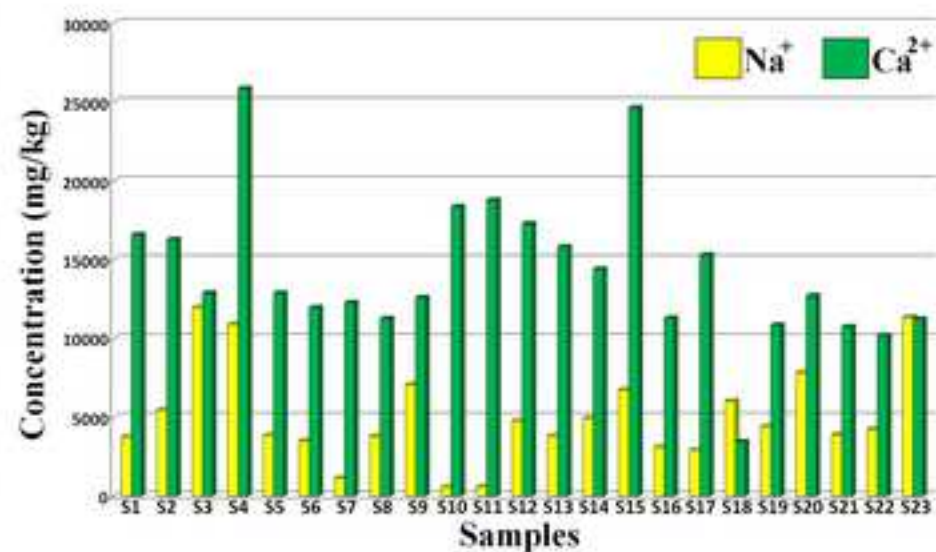
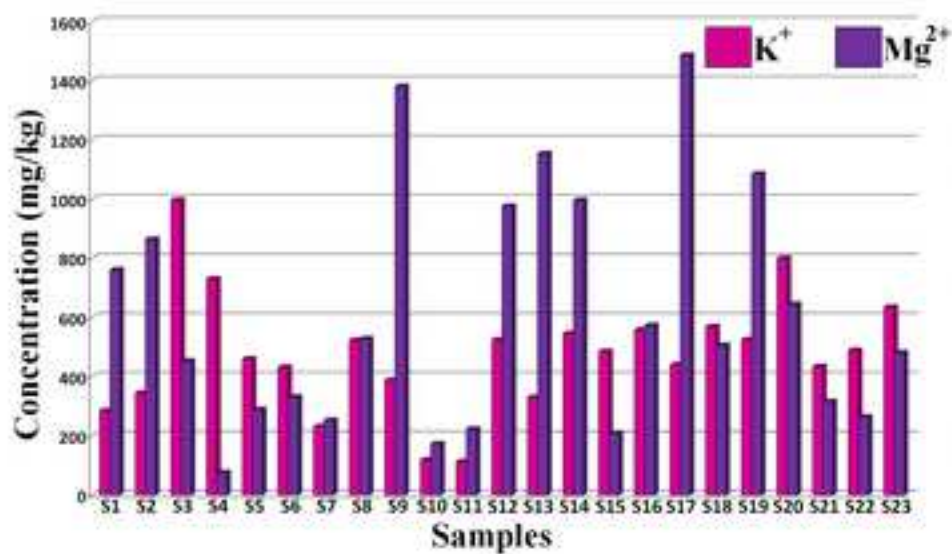
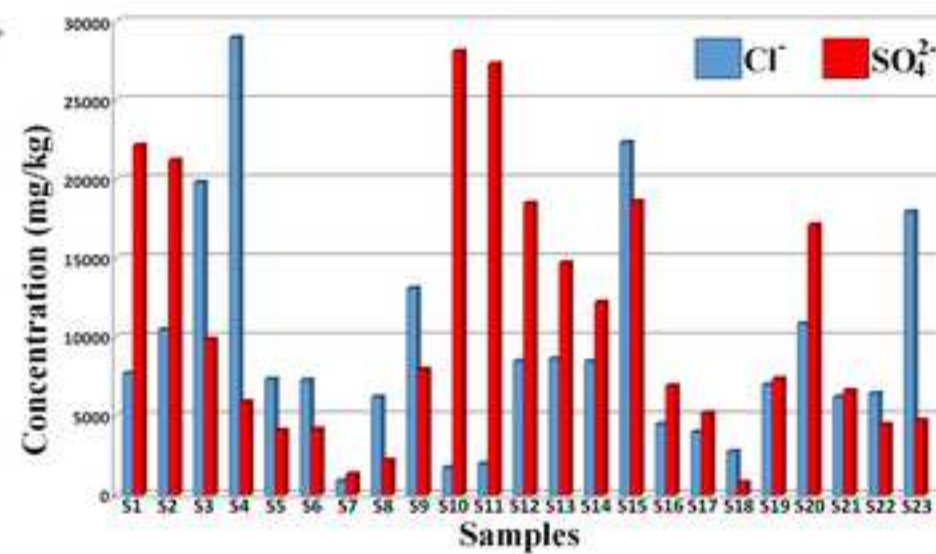
Figure 5
[Click here to download high resolution image](#)

631 **Figure 5.** Bar charts showing cations and anions concentrations (mg/kg units) on each
632 Villa Belza sample.

359 crystallization of mainly sulfate and chloride salts. To confirm the magnitude of this
360 impact, soluble salts were extracted and quantified to determine their specific nature.
361 The concentrations of the anions and cations obtained after the soluble salts test are
362 presented in Figure 5 (see also Table S1 in Supplementary Material). The results are
363 expressed as the average concentration of each ion together with the relative standard
364 deviation (at 95% confidence interval) calculated from three sample portions
365 (subsamples) for each sample.

375 Regarding alkali and alkaline earth cations, the concentrations in general terms are
376 higher for Mg^{2+} than for K^+ (506 vs 485 mg/kg respectively). On the one hand, the
377 samples that contain more than 600 mg/kg of K^+ are S3, S4, S20 and S23. Moreover,
378 these three samples have a similar calcite proportion (around 50 %). Calcite is a very
379 soluble compound, in the continuous contact with the H_2CO_3 aerosol, which can react
380 after solubilization with other anions and cations coming from the sea spray giving rise
381 to different K^+ compounds (**Morillas et al., 2013**). On the other hand, as can be seen in
382 the bar chart of Figure 5, the samples that show the highest concentrations of Mg^{2+} are
383 S9, S12, S13, S14, S17 and S19 samples. For the unique only sandstone sample (S9)
384 analyzed in this work, 8% (wt %) of dolomite was detected (see Table 1), thus the high
385 Mg^{2+} concentration could be related with the presence of this carbonate. On the
