## **Condition Assessment of an historical structure : the CNIT Vault in Paris**

## CONDITION ASSESSMENT OF AN HISTORICAL STRUCTURE: THE CNIT VAULT IN PARIS

### SUMMARY

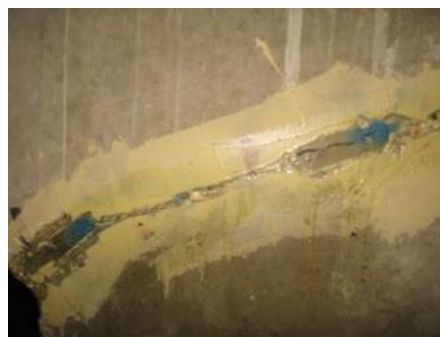
**Fig. 9.** Example of an injected crack detected in the diaphragms of the vault.

The great majority of cracks are located in the diaphragms and start from the corner of the openings which is a zone of stress concentration (Fig. 8); they have an angle of about 135 ° on the horizontal. Some of them were already injected some years back (Fig. 9), probably during the analysis and retrofitting works linked to the creation of the parking lots underneath the CNIT. The other non-injected cracks are less than 0.4-0.5 mm wide

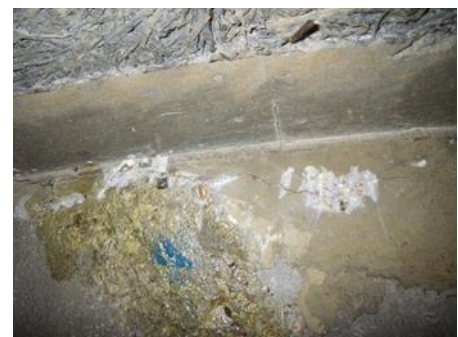
**Fig. 10.** Example of cracks located in the patch repair at diaphragm/shell junction.

Some cracks are also visible at the junction between the diaphragm and the upper shell. Five of them were investigated and it appears that the crack affects the patch repair and that under the mortar repair, the crack does not extend into the diaphragm (Fig. 10). Globally, the general conclusion of this visual inspection of a sample of cells was the overall good structural condition of the vault.

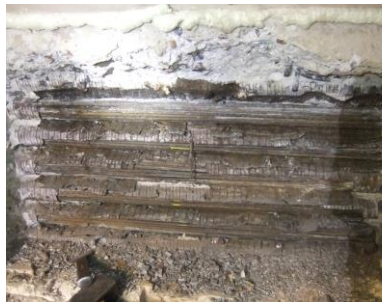
**Fig. 12.** Good conservation of the wires after removal of the ducts

The ducts were not corroded. A cursory glance inside the ducts (Fig. 12) has revealed that, except for one (out of 20), the grout still sticks to the wires and fills the ducts uniformly. No wire was broken and a few spots of superficial rust were nonetheless observed in some locations. One of the duct was without grout, and, unsurprisingly, the wires inside were found rusty, and one wire of the tendon was obviously loose.

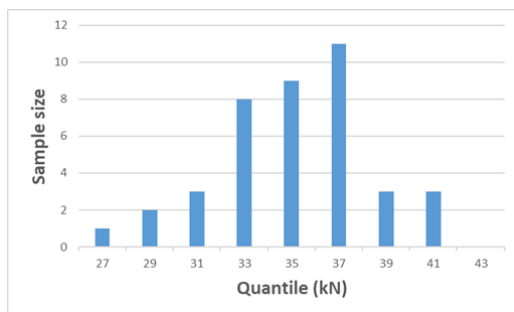
**Fig 13.** Histogram of residual tension in wires measured by the crossbow method.

Yet the main purpose of the investigation was to estimate the residual tension of the tendons. This was carried out with the help of the crossbow method [7] whose principle consists in measuring the bending stiffness of a wire that depends on the wire tension according to a definite mechanical law. Some 40 wires were tested (Fig. 13), and the estimation of the tension is summed up in figure 13. It was found that no discrepancy exists between the two pairs of openings. The mean residual tension lies between 35 and 37 kN, with 95% confidence. This is to be compared with the tension obtained in 1958 that was 34.6 kN.

It turns out that the tension has slightly increased with time, despite the relaxation of the prestressing wires. Considering that there is no external disorder showing that the concrete is affected by an internal expansion reaction (alkali-aggregate reaction or delayed ettringite formation), the most likely cause of this tension increase in the tendons is the delayed displacement of the abutments explained by the movement consecutive to the consolidation of the soil behind the abutment. The delayed horizontal displacement of an abutment

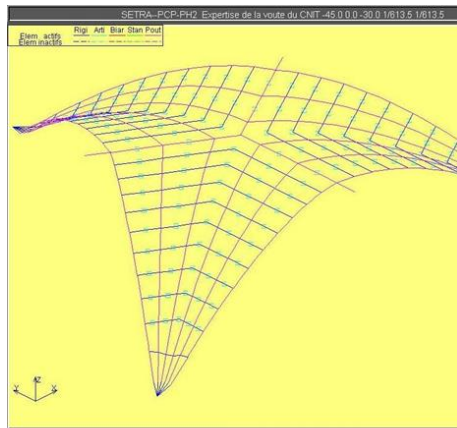
**Fig. 15.** Visualization of the PCP model

Thus, the structure of the CNIT was modelled in 3 dimensions with the PCP bar software. The structure is composed of 3 vaults of 9 spindles or 6 half-vaults connected by the front key. In the model, each half-vault was modeled by a beam, i.e. 18 beams for the shell as a whole. This segmentation allows for a relatively simple modelization of the phasing of the construction element by element. A thinner segmentation of the structure was not necessary: in view of the transversal rigidity of the beam cross section made of "3-box girders", the beam theory has been assumed despite the spans of the sections in the keys (approximately 20.80 m). Each front key was modeled by three beams in order to fit the execution phases.

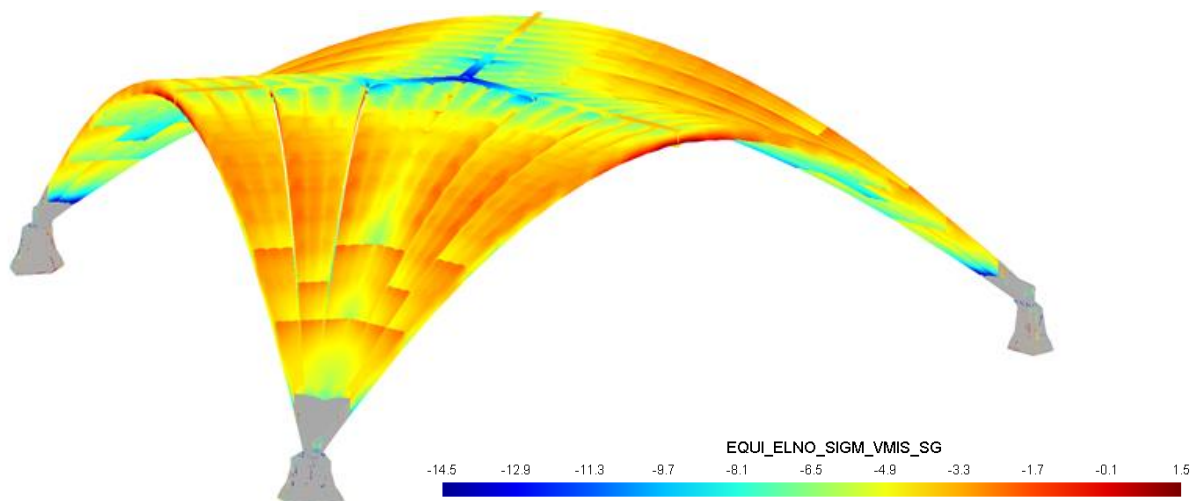
**Fig. 17.** Equivalent stresses of Von Mises represented by the trace of the tensor of the stresses, on the average layer, under own-weight (Units: MPa and compression is negative).

A finite element model of the structure using shell surface elements was implemented to model thin parts of the structure such as the upper and lower shells of the vault, while volume elements were used to model the massive parts such as the abutments and the key junction. The model comprises 74 694 elements and 215 360 nodes. An elastic linear calculation was carried out for the following loading cases: own-weight (Fig.17), thermal expansion and displacement of the vault support.

The comparison of the models with different loading cases reveals a good agreement between the bar model and the finite element model. The observed differences in the vicinity of the key and the abutments can be explained by the limits of use of the PCP model. After validation, displacements and rotations of the abutments
