Condition Assessment of an historical structure : the CNIT Vault in Paris

Bruno Godart, Franziska Schmidt, Brioist Jean-Jacques Brioist, Jean Paul Deveaud, Fernando Dias. Condition Assessment of an historical structure : the CNIT Vault in Paris. IABSE Symposium, Synergy of Culture and Civil Engineering - History and Challenges, May 2020, Wroclaw, Poland. 8 p. <hal-02545762v2>

CONDITION ASSESSMENT OF AN HISTORICAL STRUCTURE: THE CNIT VAULT IN PARIS

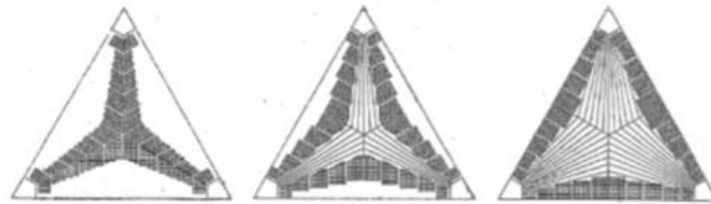
Fig. 4 Principle of construction of the vault in three stages

The vault was built in three main phases by group of three spindles (Fig. 4). These latter were built on scaffolding and then jacked in order to translate the scaffolding for the next phase. As the pressure in the jacks (10 jacks of 300 tons located near the abutment) increased by steps, the tension in the tendons of the prestressed ties was also progressively increased. Additional jacking of each group of 3 spindles was further performed to compensate for the subsequent creep deformations of the different spindles.

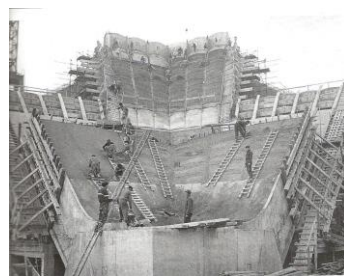
Fig. 6. Abutment and concreting of the shell of the first spindles.

Along the axis of each spindle, the total height of the vault section varies from 1.90 m (at key) to 2.75 m (at base), measured on the normal to the neutral axis [2]. Webs and diaphragms are precast and have a thickness of 6 cm [1] (Fig. 5). All these panels are pierced by rectangular openings, which allow ventilation, equalization of the temperature between shells and the internal inspection. The abutments consist of solid, 6.30 m high prismatic concrete blocks (Fig. 6) and are linked by prestressed concrete ties.

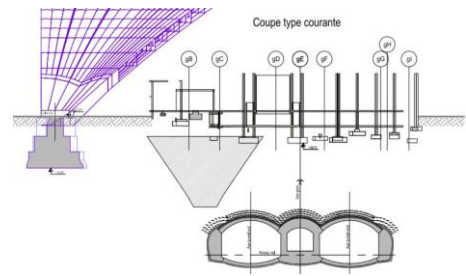
Fig. 7. Location of the new tunnel under the CNIT (Courtesy EGIS & SETEC).

The digging of tunnels for access to the new railway station located under the CNIT, the excavation of the station under the last level of the CNIT underground car park and the excavation of the tunnel access shaft were located in order to avoid any work under or close to the CNIT foundations. According to the drawings, the distance between the tunnels and the secondary ties is of the order of 7 m. The main ties are about 12 m from the tunnels. The foundations of the CNIT are located more than 40 m from the tunnels and should therefore be very little affected by the displacements generated by digging the tunnels.

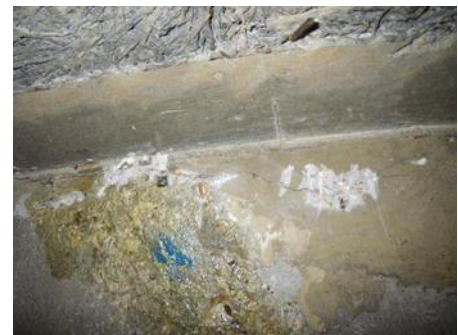
Fig. 10. Example of cracks located in the patch repair at diaphragm/shell junction.

Some cracks are also visible at the junction between the diaphragm and the upper shell. Five of them were investigated and it appears that the crack affects the patch repair and that under the mortar repair, the crack does not extend into the diaphragm (Fig. 10). Globally, the general conclusion of this visual inspection of a sample of cells was the overall good structural condition of the vault.

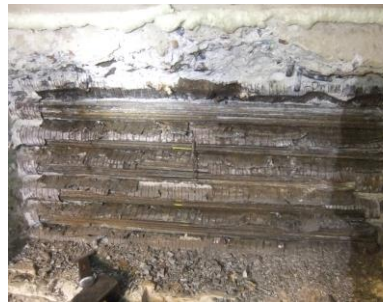
Fig. 12. Good conservation of the wires after removal of the ducts

The ducts were not corroded. A cursory glance inside the ducts (Fig. 12) has revealed that, except for one (out of 20), the grout still sticks to the wires and fills the ducts uniformly. No wire was broken and a few spots of superficial rust were nonetheless observed in some locations. One of the duct was without grout, and, unsurprisingly, the wires inside were found rusty, and one wire of the tendon was obviously loose.

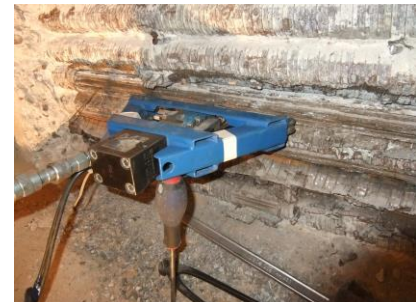
Fig. 13. Measure of the tension of a wire by the crossbow method

Yet the main purpose of the investigation was to estimate the residual tension of the tendons. This was carried out with the help of the crossbow method [7] whose principle consists in measuring the bending stiffness of a wire that depends on the wire tension according to a definite mechanical law. Some 40 wires were tested (Fig. 13), and the estimation of the tension is summed up in figure 13. It was found that no discrepancy exists between the two pairs of openings. The mean residual tension lies between 35 and 37 kN, with 95% confidence. This is to be compared with the tension obtained in 1958 that was 34.6 kN.

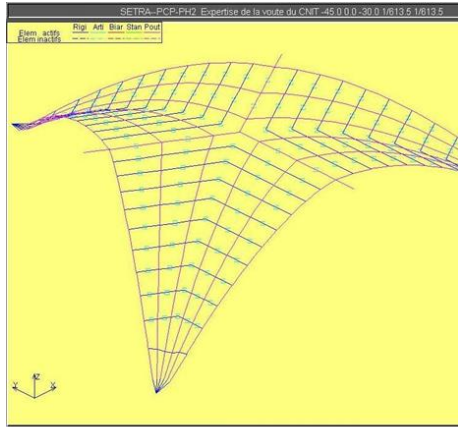
Thus, the structure of the CNIT was modelled in 3 dimensions with the PCP bar software. The structure is composed of 3 vaults of 9 spindles or 6 half-vaults connected by the front key. In the model, each half-vault was modeled by a beam, i.e. 18 beams for the shell as a whole. This segmentation allows for a relatively simple modelization of the phasing of the construction element by element. A thinner segmentation of the structure was not necessary: in view of the transversal rigidity of the beam cross section made of "3-box girders", the beam theory has been assumed despite the spans of the sections in the keys (approximately 20.80 m). Each front key was modeled by three beams in order to fit the execution phases.

Fig. 15. Visualization of the PCP model

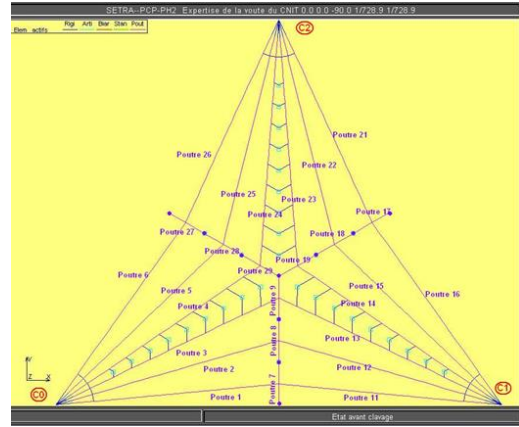
Fig. 16. Numbering of beams in the PCP model
