Condition Assessment of an historical structure: the CNIT Vault in Paris

CONDITION ASSESSMENT OF AN HISTORICAL STRUCTURE: THE CNIT VAULT IN PARIS

B. Godart¹, F. Schmidt¹, J.J. Brioist², J.P. Deveaud³, F. Dias⁴

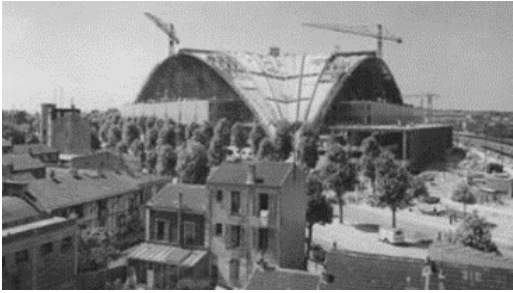
Fig. 1 The CNIT under construction

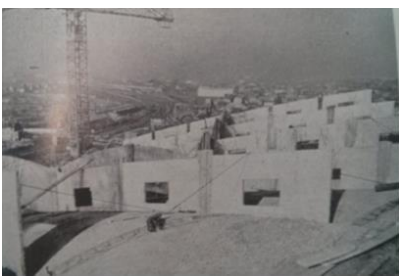
Fig. 5. View of the lower shell, webs and diaphragms.

Along the axis of each spindle, the total height of the vault section varies from 1.90 m (at key) to 2.75 m (at base), measured on the normal to the neutral axis [2]. Webs and diaphragms are precast and have a thickness of 6 cm [1] (Fig. 5). All these panels are pierced by rectangular openings, which allow ventilation, equalization of the temperature between shells and the internal inspection. The abutments consist of solid, 6.30 m high prismatic concrete blocks (Fig. 6) and are linked by prestressed concrete ties.

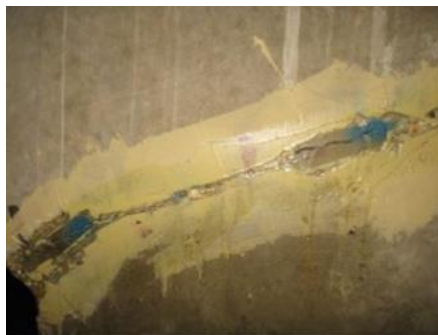
Fig. 9. Example of an injected crack detected in the diaphragms of the vault.

The great majority of cracks are located in the diaphragms and start from the corner of the openings which is a zone of stress concentration (Fig. 8); they have an angle of about 135 ° on the horizontal. Some of them were already injected some years back (Fig. 9), probably during the analysis and retrofitting works linked to the creation of the parking lots underneath the CNIT. The other non-injected cracks are less than 0.4-0.5 mm wide

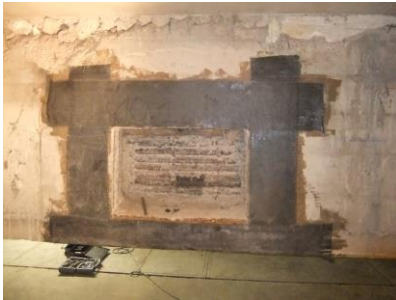
The three prestressed concrete ties are composed of 44 tendons each. Each tendon, made of 24 wires, with 7 mm in diameter, belongs to the Boussiron (BBR) process. It is reported in [2] that these tendons have an ultimate tensile strength not smaller than 1450 MPa and had been tensioned with 85-ton jacks, which corresponds to an average stress of 920 MPa inside the steel and a safety factor of 1.33. It was of course of paramount importance to keep the stress level well below the usual standard value, so as to keep a safety margin to adjust afterwards the forces in the three ties together and to cope with a possible differential settlement of the vault. The ties are enclosed in a hollow rectangular concrete box with 20 cm thick walls. The space between the 44 tendons ducts and the concrete box was filled with sand, in order to protect the tendons against fire in case of arson. The first step of investigation was then to do four 90×60 cm openings in the concrete wall of the box in some locations, and uncover the ducts (Fig. 11). Each opening could give access to 5 ducts, viz. 10 wires on average.

Fig. 11. Opening of a window in the tie after a local strengthening by CFRP.

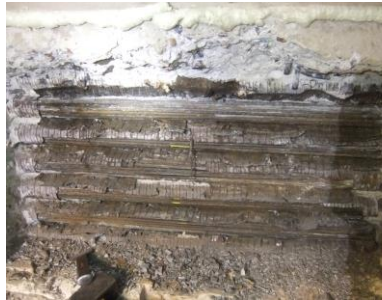
Fig. 12. Good conservation of the wires after removal of the ducts

The ducts were not corroded. A cursory glance inside the ducts (Fig. 12) has revealed that, except for one (out of 20), the grout still sticks to the wires and fills the ducts uniformly. No wire was broken and a few spots of superficial rust were nonetheless observed in some locations. One of the duct was without grout, and, unsurprisingly, the wires inside were found rusty, and one wire of the tendon was obviously loose.

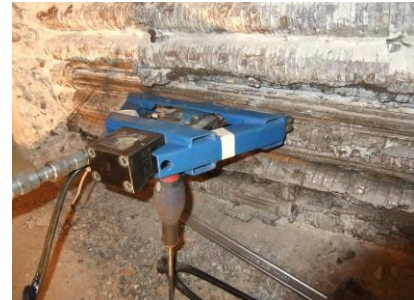
Fig. 13. Measure of the tension of a wire by the crossbow method

Yet the main purpose of the investigation was to estimate the residual tension of the tendons. This was carried out with the help of the crossbow method [7] whose principle consists in measuring the bending stiffness of a wire that depends on the wire tension according to a definite mechanical law. Some 40 wires were tested (Fig. 13), and the estimation of the tension is summed up in figure 13. It was found that no discrepancy exists between the two pairs of openings. The mean residual tension lies between 35 and 37 kN, with 95% confidence. This is to be compared with the tension obtained in 1958 that was 34.6 kN.

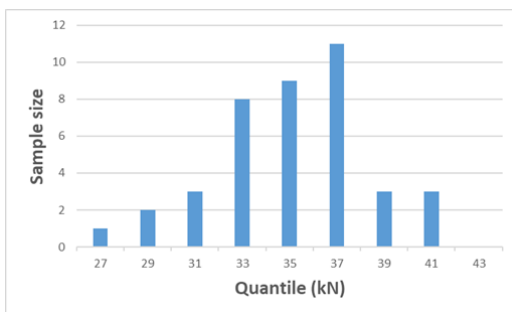
Fig 13. Histogram of residual tension in wires measured by the crossbow method.

It turns out that the tension has slightly increased with time, despite the relaxation of the prestressing wires. Considering that there is no external disorder showing that the concrete is affected by an internal expansion reaction (alkali-aggregate reaction or delayed ettringite formation), the most likely cause of this tension increase in the tendons is the delayed displacement of the abutments explained by the movement consecutive to the consolidation of the soil behind the abutment. The delayed horizontal displacement of an abutment
