Condition Assessment of an historical structure: the CNIT Vault in Paris

CONDITION ASSESSMENT OF AN HISTORICAL STRUCTURE: THE CNIT VAULT IN PARIS

B. Godart¹, F. Schmidt¹, J.J. Brioist², J.P. Deveaud³, F. Dias⁴

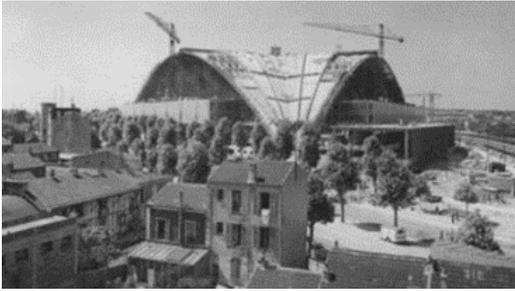
Fig. 1 The CNIT under construction

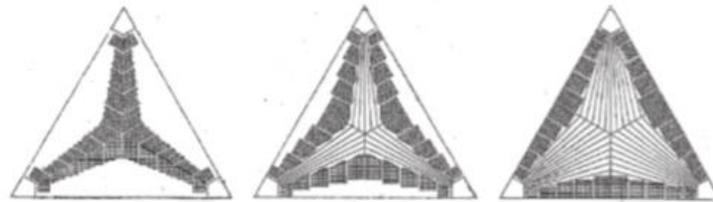
Fig. 4 Principle of construction of the vault in three stages

The vault was built in three main phases by group of three spindles (Fig. 4). These latter were built on scaffolding and then jacked in order to translate the scaffolding for the next phase. As the pressure in the jacks (10 jacks of 300 tons located near the abutment) increased by steps, the tension in the tendons of the prestressed ties was also progressively increased. Additional jacking of each group of 3 spindles was further performed to compensate for the subsequent creep deformations of the different spindles.

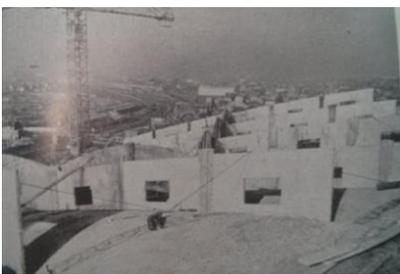
Fig. 5. View of the lower shell, webs and diaphragms.

Along the axis of each spindle, the total height of the vault section varies from 1.90 m (at key) to 2.75 m (at base), measured on the normal to the neutral axis [2]. Webs and diaphragms are precast and have a thickness of 6 cm [1] (Fig. 5). All these panels are pierced by rectangular openings, which allow ventilation, equalization of the temperature between shells and the internal inspection. The abutments consist of solid, 6.30 m high prismatic concrete blocks (Fig. 6) and are linked by prestressed concrete ties.

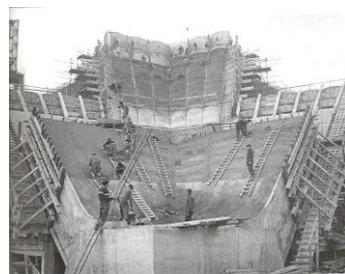
Fig. 6. Abutment and concreting of the shell of the first spindles.

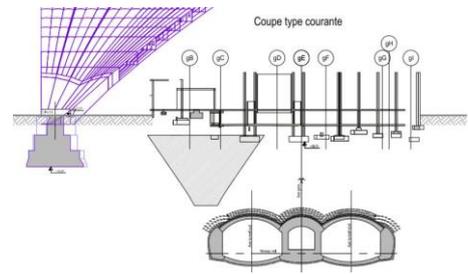
Fig. 7. Location of the new tunnel under the CNIT (Courtesy EGIS & SETEC).

The digging of tunnels for access to the new railway station located under the CNIT, the excavation of the station under the last level of the CNIT underground car park and the excavation of the tunnel access shaft were located in order to avoid any work under or close to the CNIT foundations. According to the drawings, the distance between the tunnels and the secondary ties is of the order of 7 m. The main ties are about 12 m from the tunnels. The foundations of the CNIT are located more than 40 m from the tunnels and should therefore be very little affected by the displacements generated by digging the tunnels.

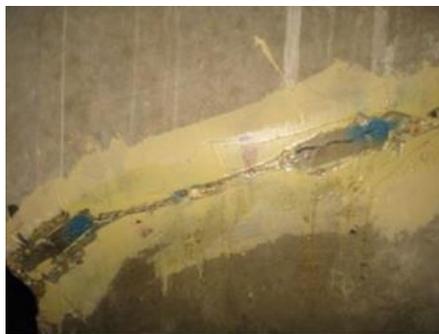
Fig. 9. Example of an injected crack detected in the diaphragms of the vault.

The great majority of cracks are located in the diaphragms and start from the corner of the openings which is a zone of stress concentration (Fig. 8); they have an angle of about 135 ° on the horizontal. Some of them were already injected some years back (Fig. 9), probably during the analysis and retrofitting works linked to the creation of the parking lots underneath the CNIT. The other non-injected cracks are less than 0.4-0.5 mm wide

and can occasionally reach an opening of 0.9 mm. Overall, these cracks do not seem active, and after their initial creation these cracks do not seem to spread or deviate.

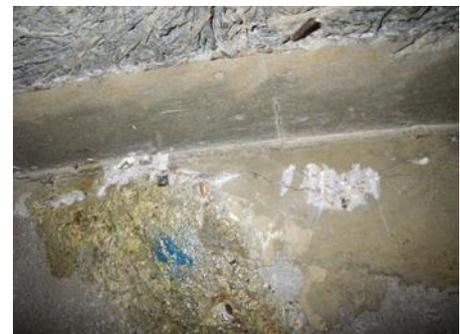
Fig. 10. Example of cracks located in the patch repair at diaphragm/shell junction.

Some cracks are also visible at the junction between the diaphragm and the upper shell. Five of them were investigated and it appears that the crack affects the patch repair and that under the mortar repair, the crack does not extend into the diaphragm (Fig. 10). Globally, the general conclusion of this visual inspection of a sample of cells was the overall good structural condition of the vault.

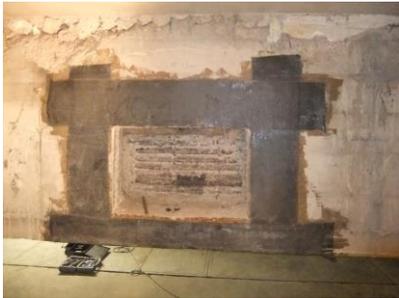
The three prestressed concrete ties are composed of 44 tendons each. Each tendon, made of 24 wires, with 7 mm in diameter, belongs to the Boussiron (BBR) process. It is reported in [2] that these tendons have an ultimate tensile strength not smaller than 1450 MPa and had been tensioned with 85-ton jacks, which corresponds to an average stress of 920 MPa inside the steel and a safety factor of 1.33. It was of course of paramount importance to keep the stress level well below the usual standard value, so as to keep a safety margin to adjust afterwards the forces in the three ties together and to cope with a possible differential settlement of the vault. The ties are enclosed in a hollow rectangular concrete box with 20 cm thick walls. The space between the 44 tendons ducts and the concrete box was filled with sand, in order to protect the tendons against fire in case of arson. The first step of investigation was then to do four $90 \times 60 \text{ cm}$ openings in the concrete wall of the box in some locations, and uncover the ducts (Fig. 11). Each opening could give access to 5 ducts, viz. 10 wires on average.

Fig. 11. Opening of a window in the tie after a local strengthening by CFRP.

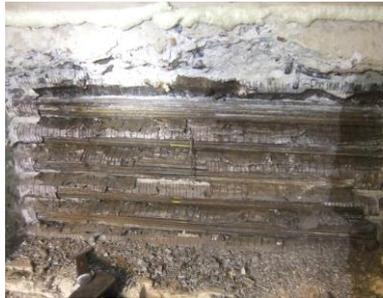
Fig. 12. Good conservation of the wires after removal of the ducts

The ducts were not corroded. A cursory glance inside the ducts (Fig. 12) has revealed that, except for one (out of 20), the grout still sticks to the wires and fills the ducts uniformly. No wire was broken and a few spots of superficial rust were nonetheless observed in some locations. One of the duct was without grout, and, unsurprisingly, the wires inside were found rusty, and one wire of the tendon was obviously loose.

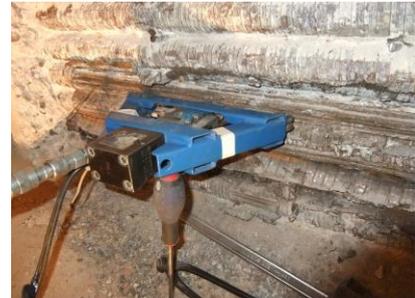
Fig. 13. Measure of the tension of a wire by the crossbow method

Yet the main purpose of the investigation was to estimate the residual tension of the tendons. This was carried out with the help of the crossbow method [7] whose principle consists in measuring the bending stiffness of a wire that depends on the wire tension according to a definite mechanical law. Some 40 wires were tested (Fig. 13), and the estimation of the tension is summed up in figure 13. It was found that no discrepancy exists between the two pairs of openings. The mean residual tension lies between 35 and 37 kN, with 95% confidence. This is to be compared with the tension obtained in 1958 that was 34.6 kN.

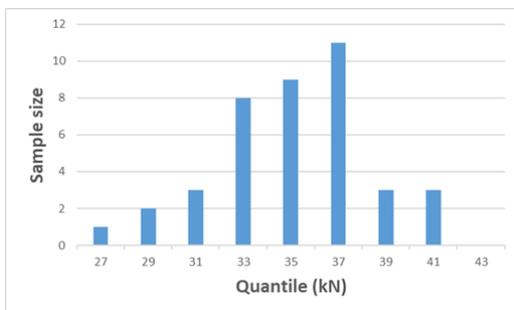
Fig 13. Histogram of residual tension in wires measured by the crossbow method.

It turns out that the tension has slightly increased with time, despite the relaxation of the prestressing wires. Considering that there is no external disorder showing that the concrete is affected by an internal expansion reaction (alkali-aggregate reaction or delayed ettringite formation), the most likely cause of this tension increase in the tendons is the delayed displacement of the abutments explained by the movement consecutive to the consolidation of the soil behind the abutment. The delayed horizontal displacement of an abutment

deduced from the increase in tension would be of the order of 5 to 7 cm, a value that seems likely. Finally, it was concluded that we had a satisfactory behaviour of these prestressing ties.

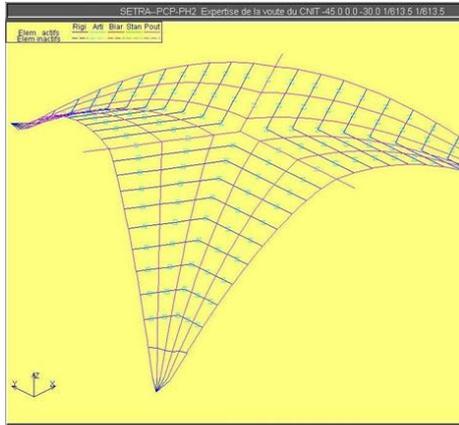
Thus, the structure of the CNIT was modelled in 3 dimensions with the PCP bar software. The structure is composed of 3 vaults of 9 spindles or 6 half-vaults connected by the front key. In the model, each half-vault was modeled by a beam, i.e. 18 beams for the shell as a whole. This segmentation allows for a relatively simple modelization of the phasing of the construction element by element. A thinner segmentation of the structure was not necessary: in view of the transversal rigidity of the beam cross section made of "3-box girders", the beam theory has been assumed despite the spans of the sections in the keys (approximately 20.80 m). Each front key was modeled by three beams in order to fit the execution phases.

Fig. 15. Visualization of the PCP model

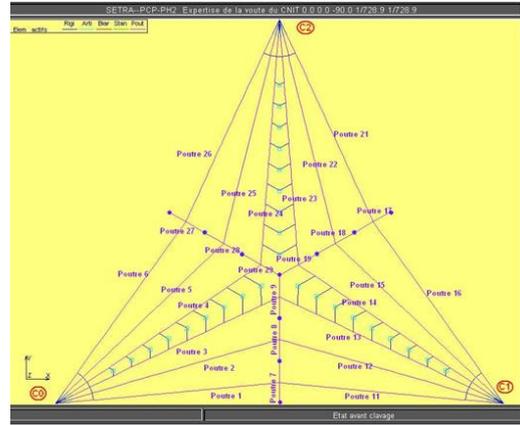
Fig. 16. Numbering of beams in the PCP model

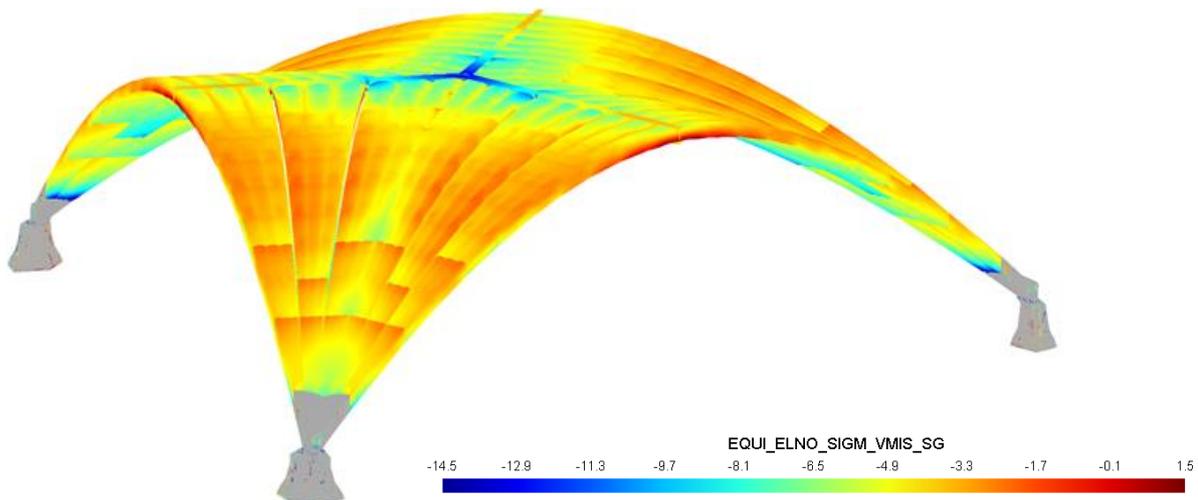
A finite element model of the structure using shell surface elements was implemented to model thin parts of the structure such as the upper and lower shells of the vault, while volume elements were used to model the massive parts such as the abutments and the key junction. The model comprises 74 694 elements and 215 360 nodes. An elastic linear calculation was carried out for the following loading cases: own-weight (Fig.17), thermal expansion and displacement of the vault support.

Fig. 17. Equivalent stresses of Von Mises represented by the trace of the tensor of the stresses, on the average layer, under own-weight (Units: MPa and compression is negative).

The comparison of the models with different loading cases reveals a good agreement between the bar model and the finite element model. The observed differences in the vicinity of the key and the abutments can be explained by the limits of use of the PCP model. After validation, displacements and rotations of the abutments
