Condition Assessment of an historical structure: the CNIT Vault in Paris

CONDITION ASSESSMENT OF AN HISTORICAL STRUCTURE: THE CNIT VAULT IN PARIS

Keywords: *CNIT vault, reinforced concrete, condition, assessment, testing, durability.*

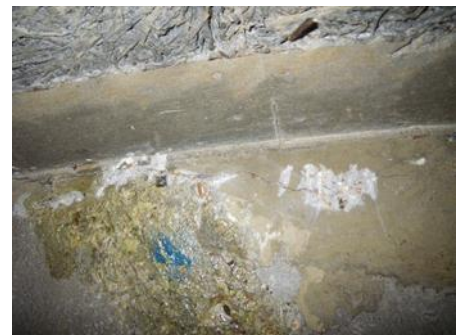
Fig. 10. Example of cracks located in the patch repair at diaphragm/shell junction.

Some cracks are also visible at the junction between the diaphragm and the upper shell. Five of them were investigated and it appears that the crack affects the patch repair and that under the mortar repair, the crack does not extend into the diaphragm (Fig. 10). Globally, the general conclusion of this visual inspection of a sample of cells was the overall good structural condition of the vault.

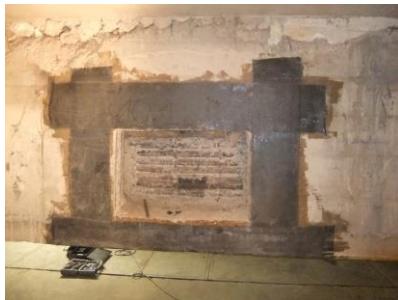
The three prestressed concrete ties are composed of 44 tendons each. Each tendon, made of 24 wires, with 7 mm in diameter, belongs to the Boussiron (BBR) process. It is reported in [2] that these tendons have an ultimate tensile strength not smaller than 1450 MPa and had been tensioned with 85-ton jacks, which corresponds to an average stress of 920 MPa inside the steel and a safety factor of 1.33. It was of course of paramount importance to keep the stress level well below the usual standard value, so as to keep a safety margin to adjust afterwards the forces in the three ties together and to cope with a possible differential settlement of the vault. The ties are enclosed in a hollow rectangular concrete box with 20 cm thick walls. The space between the 44 tendons ducts and the concrete box was filled with sand, in order to protect the tendons against fire in case of arson. The first step of investigation was then to do four 90×60 cm openings in the concrete wall of the box in some locations, and uncover the ducts (Fig. 11). Each opening could give access to 5 ducts, viz. 10 wires on average.

Fig. 11. Opening of a window in the tie after a local strengthening by CFRP.

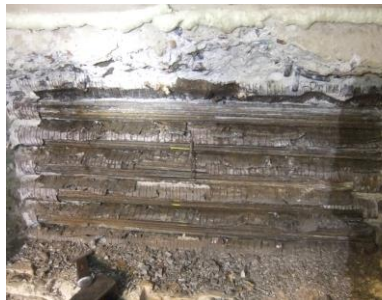
Fig. 12. Good conservation of the wires after removal of the ducts

The ducts were not corroded. A cursory glance inside the ducts (Fig. 12) has revealed that, except for one (out of 20), the grout still sticks to the wires and fills the ducts uniformly. No wire was broken and a few spots of superficial rust were nonetheless observed in some locations. One of the duct was without grout, and, unsurprisingly, the wires inside were found rusty, and one wire of the tendon was obviously loose.

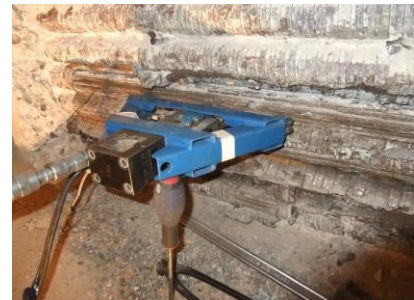
Fig. 13. Measure of the tension of a wire by the crossbow method

Yet the main purpose of the investigation was to estimate the residual tension of the tendons. This was carried out with the help of the crossbow method [7] whose principle consists in measuring the bending stiffness of a wire that depends on the wire tension according to a definite mechanical law. Some 40 wires were tested (Fig. 13), and the estimation of the tension is summed up in figure 13. It was found that no discrepancy exists between the two pairs of openings. The mean residual tension lies between 35 and 37 kN, with 95% confidence. This is to be compared with the tension obtained in 1958 that was 34.6 kN.
