Condition Assessment of an historical structure: the CNIT Vault in Paris

CONDITION ASSESSMENT OF AN HISTORICAL STRUCTURE: THE CNIT VAULT IN PARIS

B. Godart¹, F. Schmidt¹, J.J. Brioist², J.P. Deveaud³, F. Dias⁴

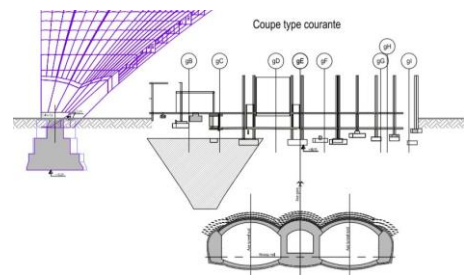
Fig. 7. Location of the new tunnel under the CNIT (Courtesy EGIS & SETEC).

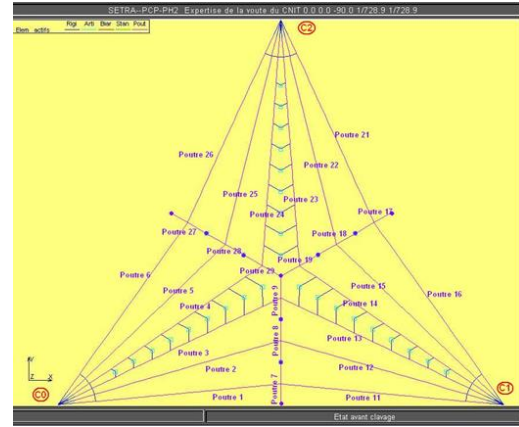
Fig. 16. Numbering of beams in the PCP model

Thus, the structure of the CNIT was modelled in 3 dimensions with the PCP bar software. The structure is composed of 3 vaults of 9 spindles or 6 half-vaults connected by the front key. In the model, each half-vault was modeled by a beam, i.e. 18 beams for the shell as a whole. This segmentation allows for a relatively simple modelization of the phasing of the construction element by element. A thinner segmentation of the structure was not necessary: in view of the transversal rigidity of the beam cross section made of "3-box girders", the beam theory has been assumed despite the spans of the sections in the keys (approximately 20.80 m). Each front key was modeled by three beams in order to fit the execution phases.

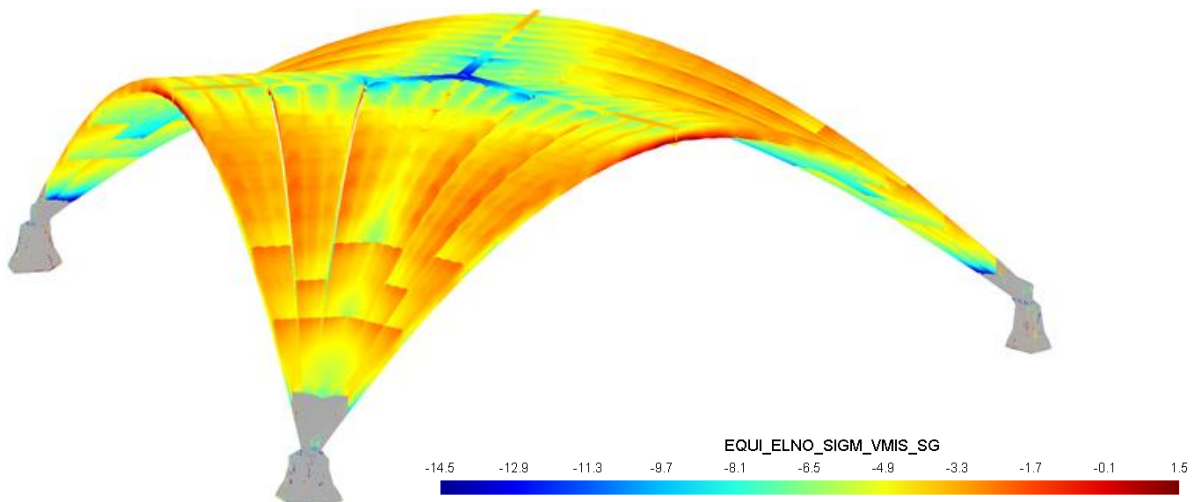
A finite element model of the structure using shell surface elements was implemented to model thin parts of the structure such as the upper and lower shells of the vault, while volume elements were used to model the massive parts such as the abutments and the key junction. The model comprises 74 694 elements and 215 360 nodes. An elastic linear calculation was carried out for the following loading cases: own-weight (Fig.17), thermal expansion and displacement of the vault support.

Fig. 17. Equivalent stresses of Von Mises represented by the trace of the tensor of the stresses, on the average layer, under own-weight (Units: MPa and compression is negative).

The comparison of the models with different loading cases reveals a good agreement between the bar model and the finite element model. The observed differences in the vicinity of the key and the abutments can be explained by the limits of use of the PCP model. After validation, displacements and rotations of the abutments
