## Effect of reinforcement shear and mesoscopic defects on the low velocity impact behavior of a GFRP

# **Effect of reinforcement shear and mesoscopic defects on the low velocity impact behavior of a GFRP.**

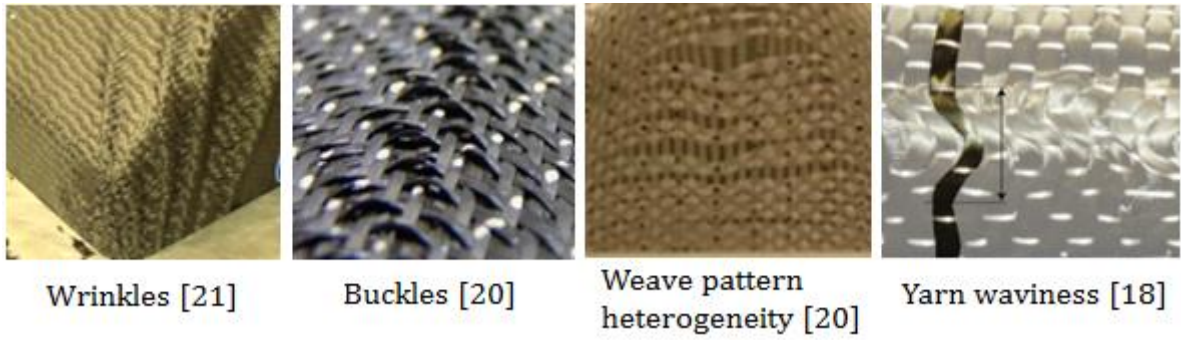
**Fig. 1.** Shaping defects: Macroscopic (wrinkles) and Mesoscopic

forming defects can be divided in two types (Fig. 1): macroscopic defects (at the fabric scale) and mesoscopic defects (at the yarn scale). Macroscopic defects (wrinkles) have been widely studied in terms of phenomenology and their effect on the behavior of the final composite. Studies have shown that wrinkling, which is an out-of-plane phenomenon, is highly dependent on the coupling of shear/tension/bending/friction behaviors of the reinforcement [17, 22-29]. This defect, appearing at the reinforcement scale, generates a significant over-thickness that affects the geometrical tolerances and aesthetics of the final part. Furthermore, studies have shown that all mechanical properties induced on the final composite drops drastically, reaching up to 40% loss of maximum breaking stress [30-32]. The presence of wrinkles also leads to stress concentration phenomena that can cause premature damage [31, 33].

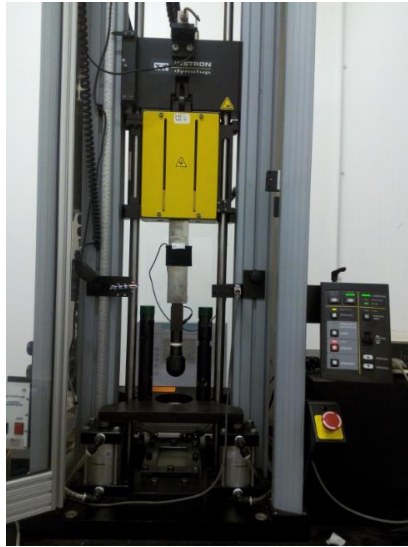
**Fig. 5.** Instrumented dropping weight impact tower.

The mechanical impact tests were performed using an instrumented drop tower machine, model Instron Dynatup 9250 HV (Fig. 5). The specimens were centered on a frame and blocked by a plate, with a clamping system, with a rectangular window of  $125 \text{ mm} \times 75 \text{ mm}$ . The center of the specimens was

impacted with a hemispherical impactor with a mass of 14 kg and a diameter of 50.8 mm. The tests were performed with three impact energy levels (10J, 20J and 30J), while maintaining the mass of the impactor constant. Five samples were impacted for each test configuration.

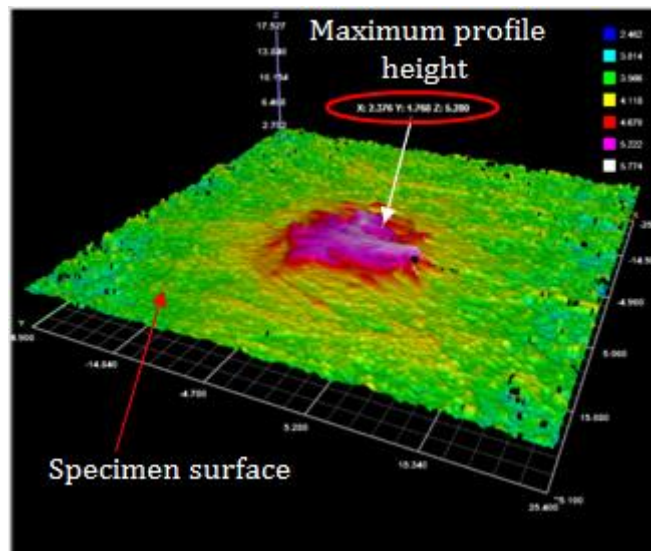
**Fig. 6.** Image of a damaged profile obtained with the interferometer.

The samples subjected to the impact were visually analyzed and then the height of the profiles of the damaged areas after impact was measured with an interferometer. This height is the difference between the maximum height of the profile of the damaged area and the surface of the plate (Fig. 6). It was measured on the side opposite the impacted surface.

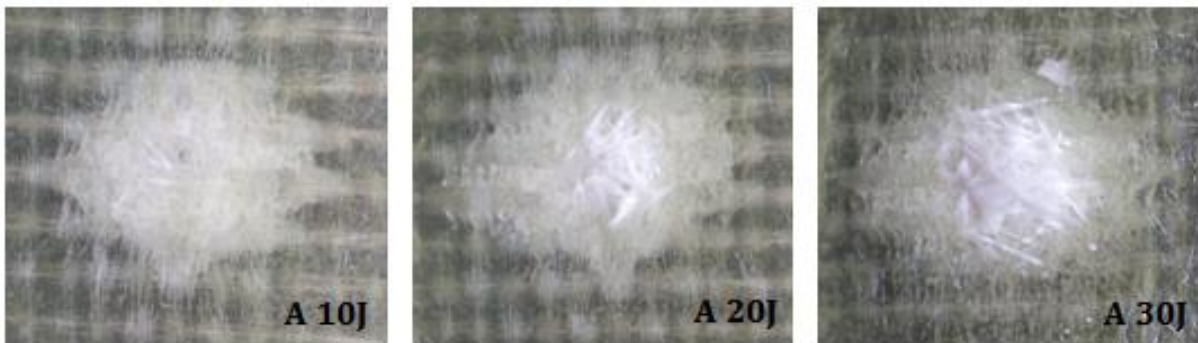
**Fig. 9.** Evolution of impact damages as a function of the impact energy for batch A.

Visual analysis of the impacted areas highlights damage of the matrix and delamination areas. In addition, several fiber breakages appear from the impact energy of 20J (Fig. 9). Damaged areas increase linearly with impact energy (Fig. 8); their extent is greater in the weft direction. This is due to the presence of gaps between the wefts (and thus resin-rich regions) and the boundary conditions applied in their direction (clamping system with a rectangular window) which promotes the propagation of delamination. In contrast, the impacted face has no visible macro-cracks on the surface.

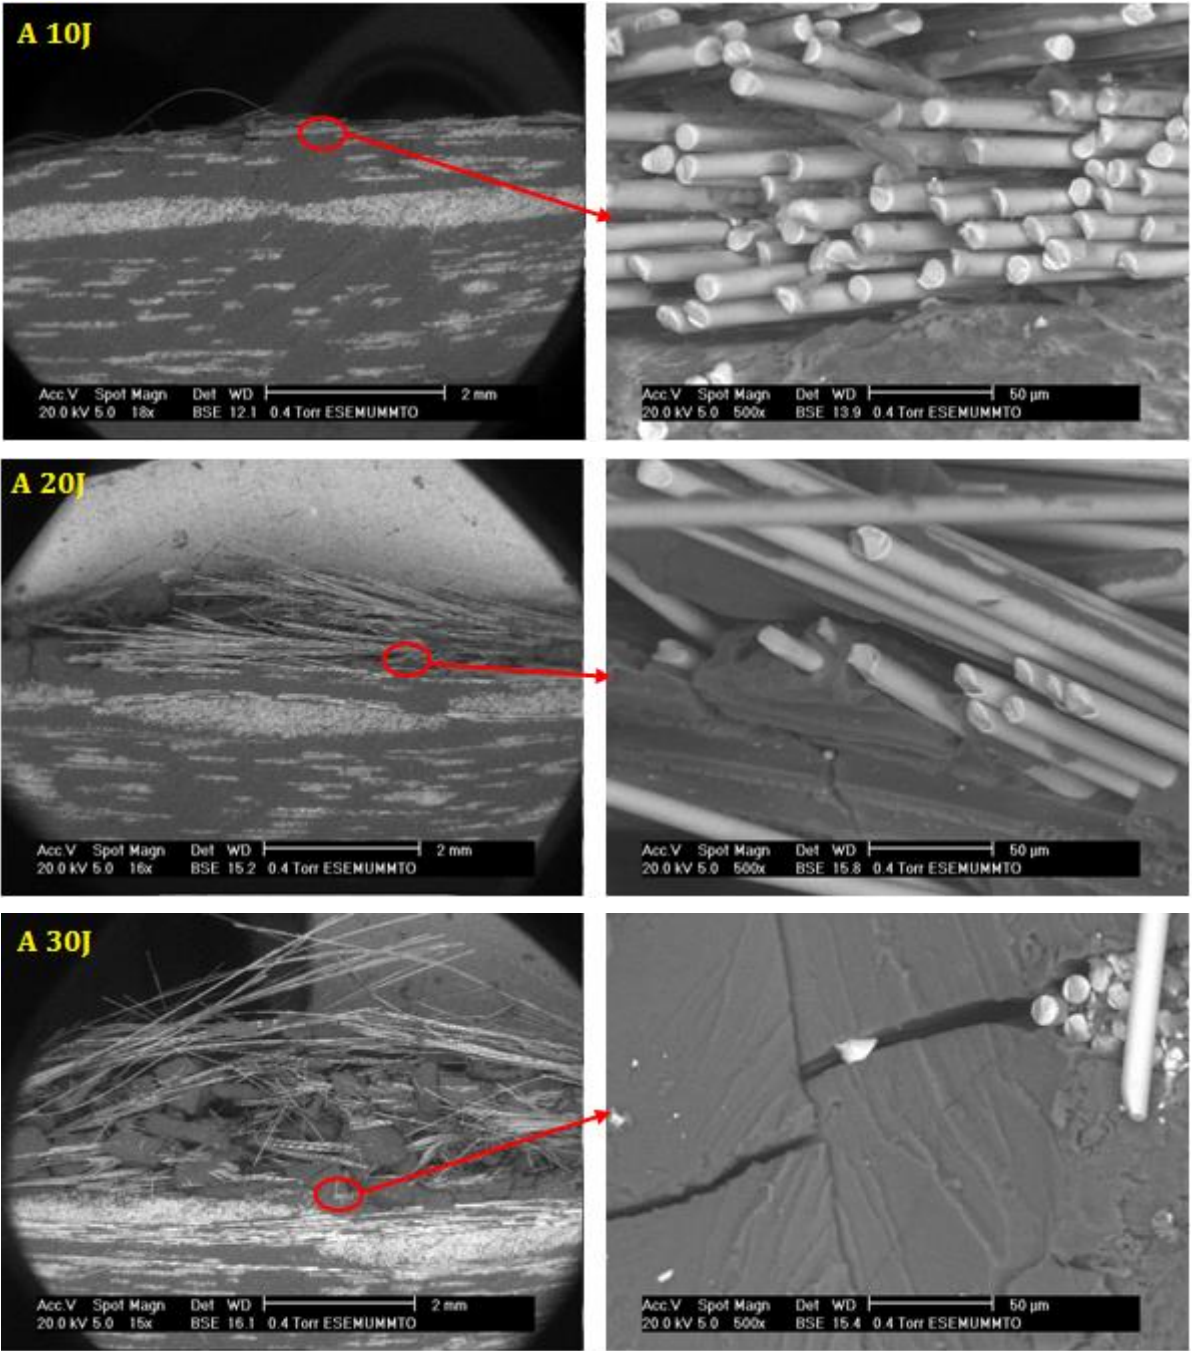
**Fig.10.** SEM observation of healthy specimens as a function of impact energy.

The results of the visual analysis were confirmed by the SEM observations, showing that the size of the damaged areas increases proportionally to the impact energy (Fig.10). This damage is present on the faces opposite to the impact. The faces show fiber breakage and multiple cracks and fragmentation of the matrix combined with fiber/matrix debonding. These damage mechanisms are those classically found during an impact on composites.

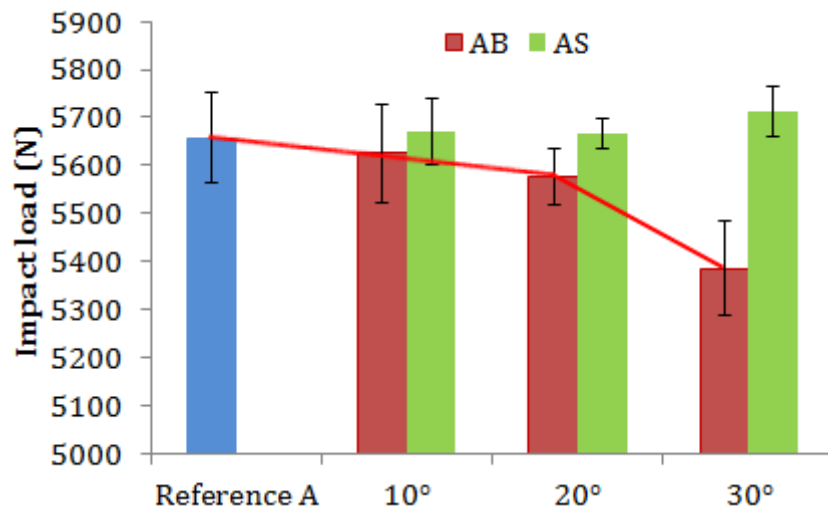
**Fig.12** : Comparison of the maximum load for healthy / with defects / sheared laminates as a function of the shear angle.

Thus, the maximum impact load of the AB specimens decreases proportionally to the amplitude of the defect due to the loss of bending stiffness generated by buckling (Fig. 12). This decrease is quasi-linear up to a defect amplitude corresponding to a shear angle of  $20^\circ$  where a change in the slope of the load evolution is observed (Fig. 12). This buckling amplitude (at  $20^\circ$ ) can therefore be considered as a threshold for the sizing of composite parts.

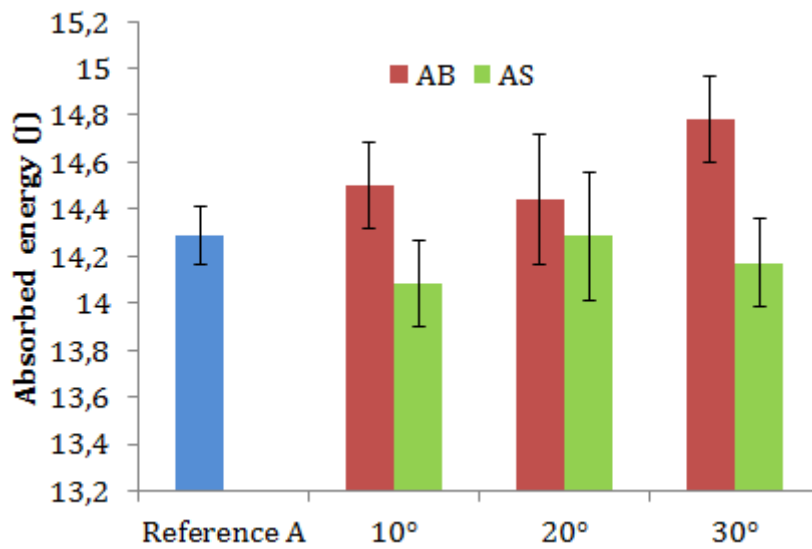
**Fig.13** : Comparison of absorbed energy for healthy / with defects / sheared laminates as a function of shear angle.

The reduction in the maximum load caused by a disorientation of the fibrous network associated with the presence of resin-rich areas causes an increase in the absorbed energy following the damage of the

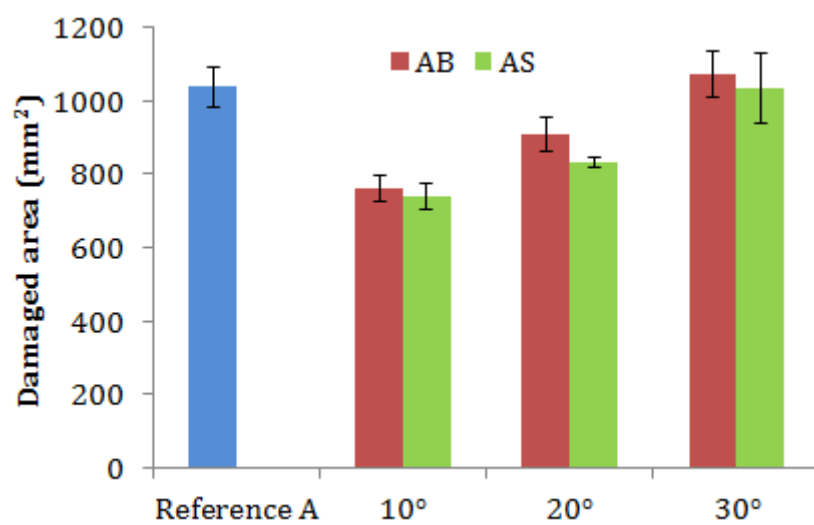
**Fig. 15.** Evolution of the damaged area of healthy / with defects / sheared laminates as a function of the shear angle.

The extent of these damaged areas for batches AB and AS is smaller than that of the healthy material. In the 10 ° configuration of batch AB, there is a 27% decrease in the damaged area compared to the healthy material, while the dissipated energy has increased (Table 2 and Fig. 15). This is because buckling predisposes the material to damage in the thickness.

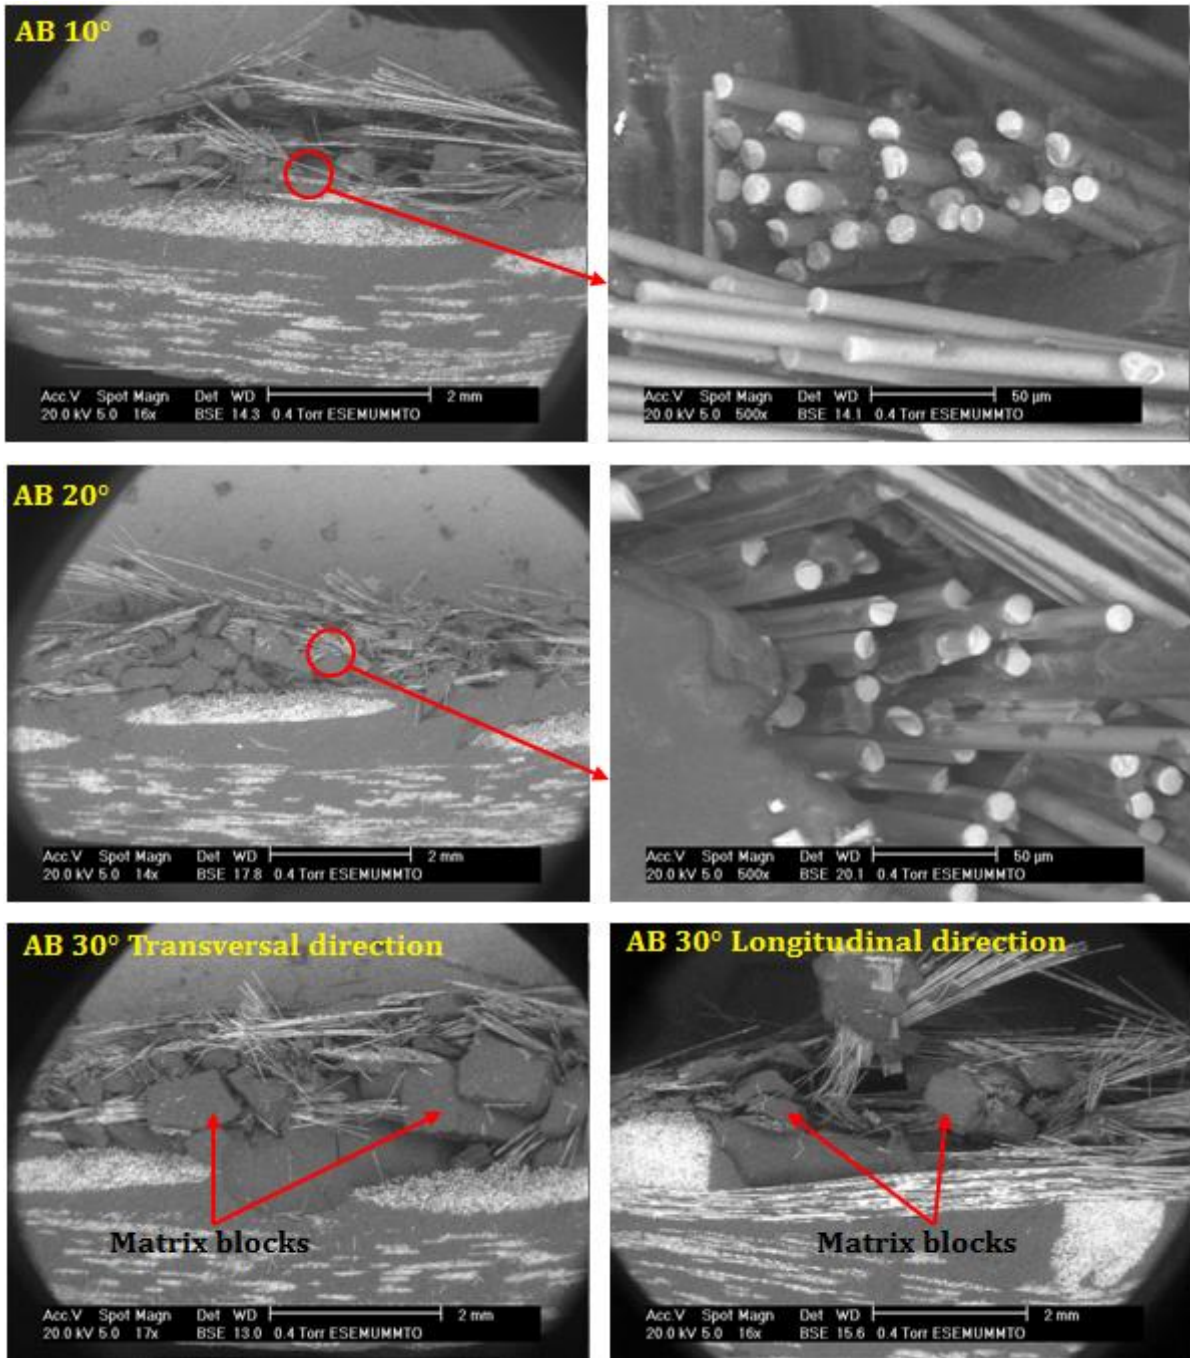
Fig. 16. SEM observation of specimens with buckles defect (AB).

This fact was verified with the help of the SEM observations, which were made in the thickness of the samples along two cutting planes (longitudinal and transverse) passing through the center of the buckled regions. These observations showed the presence of significant damage, located on the opposite side, with numerous fiber breakages, multiple cracks and fragmentation of the matrix, combined with a fiber/matrix debonding (Fig. 16). These fractographies also highlighted the presence of resin-rich areas whose extent

increases with the amplitude of the buckling. Note that the damage increased proportionally with the defect amplitude (Fig. 16) until the height of the damaged profile reached up to 88% of the material thickness for the 30° configuration (Table 2).
