Mapping erosion risk and selecting sites for simple erosion control measures after a forest fire in Mediterranean France

Dennis Fox, W Berolo, Pierre Carrega, Frédéric Darboux

Dennis Fox, W Berolo, Pierre Carrega, Frédéric Darboux. Mapping erosion risk and selecting sites for simple erosion control measures after a forest fire in Mediterranean France. *Earth Surface Processes and Landforms*, 2006, 31, pp.606-621. 10.1002/esp.1346 . hal-02572238

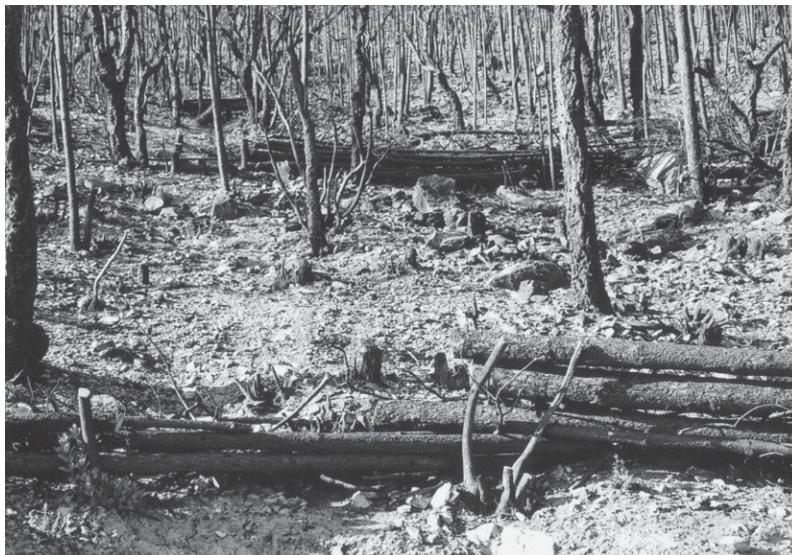
Figure 1. Log erosion barriers (LEBs) among standing vegetation.

LEBs consist of cutting and laying fire-killed trees on the ground parallel to slope contours (Figure 1). Laid across the slope, the logs slow runoff and trap sediments. The technique is widely used as a post-fire management strategy, but few data are available on the efficiency of the LEBs, measured as a quantity of sediment trapped per number of logs per hectare. Wohlgemuth *et al.* (2001) attempted to quantify the impact of LEBs on sediment delivery, and the evidence suggests that LEBs are more efficient in trapping sediments than reducing runoff. A study conducted in Greece showed that LEBs were effective in trapping sediments on steep slopes (35–55 per cent) but not on low (10–20 per cent) or intermediate (20–35 per cent) slopes (Gagari *et al.*, 2001). Marqués and Mora (1998) reported that branches used to build dykes to retain soil on slopes did not stop rill formation and some were destroyed by heavy rains. Considerable attention must therefore be paid to log size and placement on the slope, in addition to LEB density.

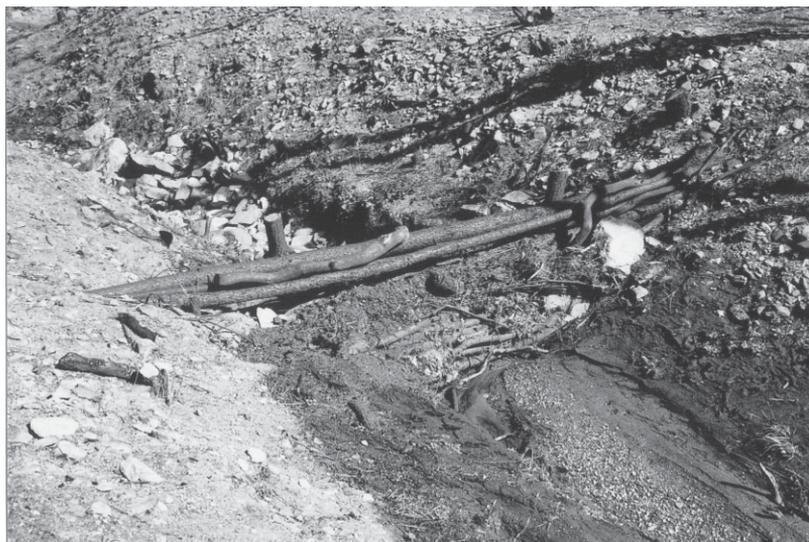
Figure 2. Log debris dam (LDD) showing trapped sediment and debris upstream of dam.

LDDs are log barriers placed across a stream and held in place with vertical log posts, or by placing the horizontal logs against the upstream side of tree stumps (Figure 2). Branches can be used to fill in spaces between logs and the voids are further clogged by leaves and floating debris carried during stream runoff. LDDs vary from LEBs in that the logs are stacked across the width of a stream while the LEBs are installed on the slopes. LEBs therefore contribute to maintaining the soil on the slope, while LDDs trap the sediments in the tributary channels.

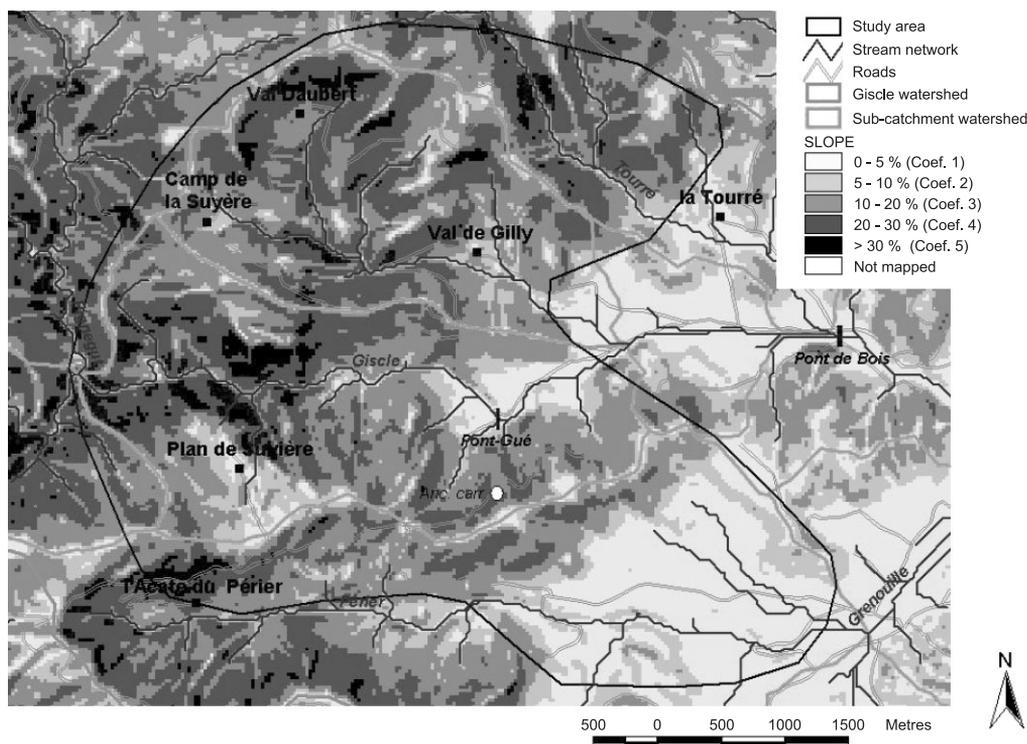
Figure 3. Map showing the distribution of slope classes and ascribed coefficients in the study area.

Figures 3 to 6 show the distribution of the four soil erosion factors in the catchment. More than 30 per cent of the slopes in the study area have an inclination greater than 20 per cent (Figure 3), showing the natural vulnerability of the zone to erosion processes. In addition, many of the steeper slopes were those most affected by the fire (Figure 4). Typically, pre-fire vegetation densities (Figure 5) were low on convexities or south-facing steep slopes with shallow

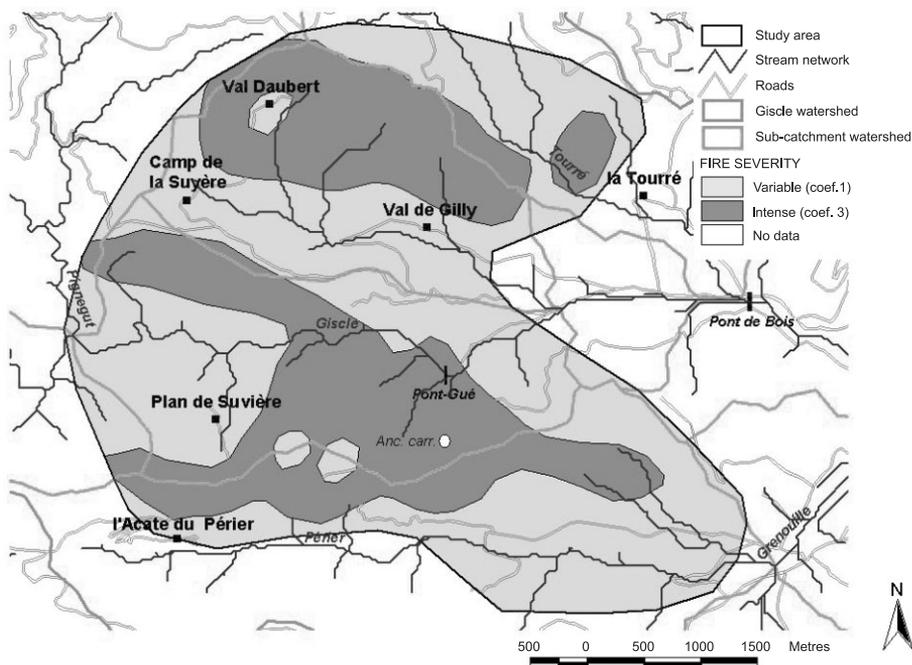
Figure 4. Map showing the distribution of fire severity and ascribed coefficients in the study area.

Fire severity (Figure 4) on this south-facing slope section was lower than the preceding sections and this is supported by the low sediment concentrations measured during the storm (Figure 9). Natural revegetation should proceed relatively quickly, and no vegetative measures were recommended.

The upper slope of this section was severely burned (Figure 4) and is likely to be an area that generates considerable runoff and erosion. However, the main channel could not be accessed during the storm in the same conditions as for the other tributaries, so no suspended sediment data are available to support this. The slope is burned entirely on the mid- and upper portions, but there is a flat, densely vegetated strip between the channel of the Périer and the base of the burned slope. Although erosion rates will probably be high on this slope and it is accessible, there are no pine stands and the soils are thin and stony (Figure 6), so the site is not adapted to grass filter strips. In addition, runoff and sediments must be transported through the densely vegetated plain and through several kilometres of channel flow in the Périer before entering the main Giscle channel, so the site was deemed more appropriate for a long-term vegetative strategy.

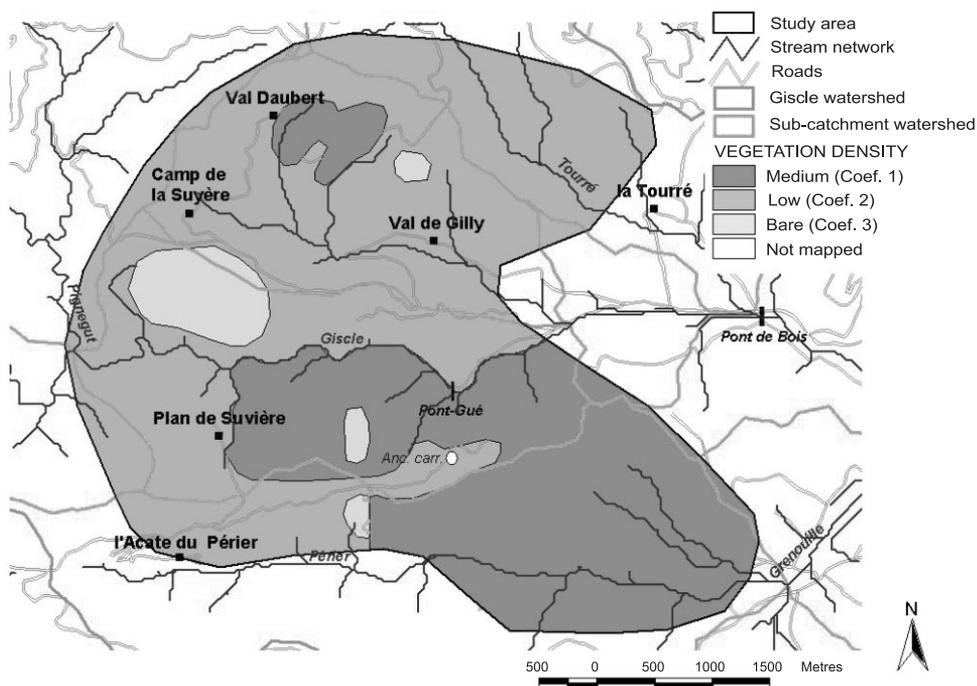
Figure 5. Map showing estimated pre-fire vegetation density and ascribed coefficients in the study area.

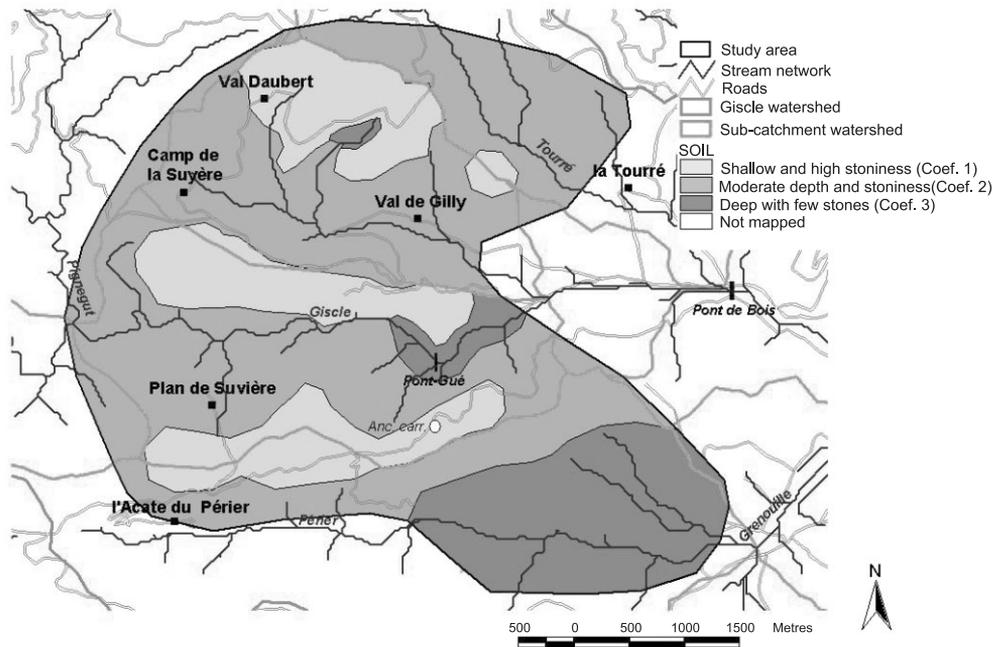
Figure 6. Map showing the distribution of soil characteristics and ascribed coefficients in the study area.

stony soils (Figure 6). Conversely, deeper soils with a denser pre-fire vegetation cover tend to be concentrated in the southeast corner of the map where slopes are gentle.

These slopes were addressed first since slope runoff enters the main channel directly. In addition, the north-facing slope A had relatively deep soils (Figure 6), a high potential erosion rate (Figure 7), and high sediment concentrations during the December rainfall event (Figure 9). This slope section therefore had an immediate impact on the main channel and soils worth protecting. The site was easily accessible. Three measures were suggested: (1) it was proposed

Slope section B was different: soils were thin and stony (Figure 6) on this south-facing slope, there were no available logs from nearby stands of pine, and the site was less accessible than slope section A. For these reasons, it was decided that the site should be addressed as part of a longer-term reforestation strategy and no short-term

Sediment concentrations reaching the main channel were high for the stream draining these sections (Figure 9), despite relatively thin stony soils (Figure 6) on much of the mainly south-facing slope. The upper part of the slope section is accessible by a paved road as far as Val Daubert. Much of the slope is cut along the contours by paths and two narrow unmade roads, but these are inaccessible by most vehicles. The lower slope is inaccessible. The abundance of pine and mixed pine and oak stands in the middle and upper part of section C makes this an ideal location for LEBs on the slopes and LDDs in the tributary channels. The lower channel is too far from the stands and too inaccessible to be treated. The poor soil conditions (Figure 6) and southern aspect of both sections make it unlikely that a grass strip would survive, and it would probably have little impact on infiltration in the thin soils. Therefore, protection of slope section D is not possible in the short term, and it should be looked at more closely in a long-term reforestation strategy.

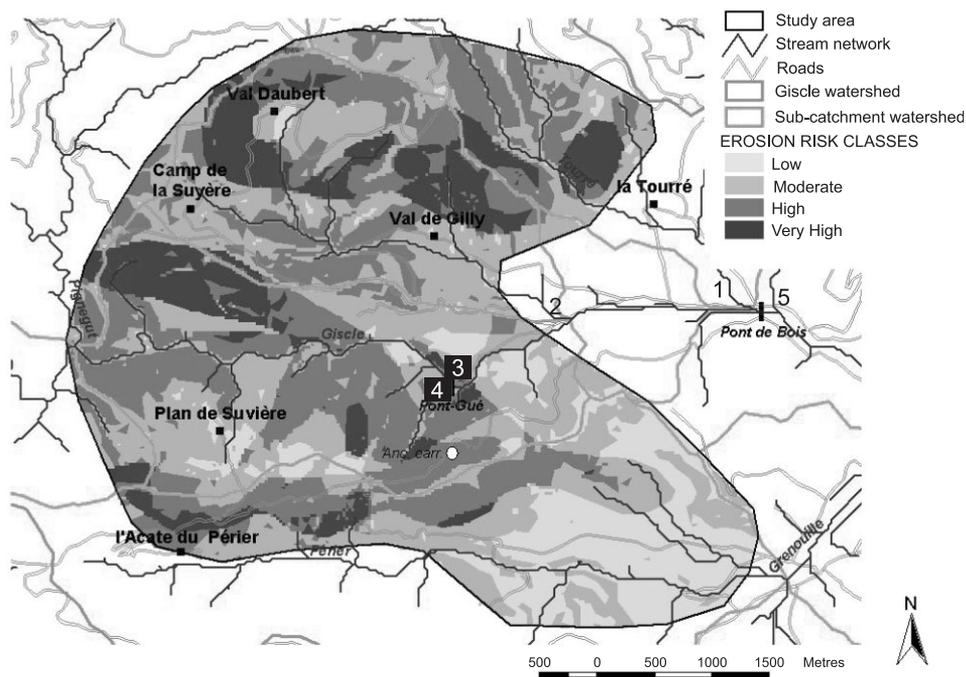
Figure 7. Soil erosion risk map showing the erosion risk categories and sites (numbered from one to four) for the suspended sediment samples used in the partial validation.

Selecting potential sites for installing erosion control measures was based on the erosion risk map (Figure 7), and these corresponded to zones where there was a concentration of high and very high risk classes (Table II). As shown in Figure 10, six sites were identified for field evaluation; these are ordered alphabetically (A–F) according to subcatchment, starting with the main Giscle channel. However, as noted above, a soil erosion risk map is not a soil conservation map. High erosion risk areas are not necessarily suitable for installing erosion control measures, and some of these are suitable for only certain types of measures. Therefore, once the high risk areas were identified, the second stage was to evaluate the following: potential risk to the main river channel, value of soil resource to be protected, and suitability for installing LEBs, LDDs and grass strips. Site suitability depended on accessibility, an estimate of the impact the measure would have on attaining the specified objective (maintaining sediments on the slope with the LEBs and grass strips or trapping sediments before they enter the channel with the LDDs), and the presence of pine logs for the LEBs and LDDs. Each of the major potential sites identified by the erosion risk map is described below with the recommendations.

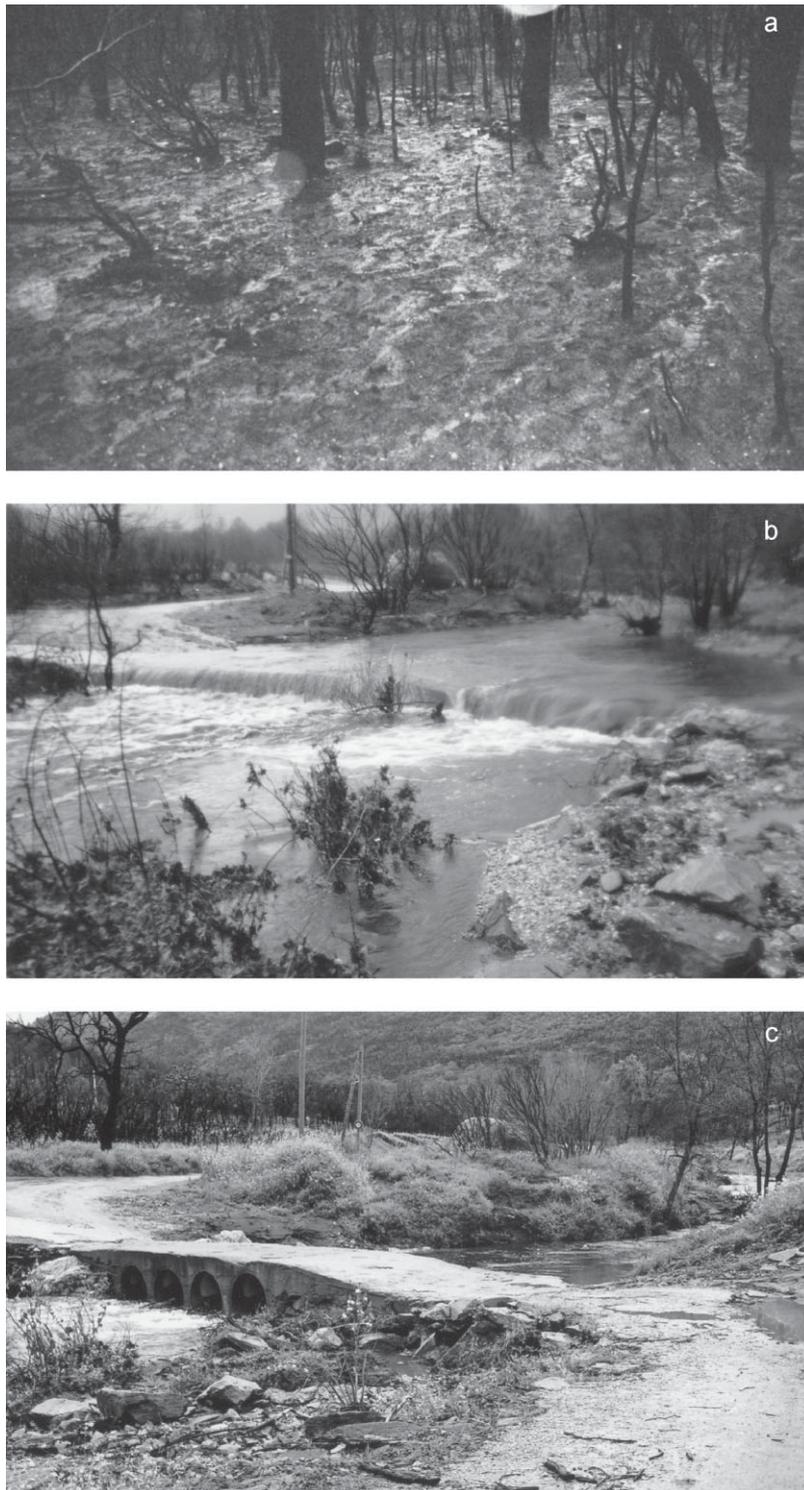
Figure 8. (a) Runoff observed in the burnt forest and (b) runoff flowing over a low bridge (Pont Gué) during the storm of 2 December 2003. (c) The same bridge as in (b) (Pont Gué) at normal discharge.

Significant runoff occurred during the storm of 2 December 2003 (Figure 8). Stream discharge samples (two replicates) were collected for three of the four main subcatchments. Sampling locations are shown in Figure 7: Tourré (1), Gilli (2), Giscle (3) (sampled upstream of other tributaries). The Périer in the southern part of the catchment could not be sampled in similar rainfall/runoff conditions, so it was not analysed. In addition, samples for the burned north-facing slope draining into the Giscle main channel (4), a vineyard (5) and an unburned forest (off the map) were collected for comparison purposes.

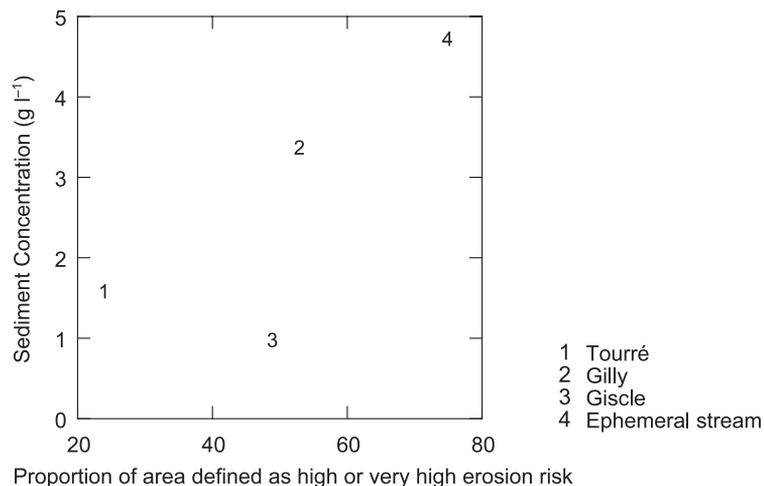
Figure 9. Relationship between sediment concentrations in storm runoff and proportion of area (%) defined as high or very high erosion risk (numbers refer to site locations shown in Figure 7).

For each of the three subcatchments sampled and the burned north-facing slope, stream suspended sediment concentration was plotted against the sum of the percentage area in the high and very high risk erosion classes (Figure 9). The numbers in Figure 9 correspond to sampling locations in Figure 7. Sediment concentration values represent the means of two samples. Differences in concentration between samples were never greater than 10 per cent except for

the Gilly, for which it was 31 per cent. Although there are only four points, there is a general trend for the sediment concentration to increase with increasing area in the high and very high erosion classes. The exception is the Giscle (sample 3) which is located immediately downstream of a long straight section with natural sediment deposition. Therefore, the low suspended sediment concentration of the Giscle was attributed to natural deposition in the stream bed upstream of the sampling area. Sediment concentrations for the vineyard (5) and unburned forest were 1.64 g l^{-1} and 0 g l^{-1} , respectively.

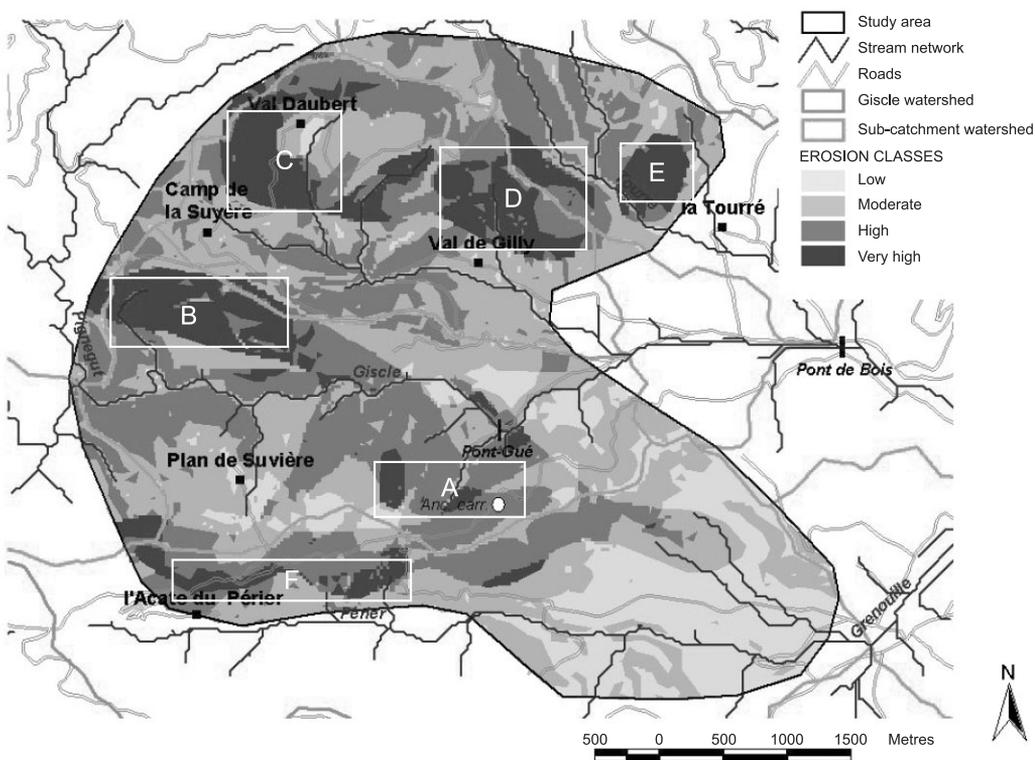
Figure 10. Location of priority zones (A–F) to be assessed for the installation of erosion control methods.
