## Putting a Grill (or Not) in Slit Dams Aiming at Trapping Debris Flows? Lessons Learnt From France

# PUTTING A GRILL (OR NOT) IN SLIT DAMS AIMING AT TRAPPING DEBRIS FLOWS? LESSONS LEARNT FROM FRANCE

Guillaume PITON<sup>a,\*</sup>, Gilles CHARVET<sup>b</sup>, Damien KUSS<sup>b</sup>, Simon CARLADOUS<sup>c</sup>

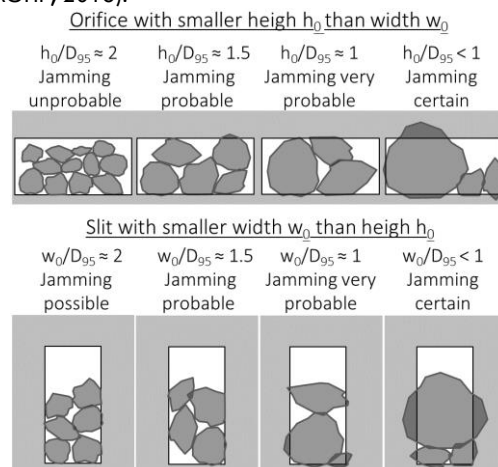
Fig. 1: Effect of increasing grain size on clogging probability of orifices (upper panel) and slits (lower panel). Jamming becomes likely for an opening size of  $D_{95} = 1.5-2.0$ . Jamming occurs in slits for grains slightly smaller than orifices because arches between grains emerge more easily horizontally than vertically.

Guidelines say that debris flows passing through slits will likely jam it if the slit width is less than 1.5 – 2.0 times the grain diameters of the coarsest grains (Fig. 1) (Ikeya & Uehara, 1980, Watanabe et al., 1980, CAGHP, 2018).

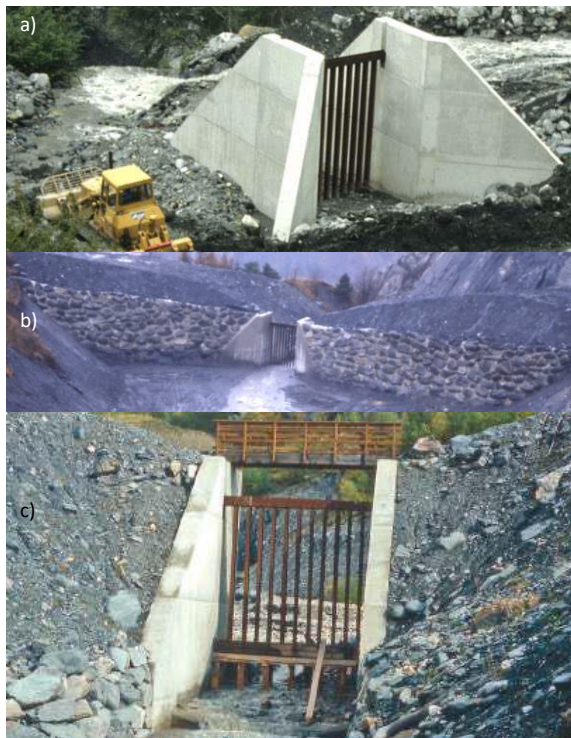
The structure was built in 1986-1987 (Fig. 2). It was initially equipped with a steel grill anchored at the bottom in the apron and held at the top by a steel beam.

Fig. 2: The upper slit dam in its first design: a) upstream view of the slit structure in 1986; b) upstream view of the slit and side dykes protected with grouted riprap in 1987; c) downstream view zooming in on the slit and the grill. Note that the downstream face was not protected at that time against erosion during overtopping.

As soon as 1989, the chronic filling of the basin and jamming of the grills by cobbles led to the first adaptation: installing an opening at the base with a clearance of 1 m, and the installation of a horizontal beam to hold the vertical bars.

During the events of 2005, 2010 and 2011, damage was observed on the slit dam apron and the downstream face of the dam. The dam was first protected with grouted riprap to prevent erosion when overtopping occurred (compare Fig. 2b and 3b). Secondly, it was equipped with a downstream lined channel, a 7.5 m-high counter dam and 2-m high wings on the spillway (Fig. 5).

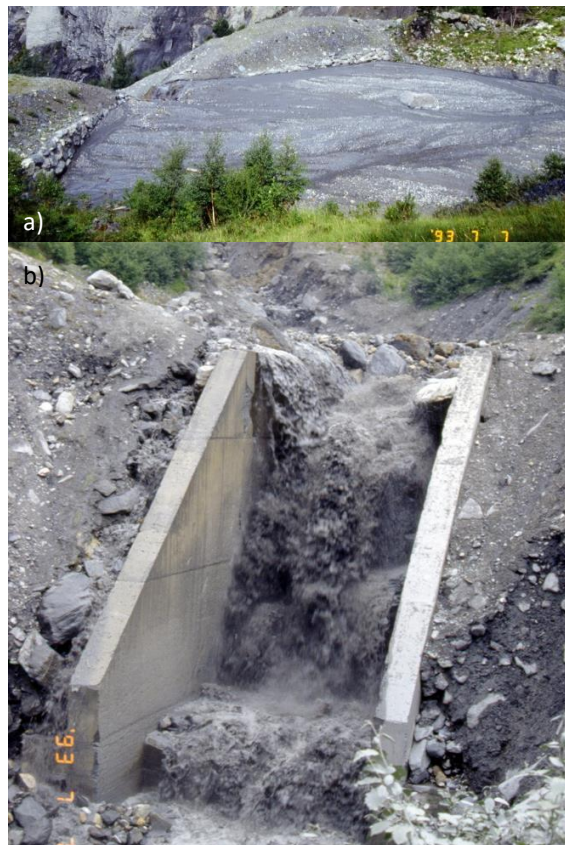
Five days later, on Jul. 7<sup>th</sup>, new debris flows occurred. This time a huge boulder (volume 104 m<sup>3</sup>) jammed the slit and the basin was completely filled (Fig. 3). This was again considered satisfactory because such a boulder would likely have damaged the downstream lined channel and the canal bridge, or might have obstructed them.

Fig. 3: Second debris flow event of July 7<sup>th</sup> 1993: a) upstream view of the basin filled up the crest and b) downstream view of the slit jammed boulders. Note the evidences of overtopping and the related marginal erosion.

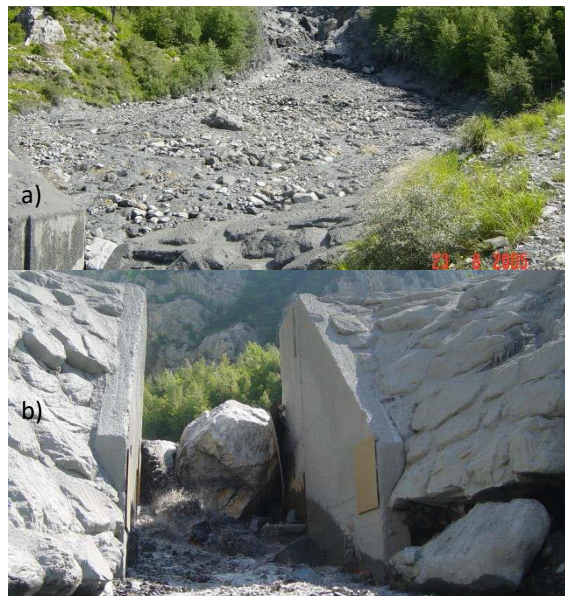
Date	Excavated Vol. (m <sup>3</sup> )	Comment
7/1/1993	5,000	Open check dam filled followed by grill failure, dredging: 5,000 m <sup>3</sup>
7/7/1993	15,000	Huge boulder jammed the empty slit.
03/22/2001	4,000	No slit jamming
06/22/2005	18,300	Slit jammed by boulders (Fig. 4)
08/02/2007	4,280	No slit jamming
07/02/2010	14,000	Slit jammed
08/22/2011	6,000	No slit jamming

Fig. 4: Deposit after the debris flows of June, 22<sup>nd</sup> 2005: a) bouldery deposit nearly filling the basin and b) slit nearly jammed by two large boulders

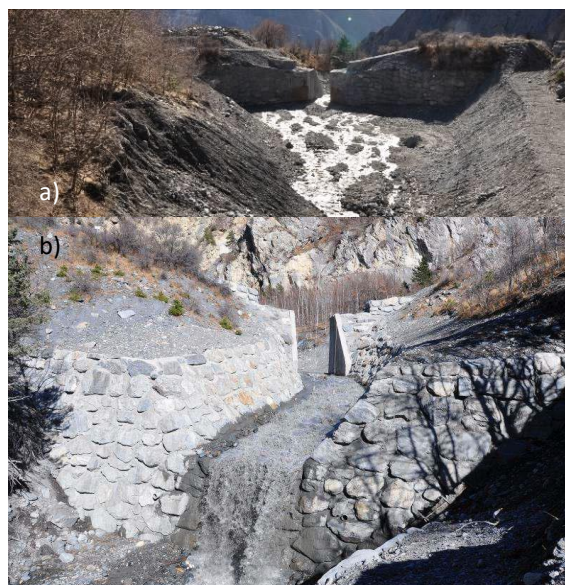
Fig. 5: Structure in 2020 with wings, lined channel and counter dam: a) upstream view and b) downstream view
