## Sealing of concrete confining structures of French nuclear reactors

Yan Pei, Shucaï Li, Franck Agostini, Frédéric Skoczylas, Benoît Masson

Yan Pei, Shucaï Li, Franck Agostini, Frédéric Skoczylas, Benoît Masson. Sealing of concrete confining structures of French nuclear reactors. *Engineering Structures*, 2019, 197, pp.109283. 10.1016/j.engstruct.2019.109283 . hal-02894316

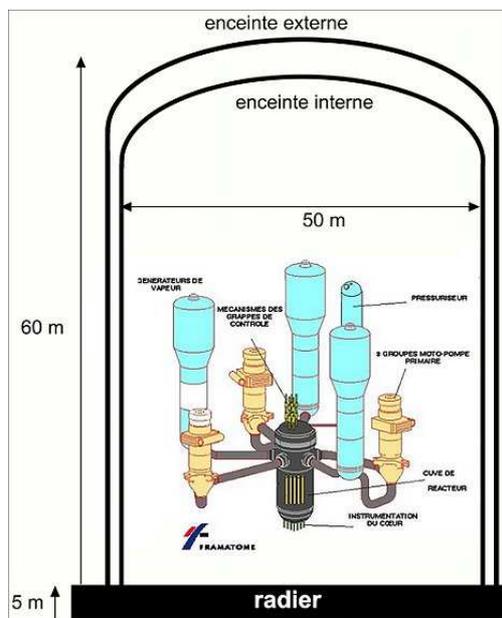
105 *Figure 1: Schematic view of a second generation nuclear power plant*

44 containment structures) are in need of refurbishment to improve their gas-tightness (**Figure**

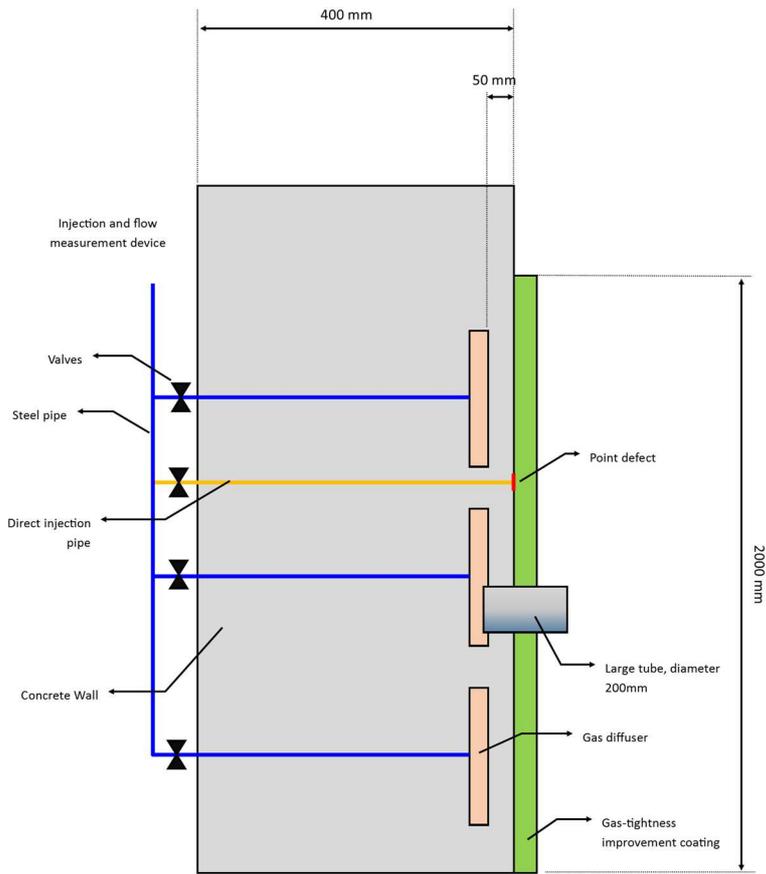
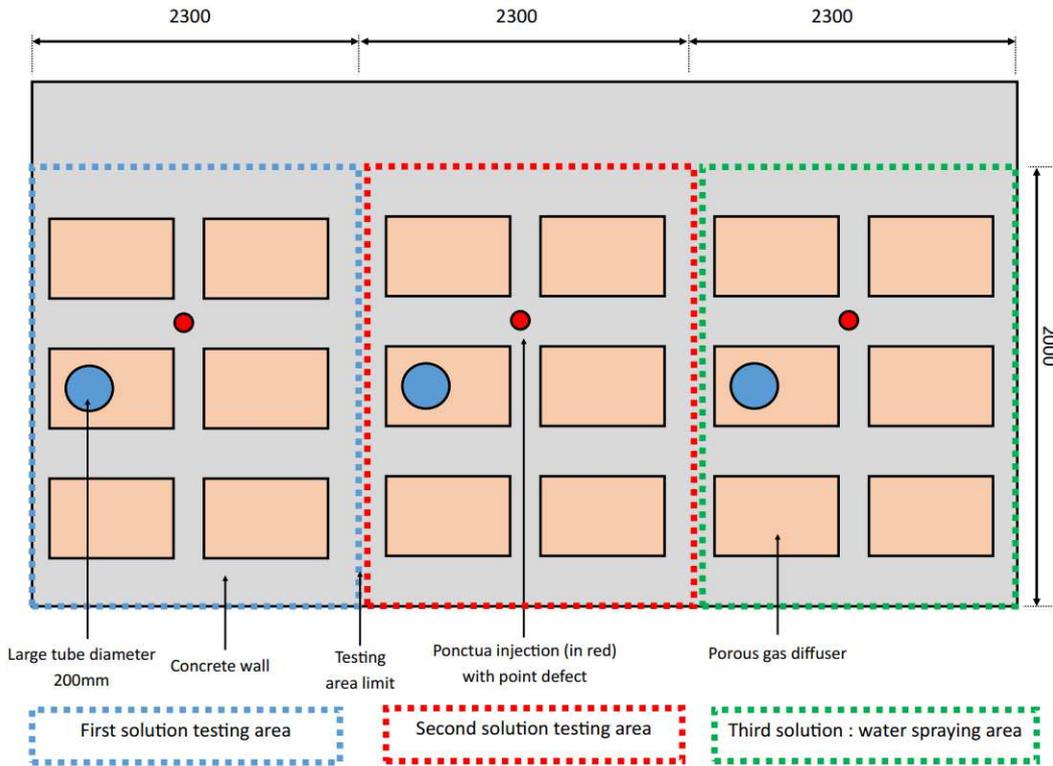
151 *Figure 2: Schematic cross-sectional view (a) and front view of the wall, designed to have three independent test sections. The*

152 *red points (injection points) are used to measure the gas pressure at the interface.*

127        measured at the interface between the wall and the coating through the gas injection points  
128        (shown in red in **Figure 2**). Strong steel reinforcement was used in order to avoid any risk of  
129        delamination (see **Figure 3**), especially during the coating test, for which the surface is almost

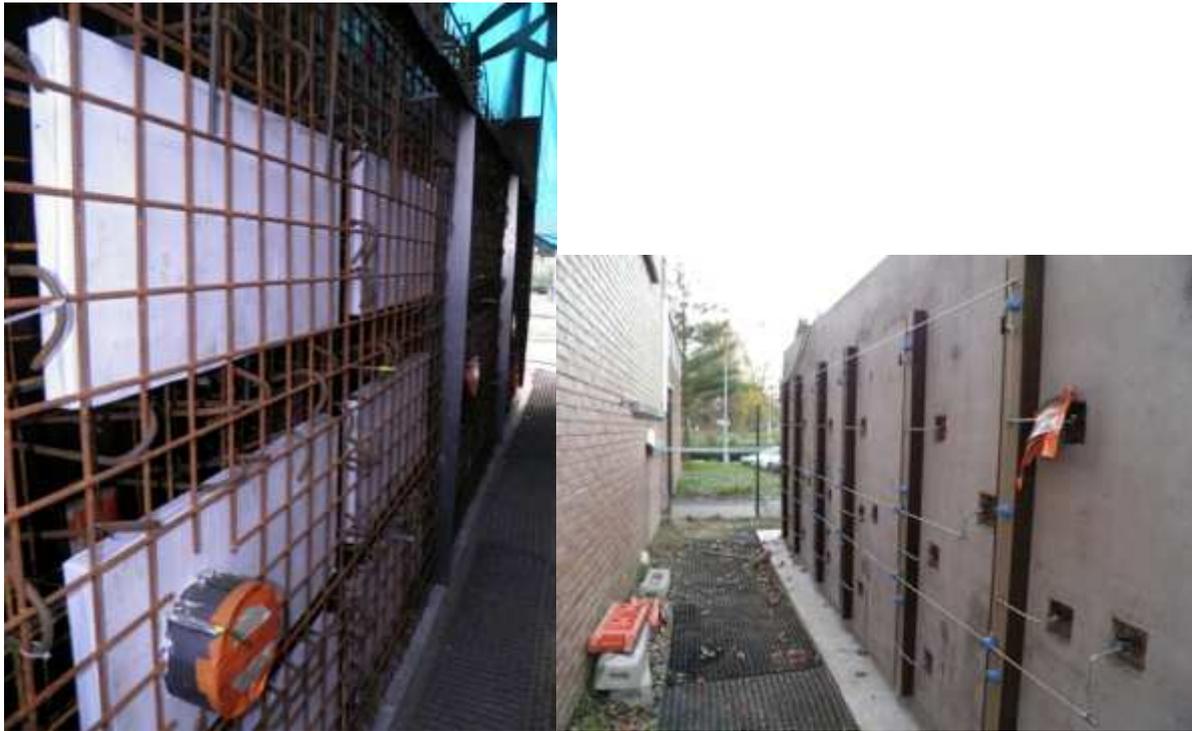
155 *Figure 3: Steel reinforcement, large tube, diffusers and rear side of the wall, showing the injection tubes and valves.*

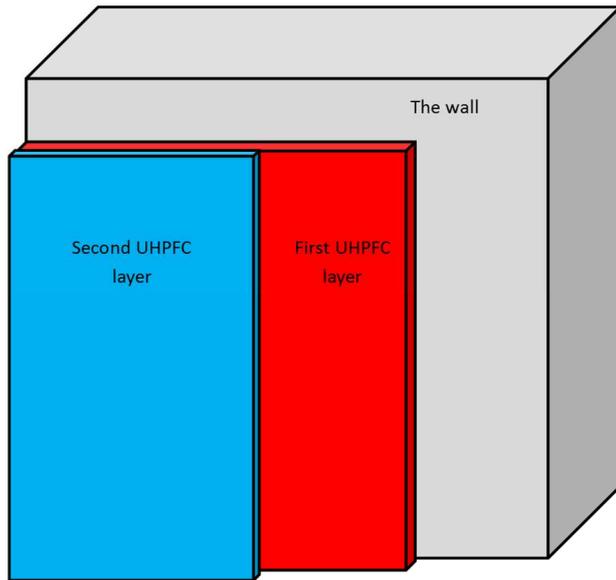
178 *Figure 4: First solution. Layers applied directly to the wall*

162 The first of these involved the application of two UHPFC layers, each having a thickness of  
163 3 cm. These layers were applied directly to the wall in two successive steps (**Figure 4** and  
164 **Figure 6**).

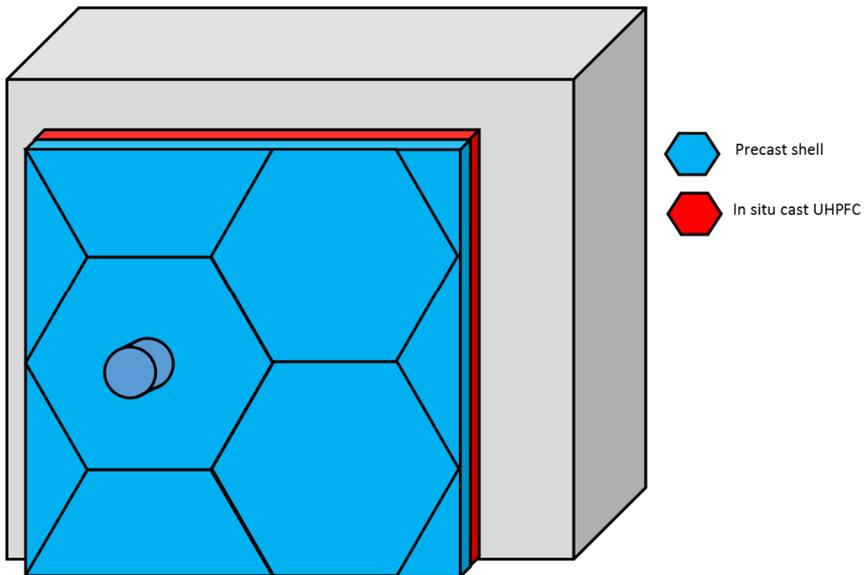
181 *Figure 5: Second solution. Precast shells screwed onto the wall and sealed with UHPFC.*

165 The second procedure made use of (3 cm thick) precast hexagonal shells, which were attached  
166 to the wall by means of special screws. The gap between the shells and the wall was then  
167 filled with UHPFC (**Figure 5** and **Figure 6**). It was decided to perform gas-tightness

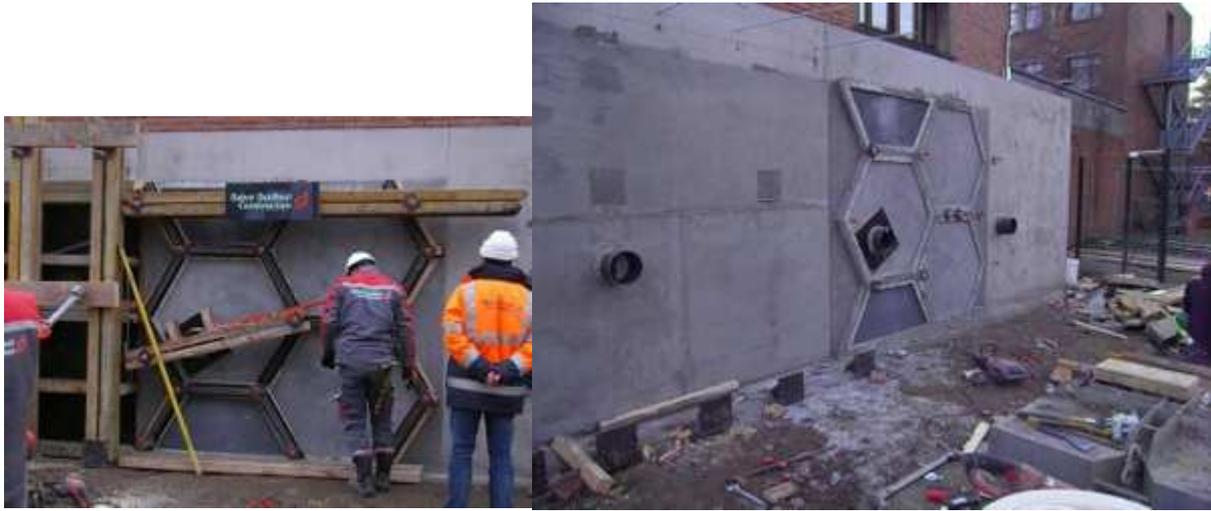
183 *Figure 6: Pictures of the wall showing coating work and the two different solutions.*

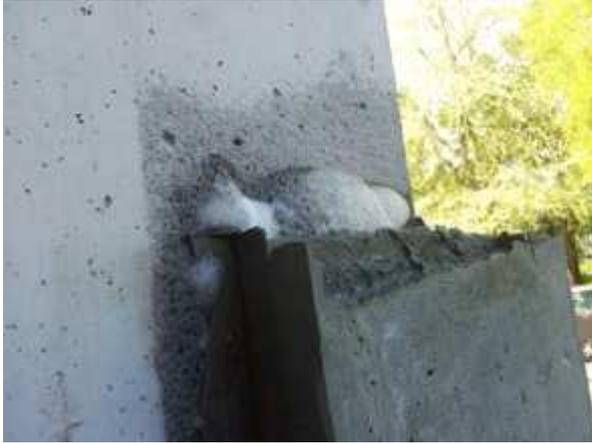
196 *Figure 7: Gas flow bypassing the coating – detected by the application of soapy water.*

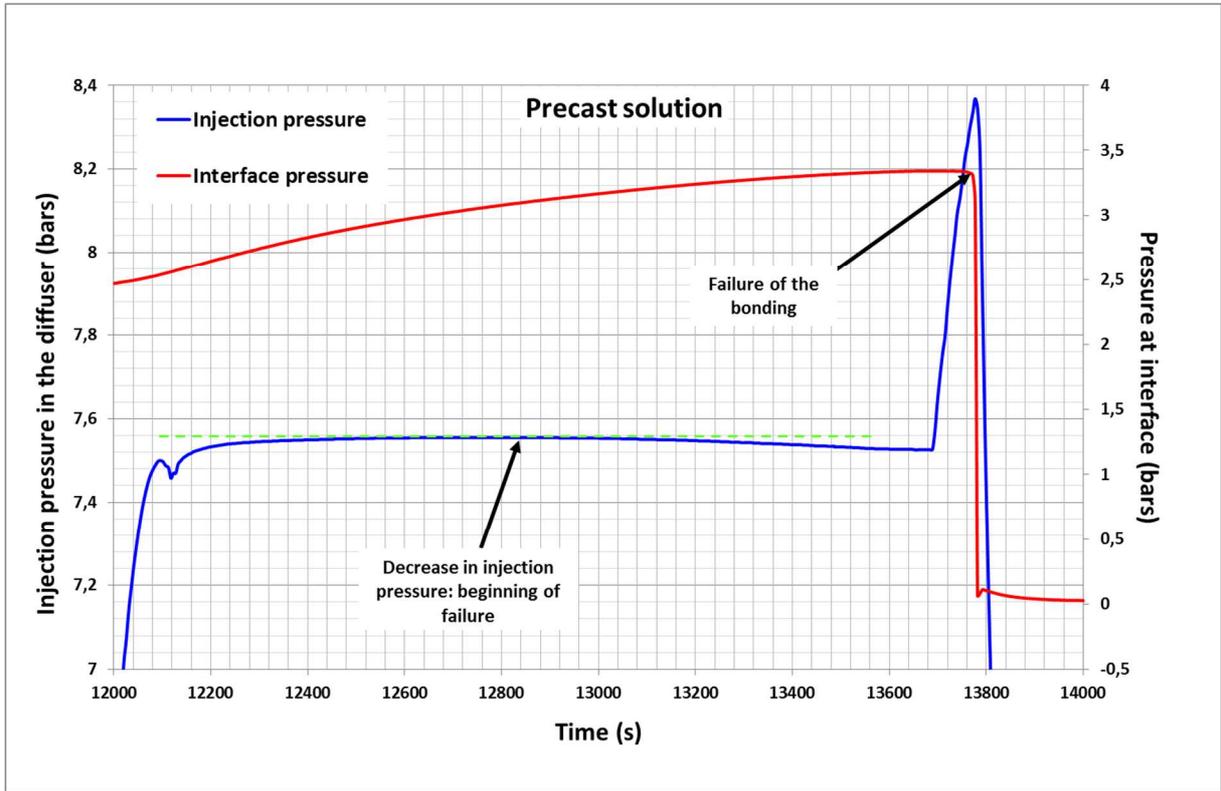
211 *Figure 8: Gas pressure measurements. A sudden drop in interface pressure (red line) occurred at 3.3 bars.*

206 in injection pressure, achieved by means of a rapid increase in injection flow rate (peaking at  
207  $t = 13780$  s, in **Figure 8**) was thus applied, resulting in a negligible increase in interface  
208 pressure, which reached a maximum value of 3.3 bars, prior to its complete failure. The  
209 resulting delamination of the interface can be seen in **Figure 9**.

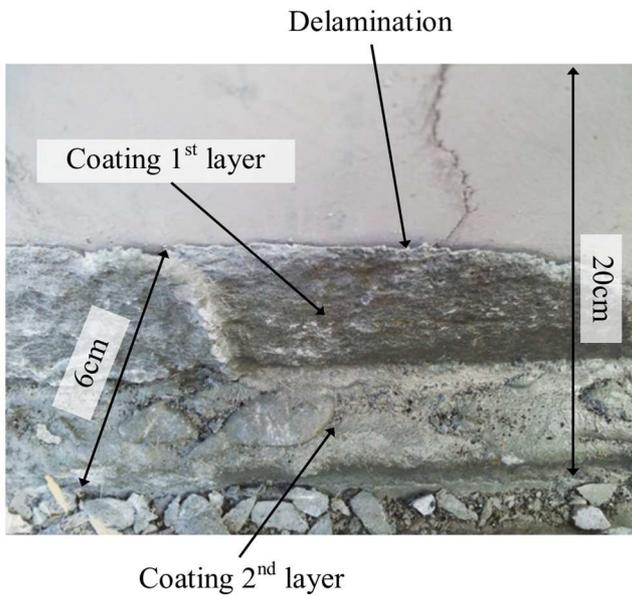
214 *Figure 9: Coating delamination observed on the "in-situ cast" prototype.*

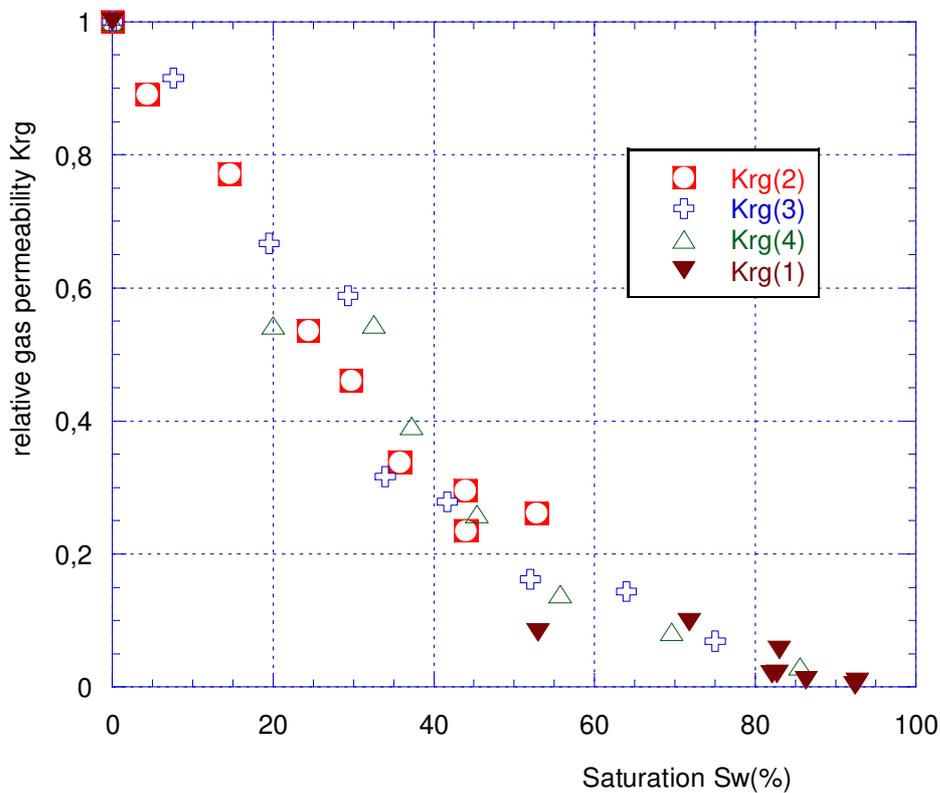
247 *Figure 10: Relative gas permeability for four different concretes [3].*

231 A typical gas relative permeability curve is shown in **Figure 10**, for the case of intact  
232 concrete.

233 These results indicate that, depending on the characteristics of its porous structure, the gas  
234 relative permeability ( $K_{rg}$ ) of concrete can decrease by two (or three) orders of magnitude,  
235 when the matrix changes from the dry state to 80% water saturation ( $S_w$ ).

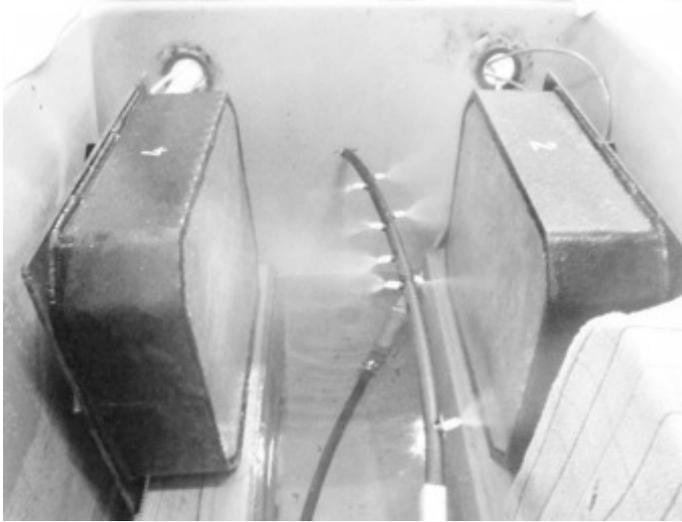
278 *Figure 11: Two concrete slabs during spraying.*

272 Their water saturation was increased by spraying them with water for several weeks (**Figure**  
273 **11**). The same arrangement was also used to spray water onto concrete test cylinders (**Figure**  
274 **12**). As their lateral surface was initially sealed with glue, the saturation of these cylinders  
275 was thus achieved axially via their flat ends. Spraying was achieved by means of electric  
276 pumps and a small spray-pipe system.

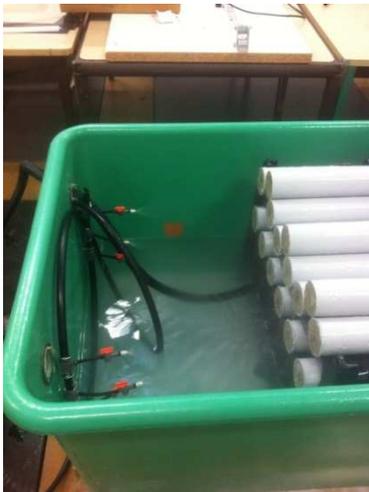
280 *Figure 12: Water spraying of concrete cylinders stored above the collected water.*

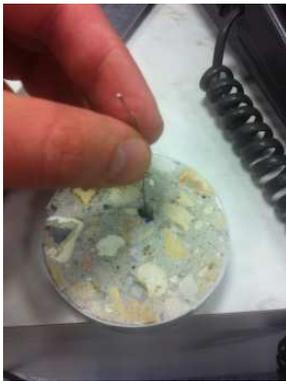
292 *Figure 13: bubbles in concrete slices.*

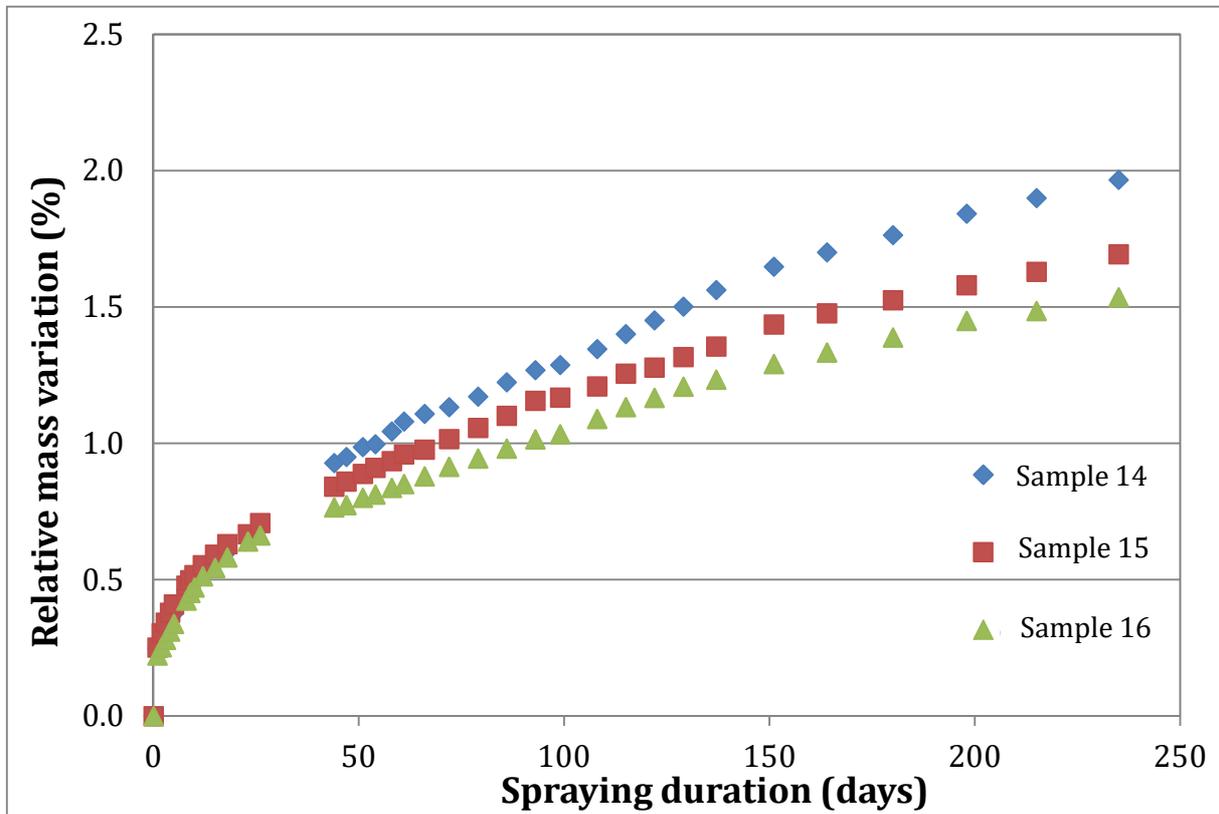
327 *Figure 14: Relative mass variation for three control samples.*

321 The global increase in mass of the three samples ranged between 1.5% and 2%. The  
322 dispersion in these values can probably be explained by small differences in porosity, or the

323 presence of bubbles. Fifty percent of the mass increase was obtained after the first 50 days. It  
324 confirms that imbibition, with liquid water, occurs significantly faster than drying that is  
325 mainly a diffusive phenomenon.

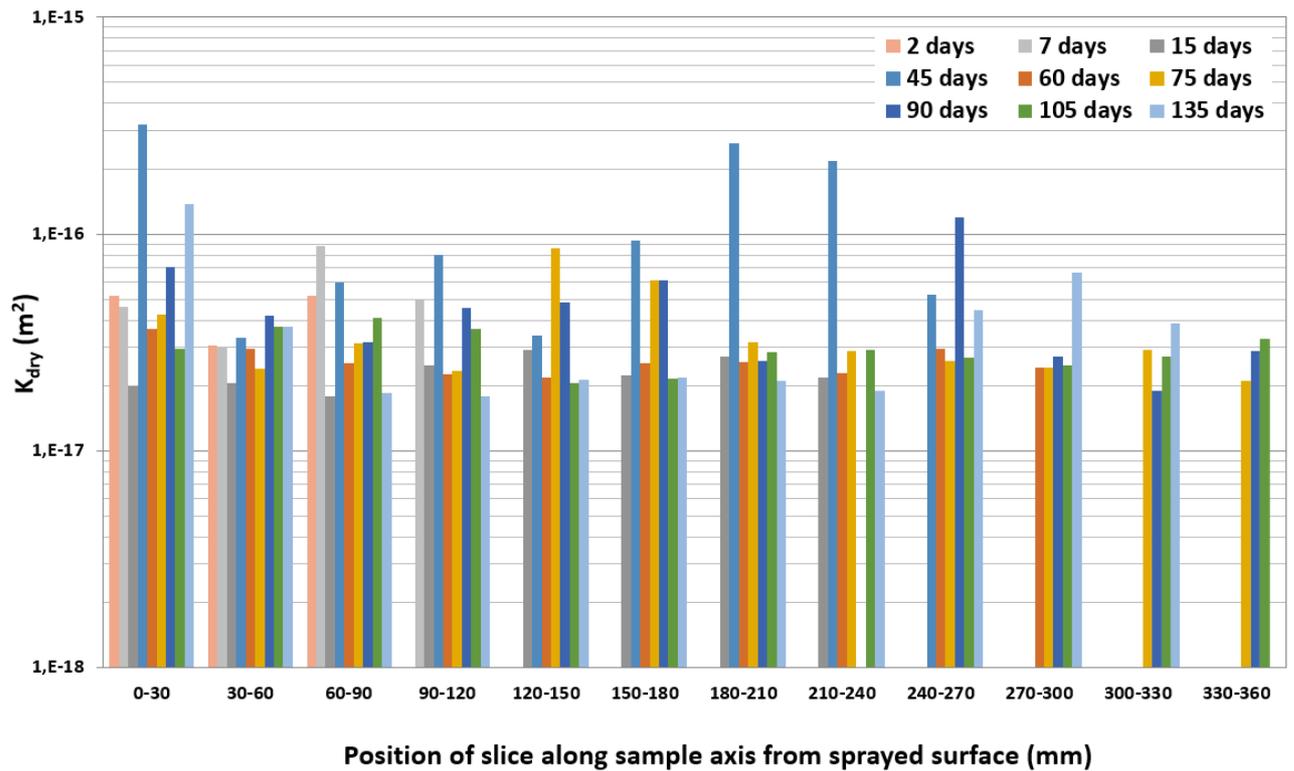
342 *Figure 15: Dry gas permeability of concrete slices (30 mm thick) taken from 9 different cylindrical samples (each with a*  
 343 *different spraying duration). The position of each slice along its parent cylinder is measured from the sprayed end surface of*  
 344 *the cylinder.*

336 these samples is nearly homogeneous as a function of depth. The mean gas permeability is  
 337 found to be approximately  $2.5 \cdot 10^{-17} \text{ m}^2$ , however some of the cylinders had contrasted  
 338 properties, when compared with this average value. This is the case for the cylinder sawn  
 339 after 45 days of spraying, since its permeability was ten times greater than the average value.  
 340 This kind of dispersion is frequently met for in-situ structures.

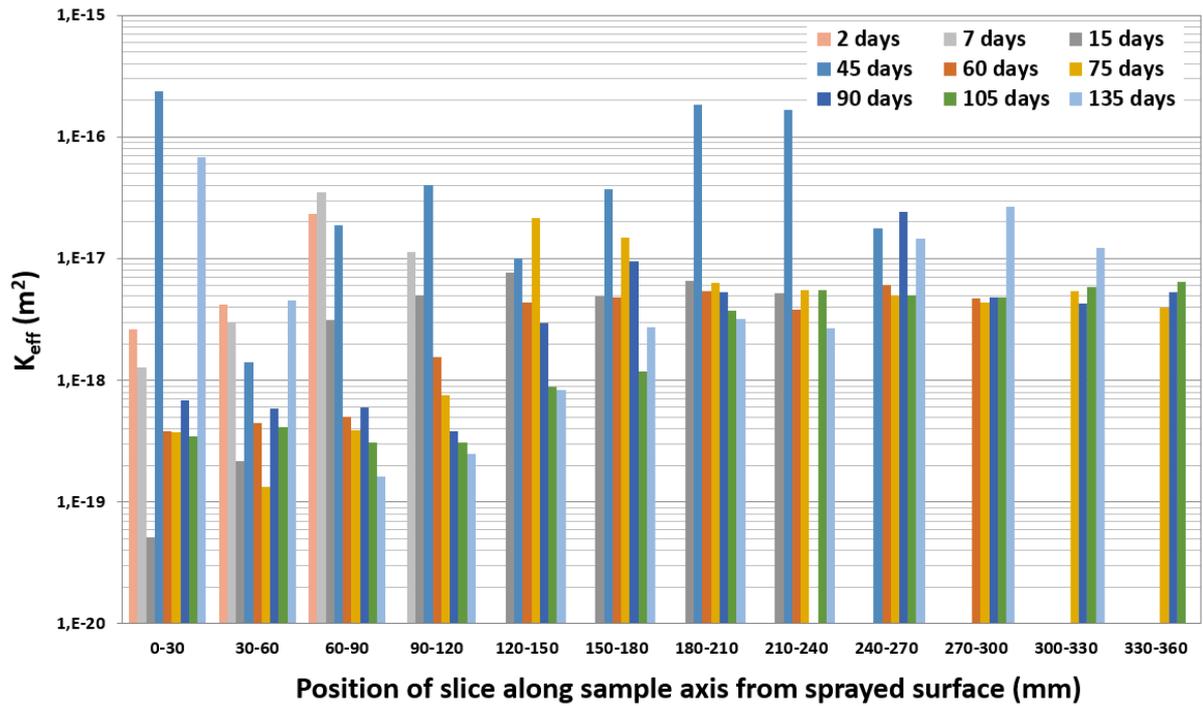
368 *Figure 16: Effective gas permeability of 30 mm slices of concrete as a function of their distance (measured from the sprayed*

369 *surface of the original sample), and the spraying duration*

345 Before being dried, the effective gas permeability of the partially saturated slices was  
 346 measured. The full set of results is shown in **Figure 16**. Some samples are atypical, since their  
 347 gas permeability remains very high, despite a high level of saturation (close to 90%, see  
 348 further). Although the origin of this phenomenon has not yet been identified, we assume that  
 349 these samples contained very large pores and cracks along their length, which even at high

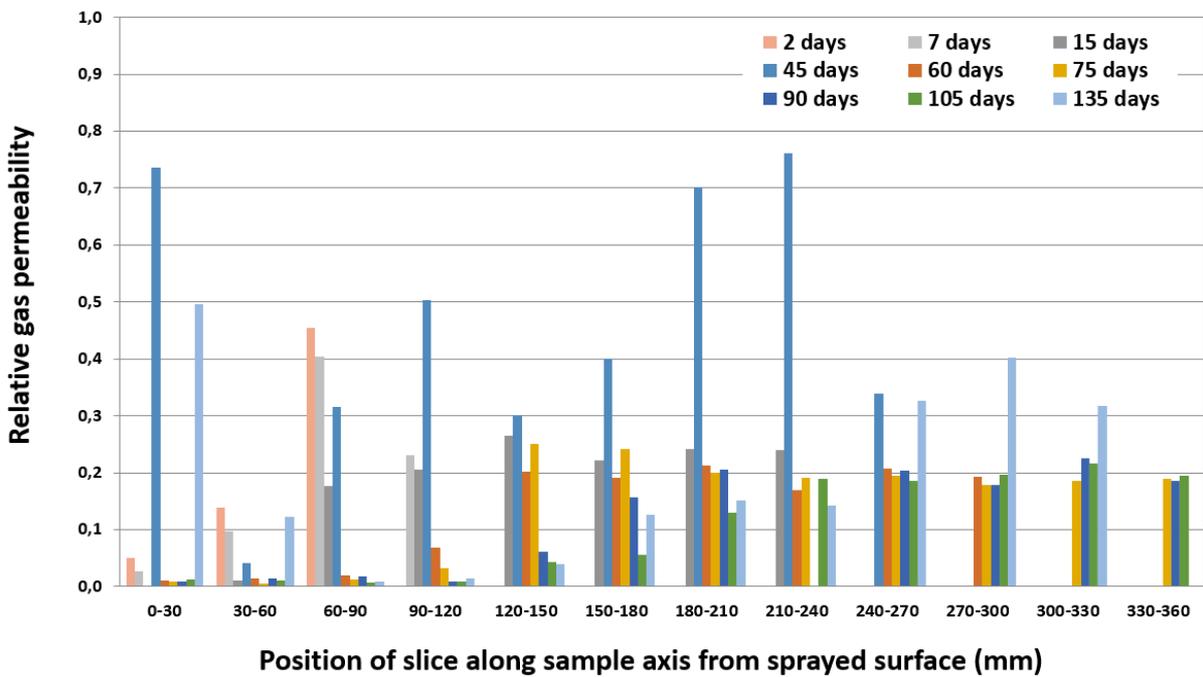
371 *Figure 17: Relative gas permeability of 30 mm slices of concrete as a function of their distance (measured from the sprayed*

372 *surface of the original sample), and the spraying duration*

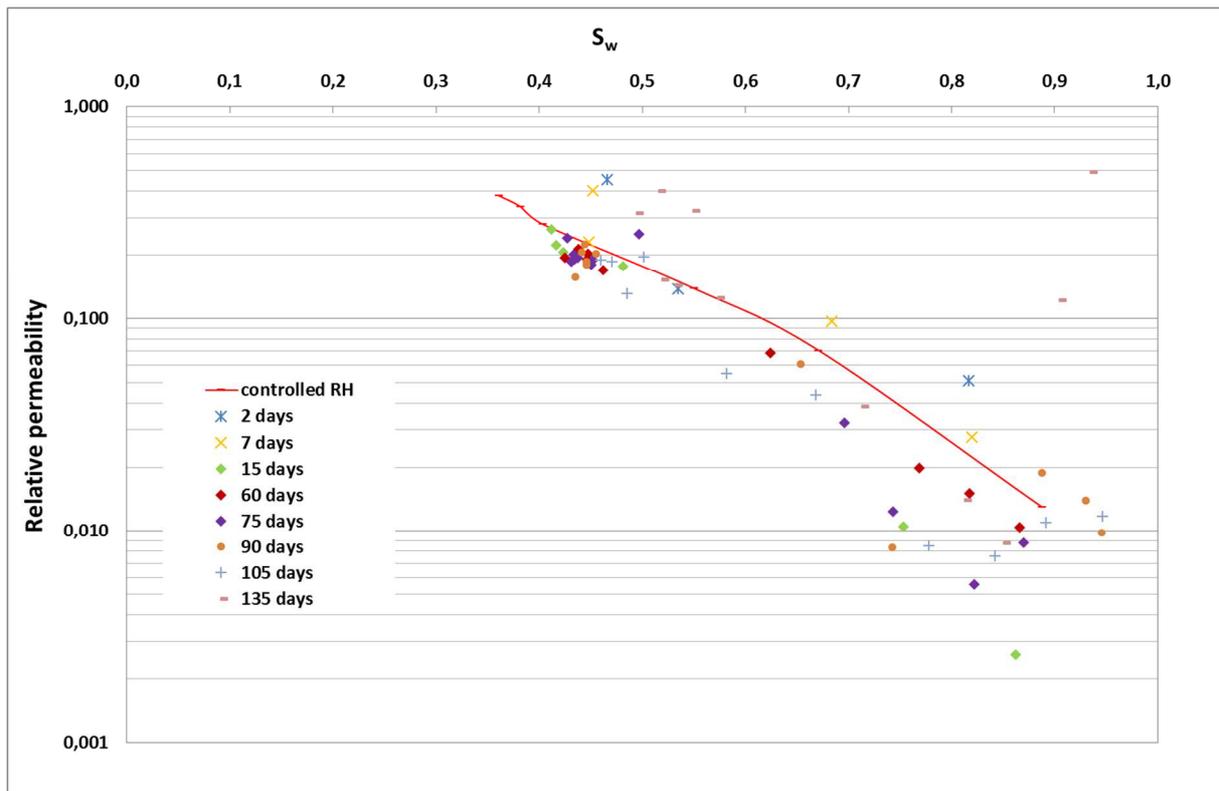
374 *Figure 18: Semi-log representation of the relationship between relative permeability and water saturation ( $S_w$ ), measured on*  
 375 *slices of sprayed samples, and on samples stored under controlled relative humidity conditions (RH controlled using a brine*  
 376 *solution).*

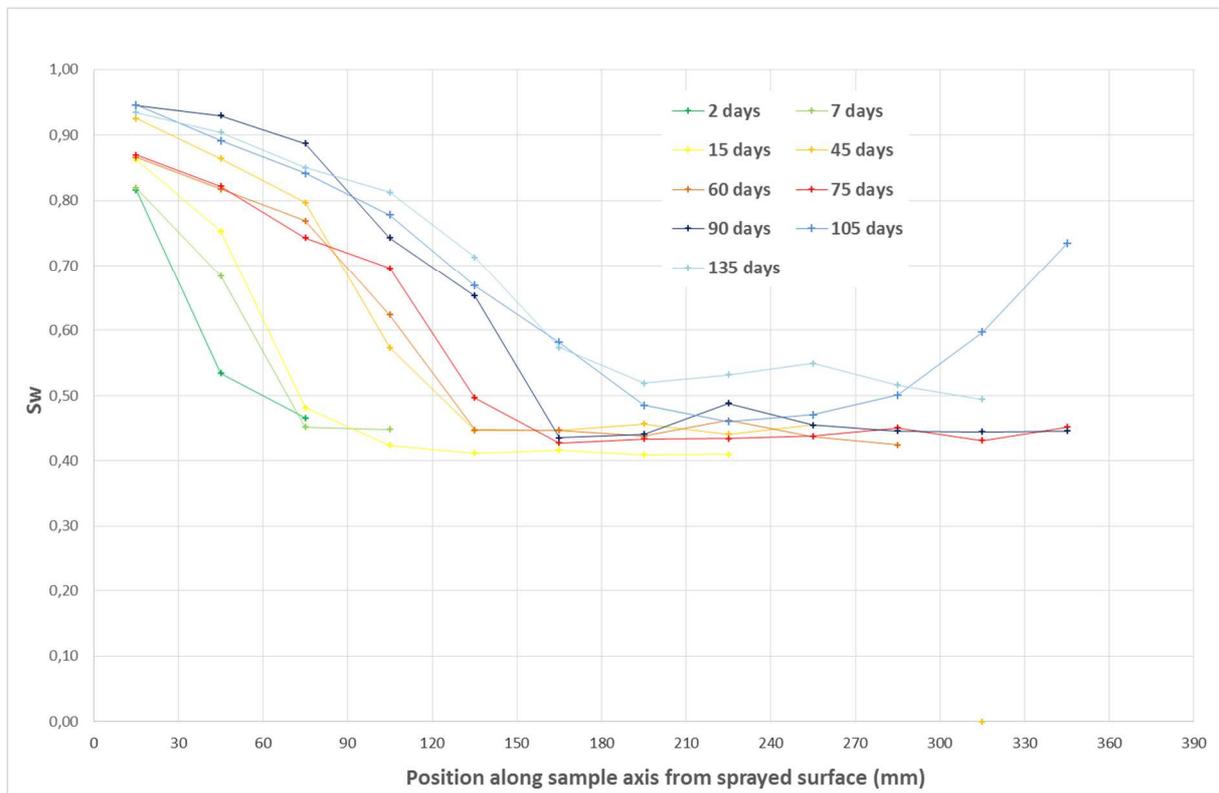
397 *Figure 19: Water saturation distribution as a function of distance from the sprayed surface, and spraying duration.*

378 The water front propagation kinetic is presented in Figure 19, which plots the material's water  
 379 saturation as a function of distance from the sprayed surface and spraying time. The initial  
 380 values of saturation lie in the range between 40-50%, with a mean value of 45%. Some  
 381 scattering can be observed in this data, resulting from the typical dispersion of porous  
 382 structures in cementitious materials. Imbibition and saturation increase rather quickly, since in  
 383 the zone situated 30-40 mm below the sprayed surface, the saturation reaches more than 70%  
 384 after 15 days of spraying. After 90-105 days of spraying, this relatively highly saturated zone  
 385 extends to a distance of 120-130 mm from the sprayed surface, and the 30-40 mm zone  
 386 reaches more than 90% saturation. After 135 days, the partially saturation zone has extended

387 to more than 240 mm from the sprayed surface, and a concrete thickness of at least 120 mm is  
 388 highly saturated. The latter value represents approximately 10% of a confining structure's  
 389 thickness, and could be sufficient to considerably reduce the gas permeability of the entire  
 390 structure. A simple calculation shows that if the relative gas permeability of the 120 mm zone  
 391 is approximately 1% (assuming water saturation of the concrete greater than 80% - see Figure  
 392 19), the gas permeability of the overall structure would be 2 to 3 times lower than before  
 393 spraying. This technique could thus be a viable solution for the recovery of a significant  
 394 proportion of the gas tightness of reactor confining structures.

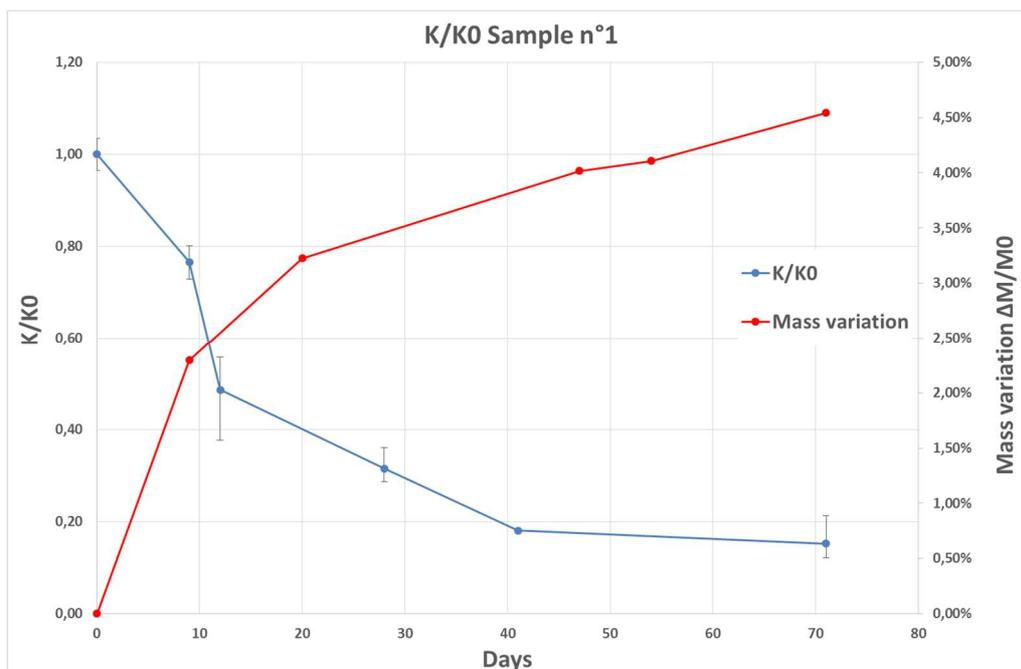
414 *Figure 20: Decrease in permeability (K/Ko) and mass variation (M/Mo) vs. spraying duration for sample 1.*

404 The initial gas permeability  $K_0$  (i.e. before spraying) was first measured on each slab. For the  
405 slab with no concreting joint,  $K_0$  was found to be  $7.8 \cdot 10^{-18} \text{ m}^2$ . The gas permeability of the  
406 slab with a concreting joint was two orders of magnitude higher ( $K_0 = 1,5 \cdot 10^{-15} \text{ m}^2$ ). This  
407 strong difference comes from the “bad” joint quality, which behaves almost like a macro-  
408 crack. The influence of spraying on the mass and gas permeability of the slab with no  
409 concreting joint is plotted in Figure 20 : its permeability is found to decrease by a factor of 5  
410 after only 6 weeks of imbibition. A much stronger decrease, by a factor of 20, is also observed  
411 for the slab with concrete joints (see Figure 21). This is evidence that the water spraying  
412 operation is efficient even in the case of a damaged material.

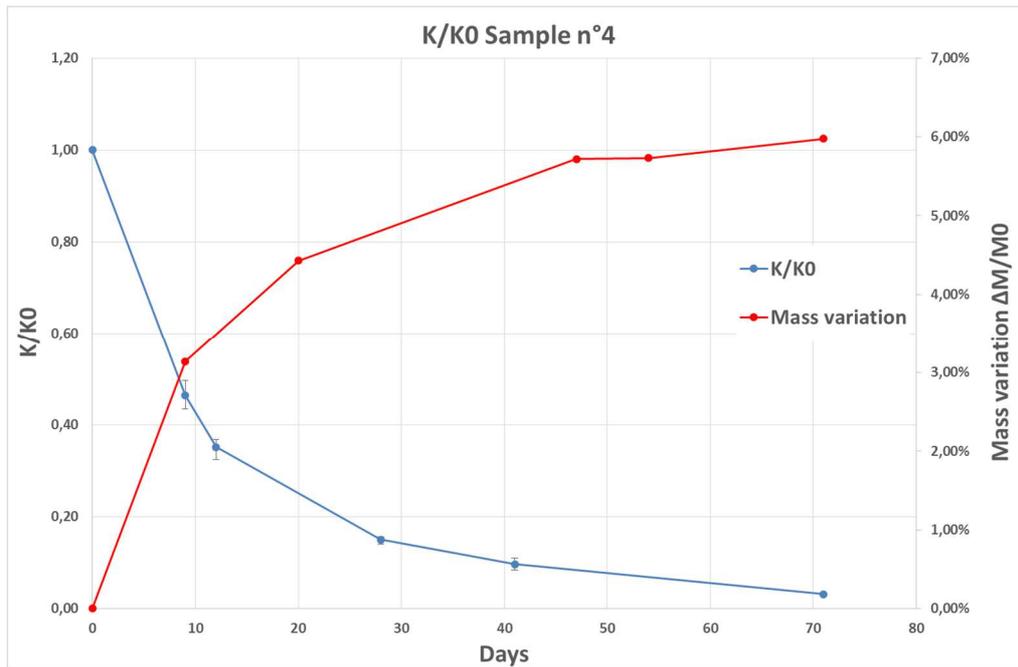
416 *Figure 21: Decrease in permeability (K/Ko) and mass variation (M/Mo) vs. spraying duration for sample 2 (with a concrete*  
417 *joint).*

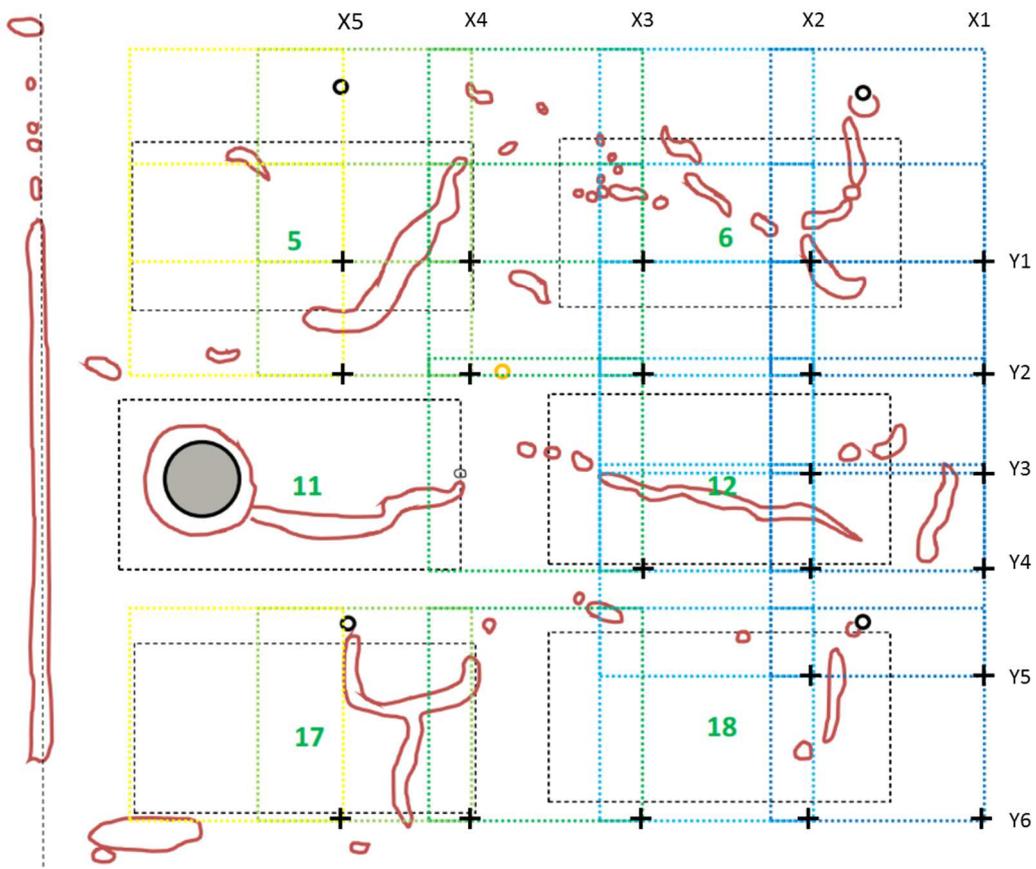
459  
460 *Figure 22: map of the test wall showing the main flow paths (continuous red lines), position of the gas diffusers (black*  
461 *rectangles drawn in dotted lines), and zones where the permeability is measured (blue, green and yellow rectangles drawn in*  
462 *dotted lines), identified by their corresponding X and Y coordinates.*

140 diffusor, and to promote cracking due to desiccation [8], thus ensuring its high gas  
141 permeability. On the other hand, the concrete behind the diffuser (with a thickness of 30 cm)  
142 was intended to remain almost fully saturated, i.e. to ensure that this portion of the concrete  
143 wall had a low gas permeability. A complete map of the wall's major leaks was produced,  
144 through the use of soapy water and the measurement, at each diffuser, of the gas flow rate  
145 induced by an injection pressure of either 2 or 4 bars (see Figure 22)

420 The encouraging results described above led to the design of a dedicated system allowing  
421 water to be sprayed onto the third portion of the wall, which had not been used for the testing  
422 of coating solutions. Figure 22 is a map of the third portion of the wall, showing the positions  
423 of gas diffusers (black dotted lines and green numbers) and the main leakage areas  
424 (continuous red lines, identified with a bubbling agent).

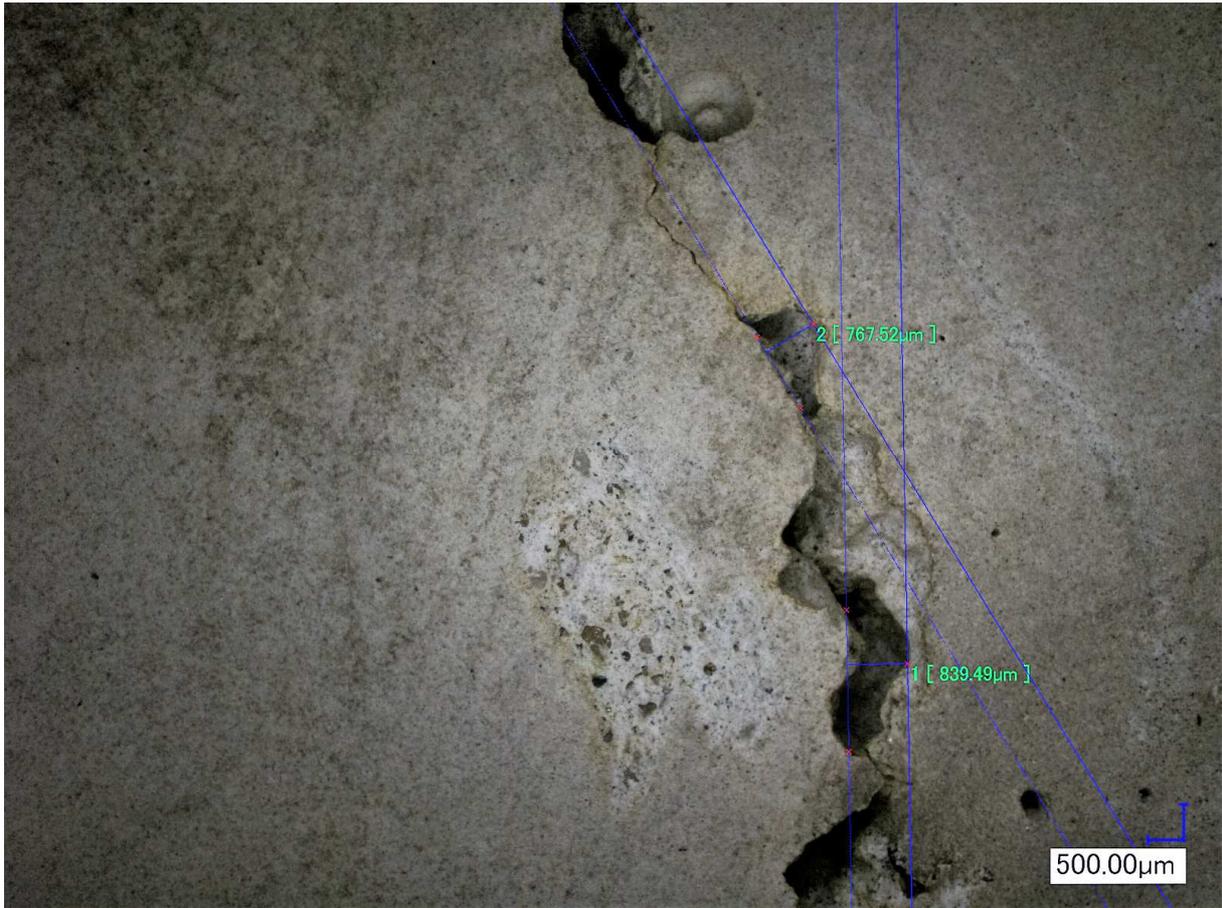
481 *Figure 23: drying crack in the XIY4 and XIY5 measurement zones.*

433 The results in **Table 2** reveal a strong dispersion in gas permeability, which ranges from  
434  $0.7 \cdot 10^{-18} \text{ m}^2$  to  $446.10^{-18} \text{ m}^2$ . This is due to drying shrinkage of the wall, which was built using  
435 “poor” quality concrete. This particular type of concrete, made with a high water-to-binder  
436 ratio, was selected for practical and scheduling reasons, in order to improve the drying  
437 kinetics of the concrete and to obtain high (more easily measurable) values of permeability.  
438 As a consequence, large drying cracks formed, especially on the sides of the wall, due to  
439 structural effects. Examples of these cracks are shown in the optical microscope enlargements  
440 of Figure 23, Figure 24, Figure 25, Figure 26 **and** Figure 27. Some of the cracks, such as that  
441 shown in Figure 23, reached a width of  $800\mu\text{m}$ , thus explaining the high gas permeability of

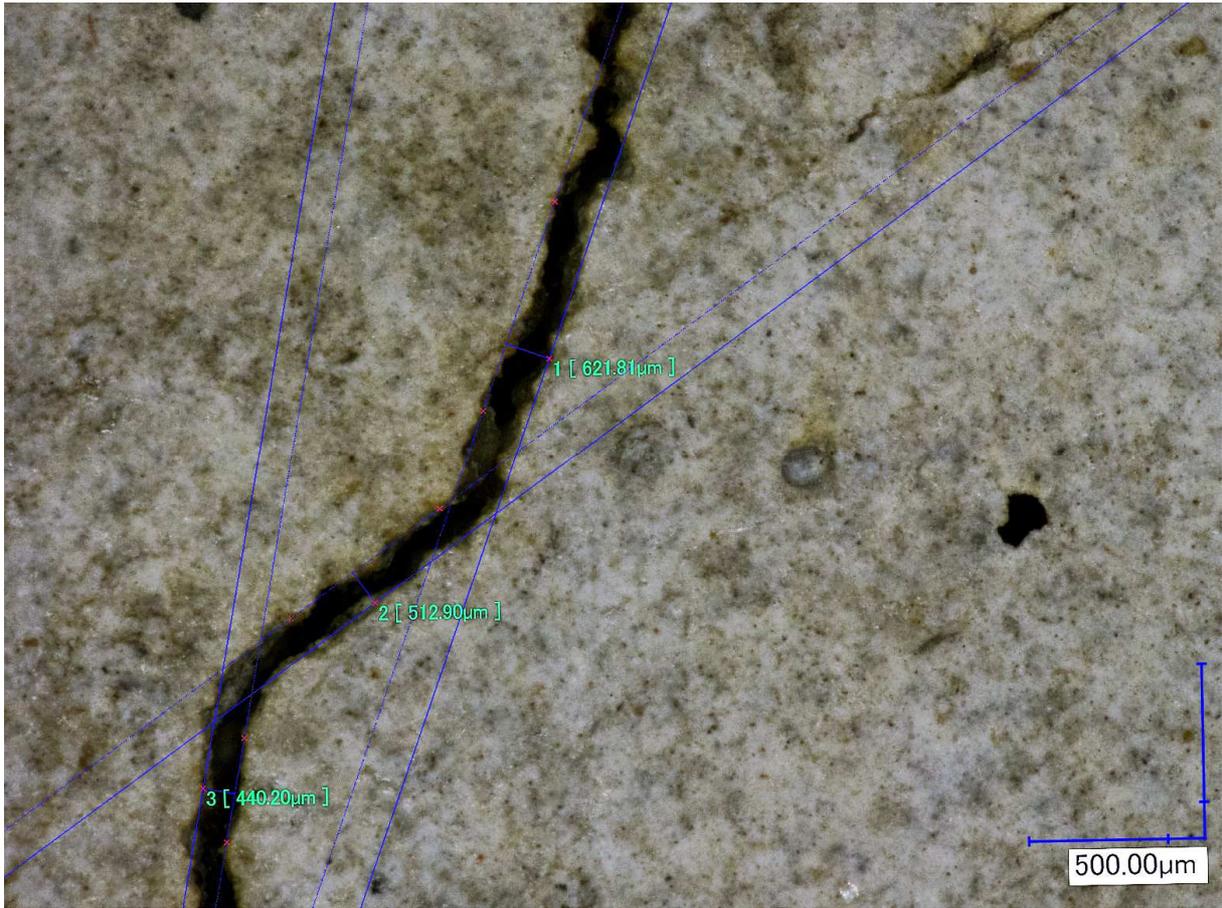
483 *Figure 24: drying crack in the XIY6 measurement zone.*

442 areas X1Y4 and X1Y5. The widths of the other cracks shown in these images are:  
443 approximately  $500\mu\text{m}$  in **Figure 24** (area X1Y6),  $140\mu\text{m}$  in Figure 25 (areas X1Y1 and  
444 X1Y2),  $200\mu\text{m}$  in Figure 26 (area X4Y6), and from  $120$  to  $330\mu\text{m}$  in Figure 27 Figure 27  
445 (areas X2Y5 and X2Y4). No clear correlation was found between the appearance of the  
446 cracks and their corresponding gas permeability, mainly because they were observed only  
447 superficially, and their depth and length were not determined.

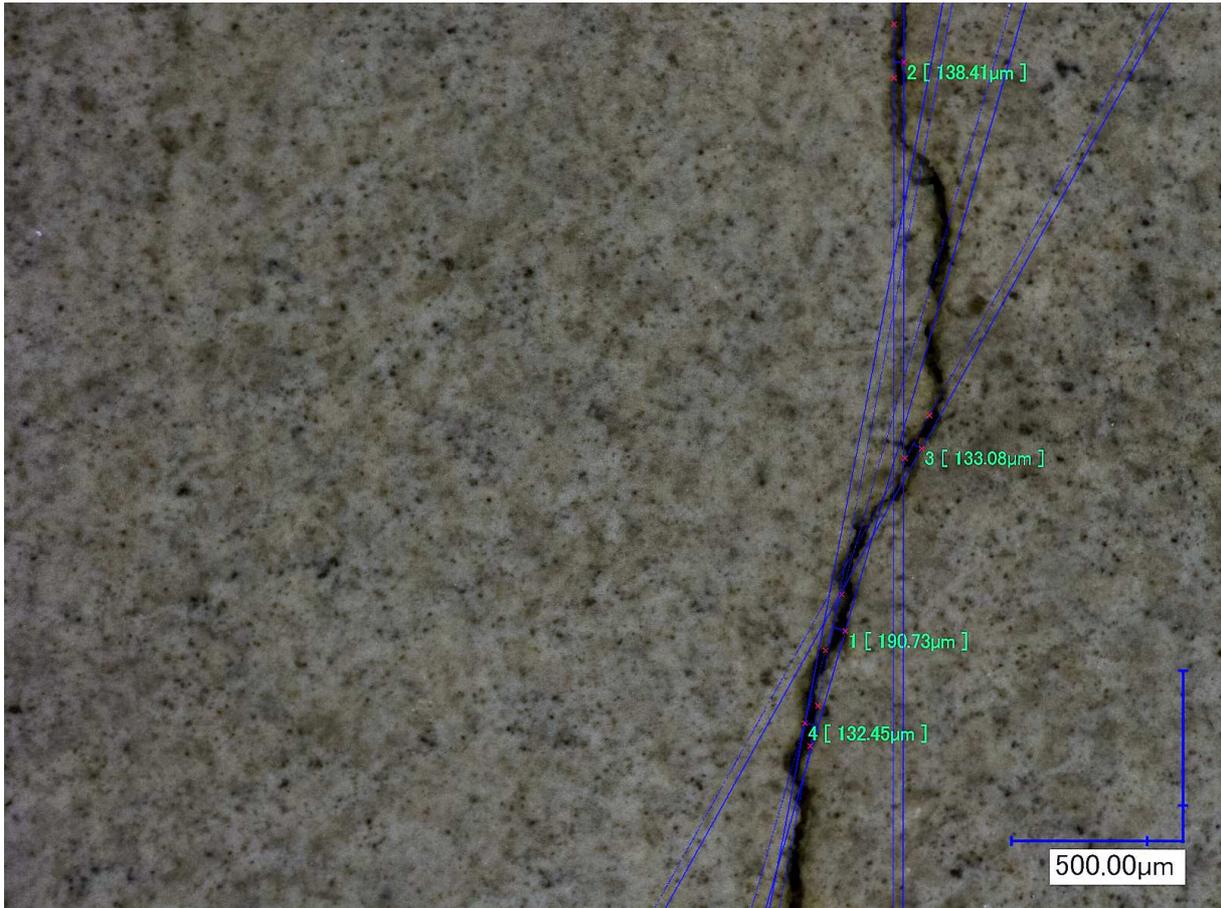
485 *Figure 25: drying crack in the XIY1 and XIY2 measurement zones.*

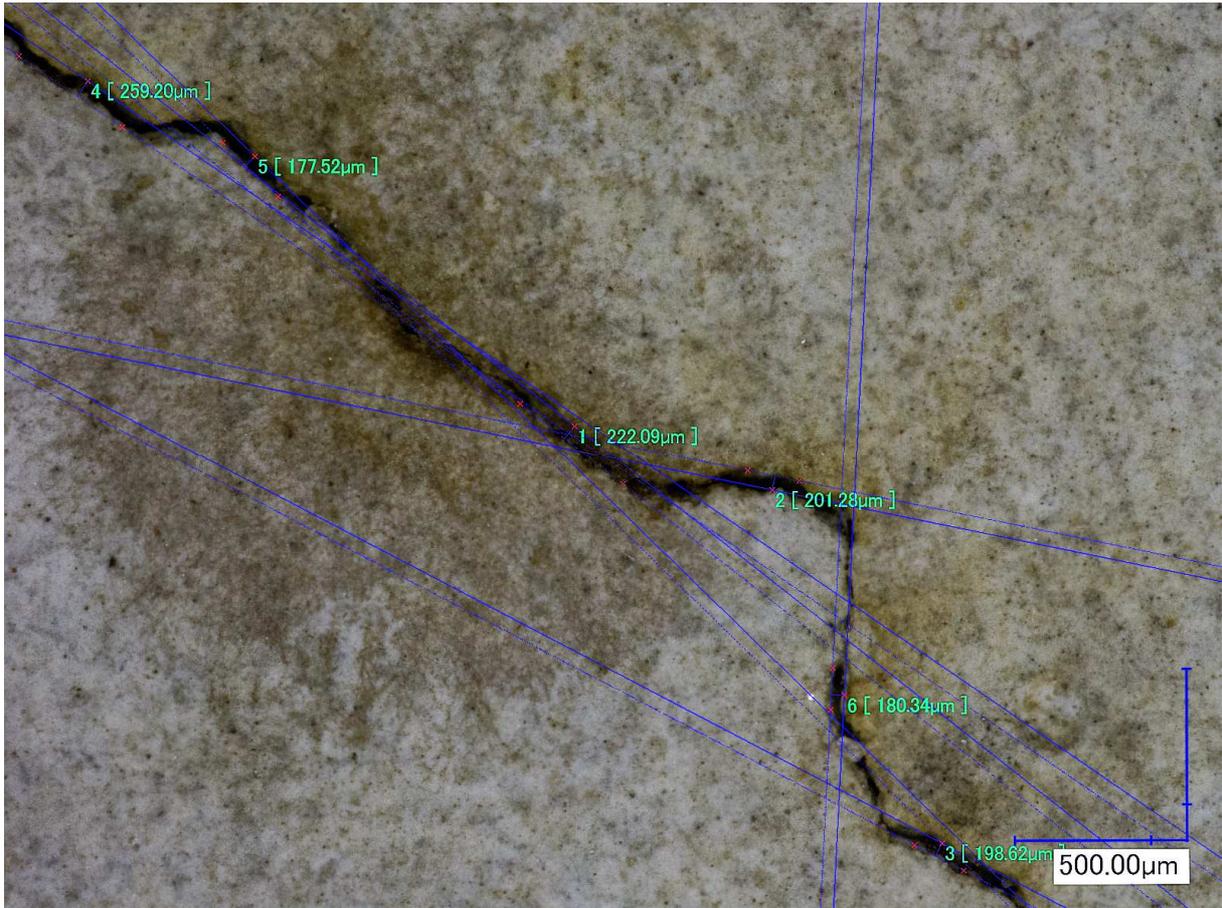
487 *Figure 26: drying crack in the X4Y6 measurement zone.*
