## Sealing of concrete confining structures of French nuclear reactors

Yan Pei, Shucaï Li, Franck Agostini, Frédéric Skoczylas, Benoît Masson

Yan Pei, Shucaï Li, Franck Agostini, Frédéric Skoczylas, Benoît Masson. Sealing of concrete confining structures of French nuclear reactors. *Engineering Structures*, 2019, 197, pp.109283. 10.1016/j.engstruct.2019.109283 . hal-02894316

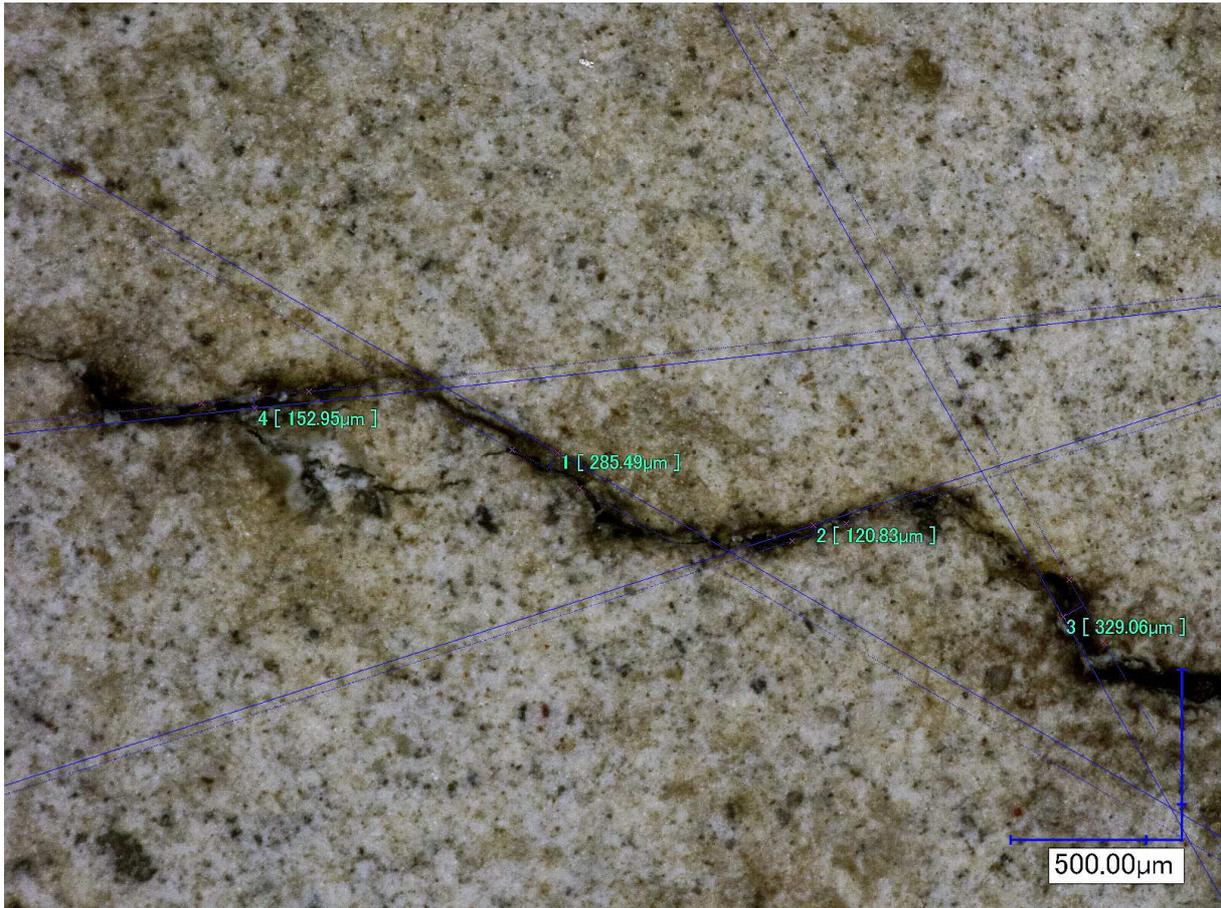
489 *Figure 27: drying crack in the X2Y5 and X2Y4 measurement zones.*

442 areas X1Y4 and X1Y5. The widths of the other cracks shown in these images are:  
443 approximately  $500\mu\text{m}$  in **Figure 24** (area X1Y6),  $140\mu\text{m}$  in Figure 25 (areas X1Y1 and  
444 X1Y2),  $200\mu\text{m}$  in Figure 26 (area X4Y6), and from  $120$  to  $330\mu\text{m}$  in Figure 27 Figure 27  
445 (areas X2Y5 and X2Y4). No clear correlation was found between the appearance of the  
446 cracks and their corresponding gas permeability, mainly because they were observed only  
447 superficially, and their depth and length were not determined.
