Micro-climatic monitoring to optimize ageing test methodology:

Application on the Saint-Remi Basilica (Rheims, France)

E. HUBY, C. THOMACHOT-SCHNEIDER, P. VAZQUEZ, G. FRONTEAUGEGENAA EA 3795, URCA, France

EGU 2019 - 10/04/2019

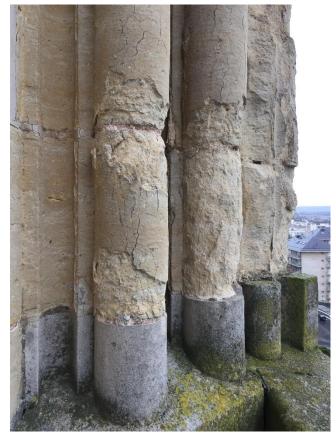
Two types of limestone:

"Courville"

Lutetian limestone Original stone

"Savonnières"

Jurassic limestone Restoration stone

Picture of weathered stones and restored stones on the Basilica.
