## In situ monitoring of the weathering agents of Saint-Remi Basilica (Rheims, France)

Emilie Huby, Céline Thomachot-Schneider, Gilles Fronteau, Patricia Vázquez. In situ monitoring of the weathering agents of Saint-Remi Basilica (Rheims, France). Japan Geoscience Union Meeting 2018 (JpGU), May 2018, Chiba, Japan. hal-02945559

# In situ monitoring of the weathering agents of Saint-Remi Basilica (Rheims, France)

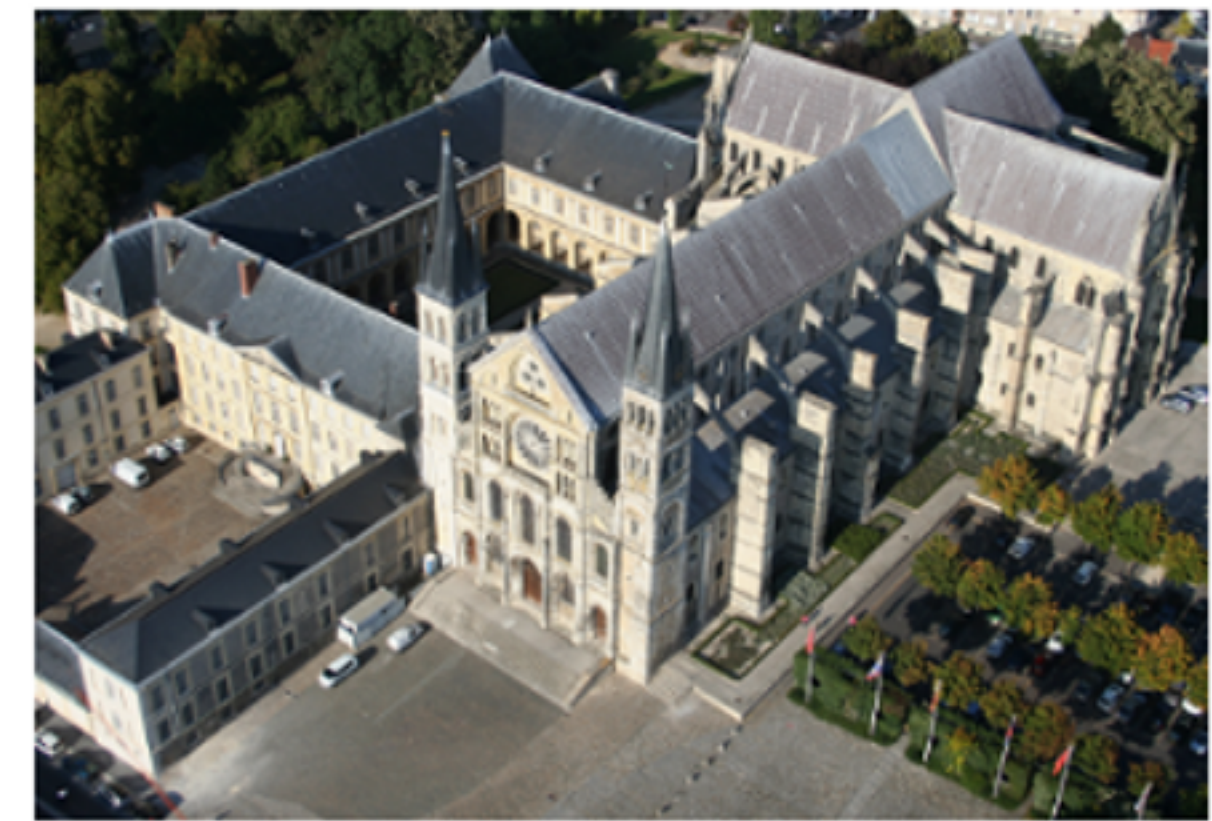
View of the Saint-Remi Basilica.

The **Saint-Remi Basilica** (Rheims, France) is an architecturally complex building, composed of various stones at different orientations and heights. The **variability** of the **micro-environmental parameters** are studied through a sensor network

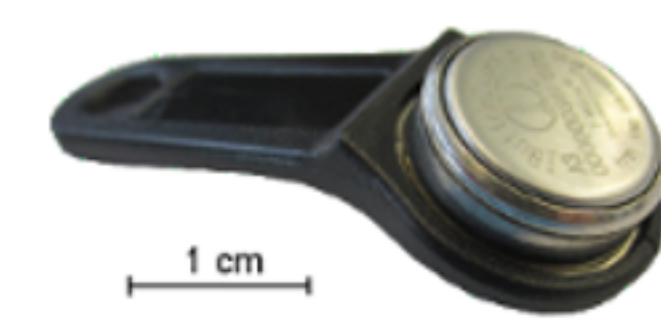
**14 sensors** (i-Buttons) recording **temperature** and **relative humidity** were placed on the 2 towers of the Saint-Remi Basilica.

i-Button sensor.

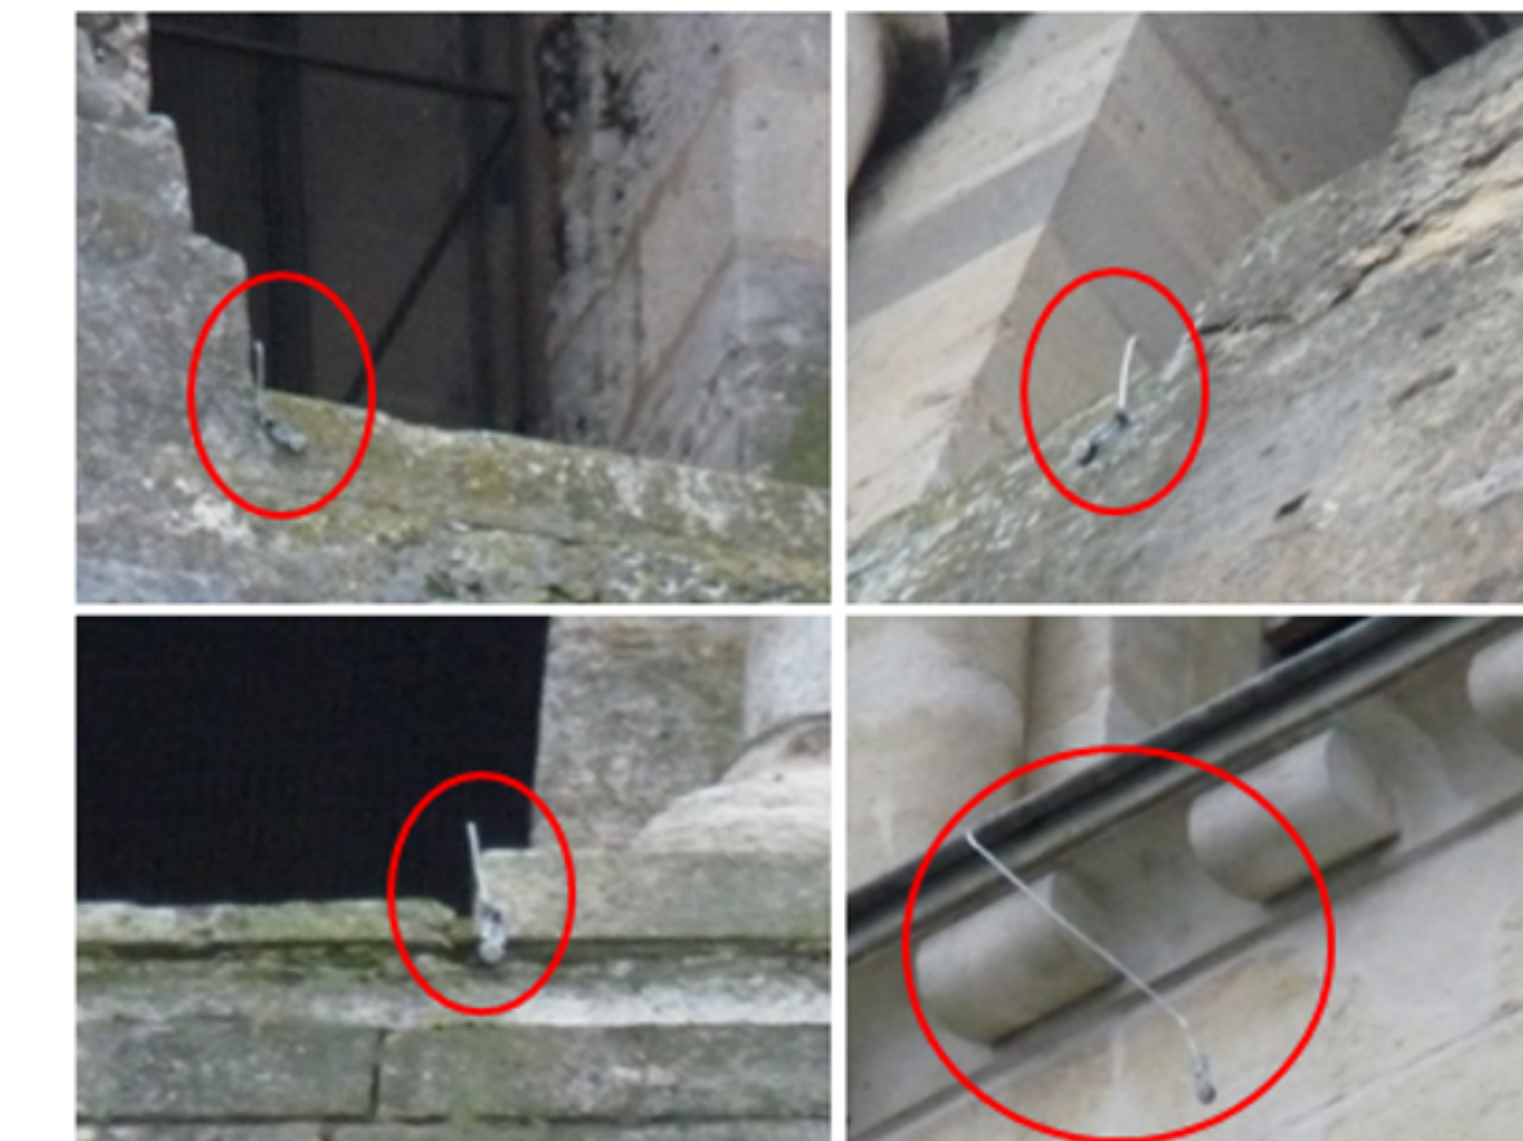
Different heights: 19 and 23m.  
Different orientations:  
**North, South, East and West.**

Pictures of sensors in place on the towers.

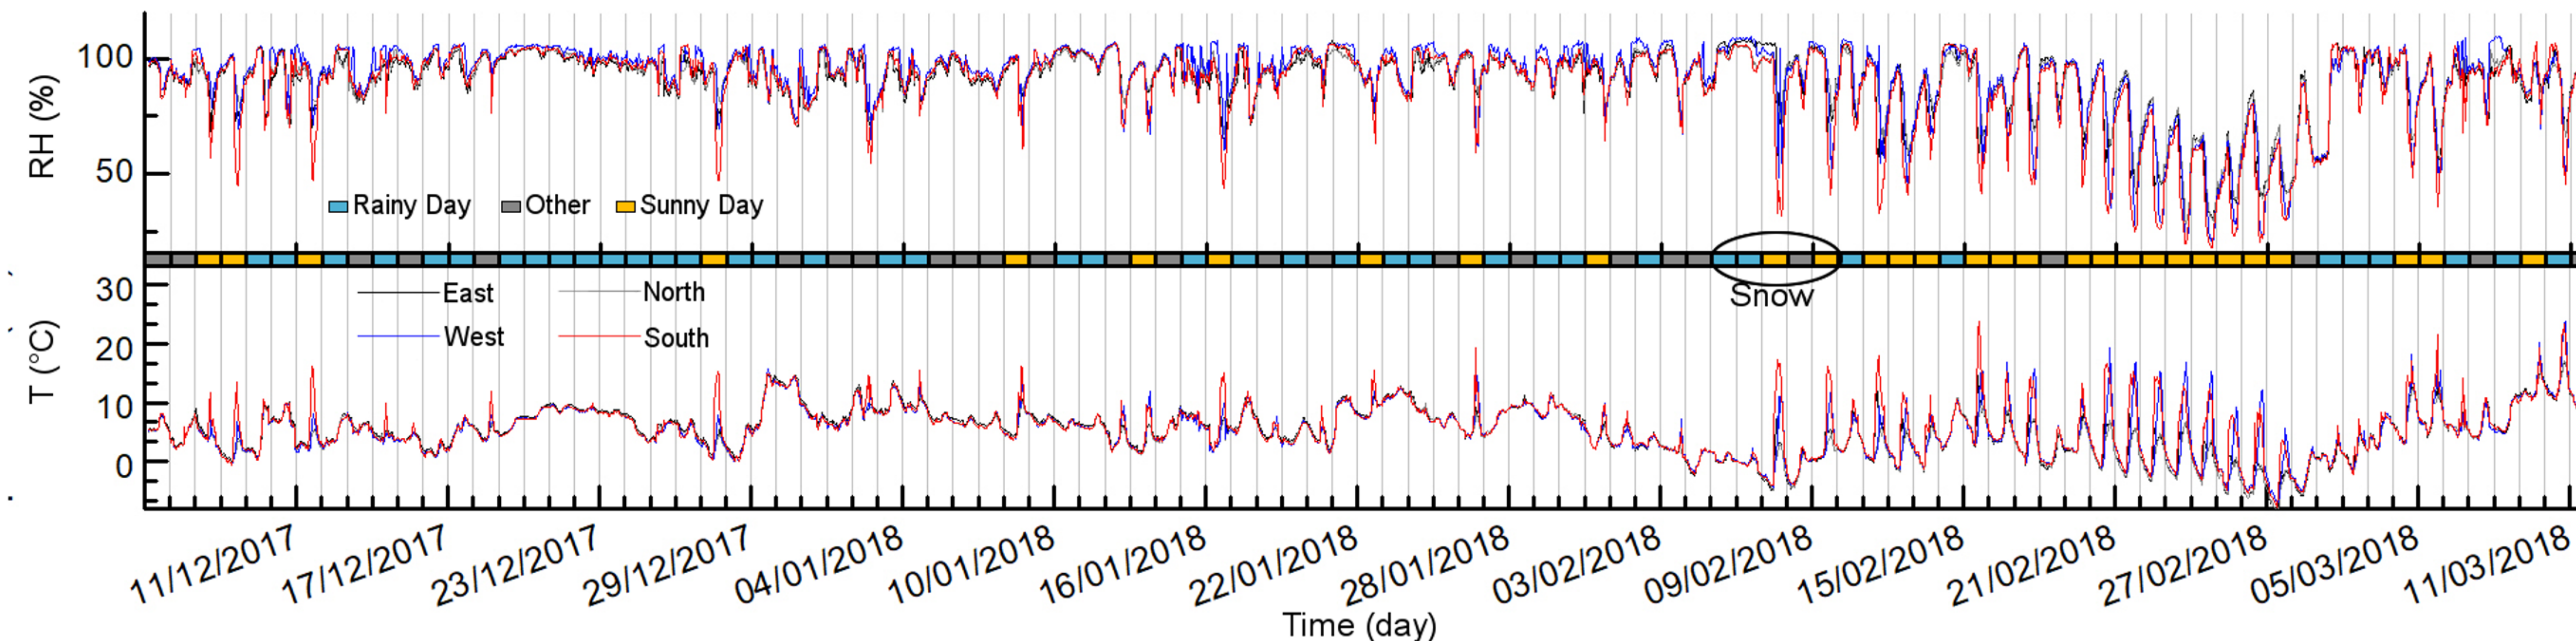
Relative Humidity (RH) and Temperature (T) evolution of the upper level of the south tower in the 4 directions through time.

**Recording:** 1 measurement per hour since December 2017.

**2 types of variation of temperature and humidity:**

- with the **daily cycle**: up to 20,5°C and 67% humidity on the **South** façade. Recording throughout the year will allow to identify **seasonal cycles** as well.
- with the **orientation**: up to 14°C and 39% humidity between **South** and **North**.

Façades facing **South** and **West** present the largest temperature increase and humidity decrease.

These results are also valid for the lower level of the South tower and for the North tower.

**Modelling of the Basilica's environment during winter:**

- categorization of days : **30 sunny**, **41 rainy**, **26 other**.
- possible freeze-thaw cycles (from the 21th to the 28th February).

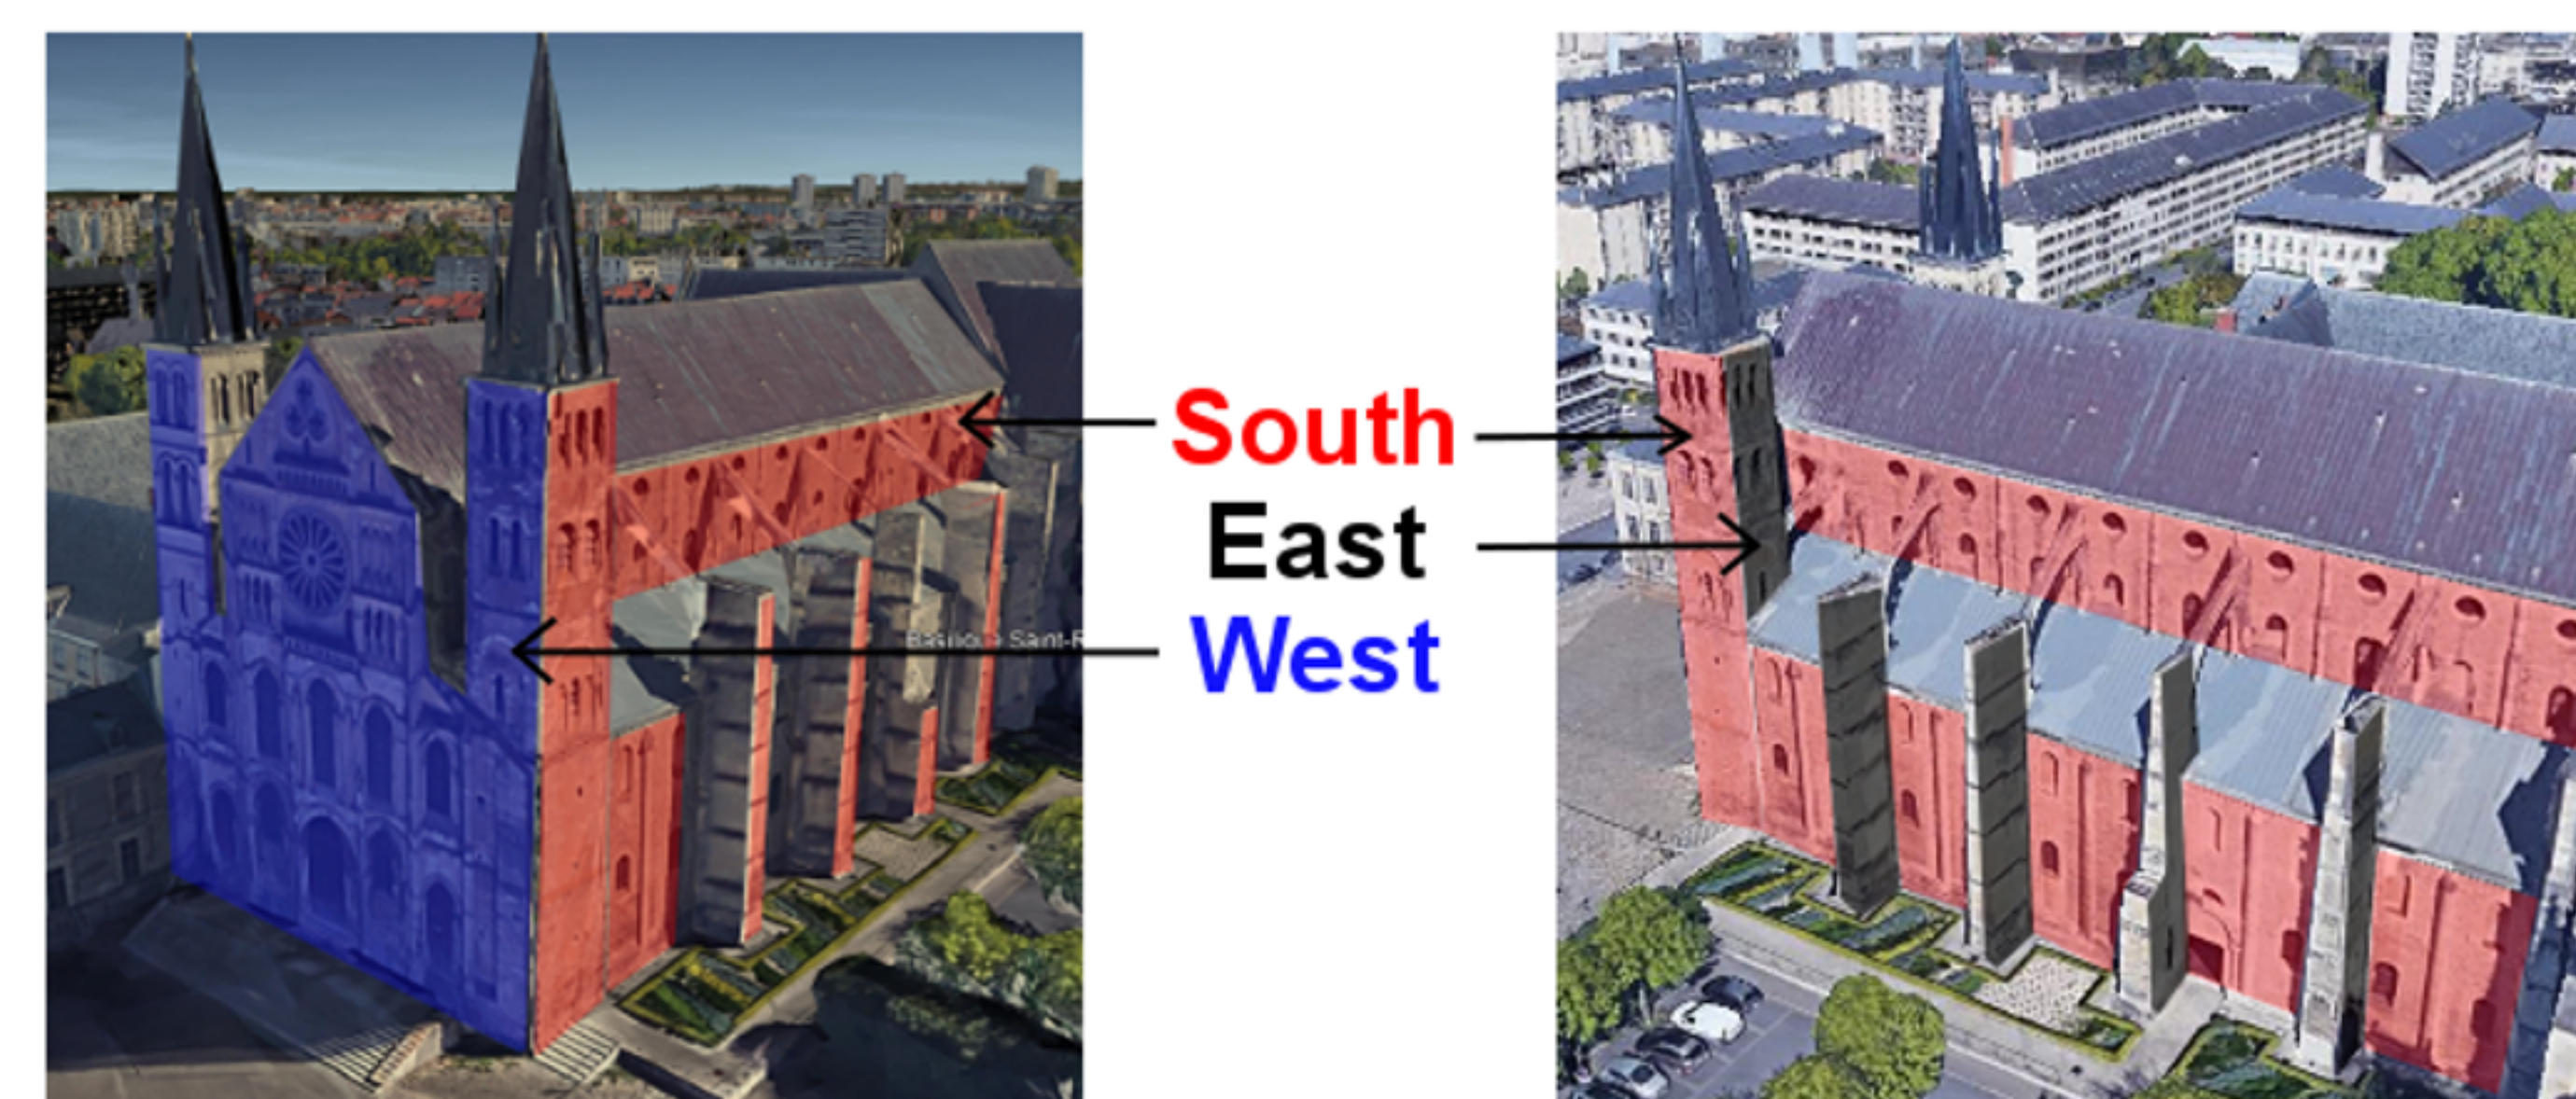
Façades orientation of the Basilica (Google Earth view).

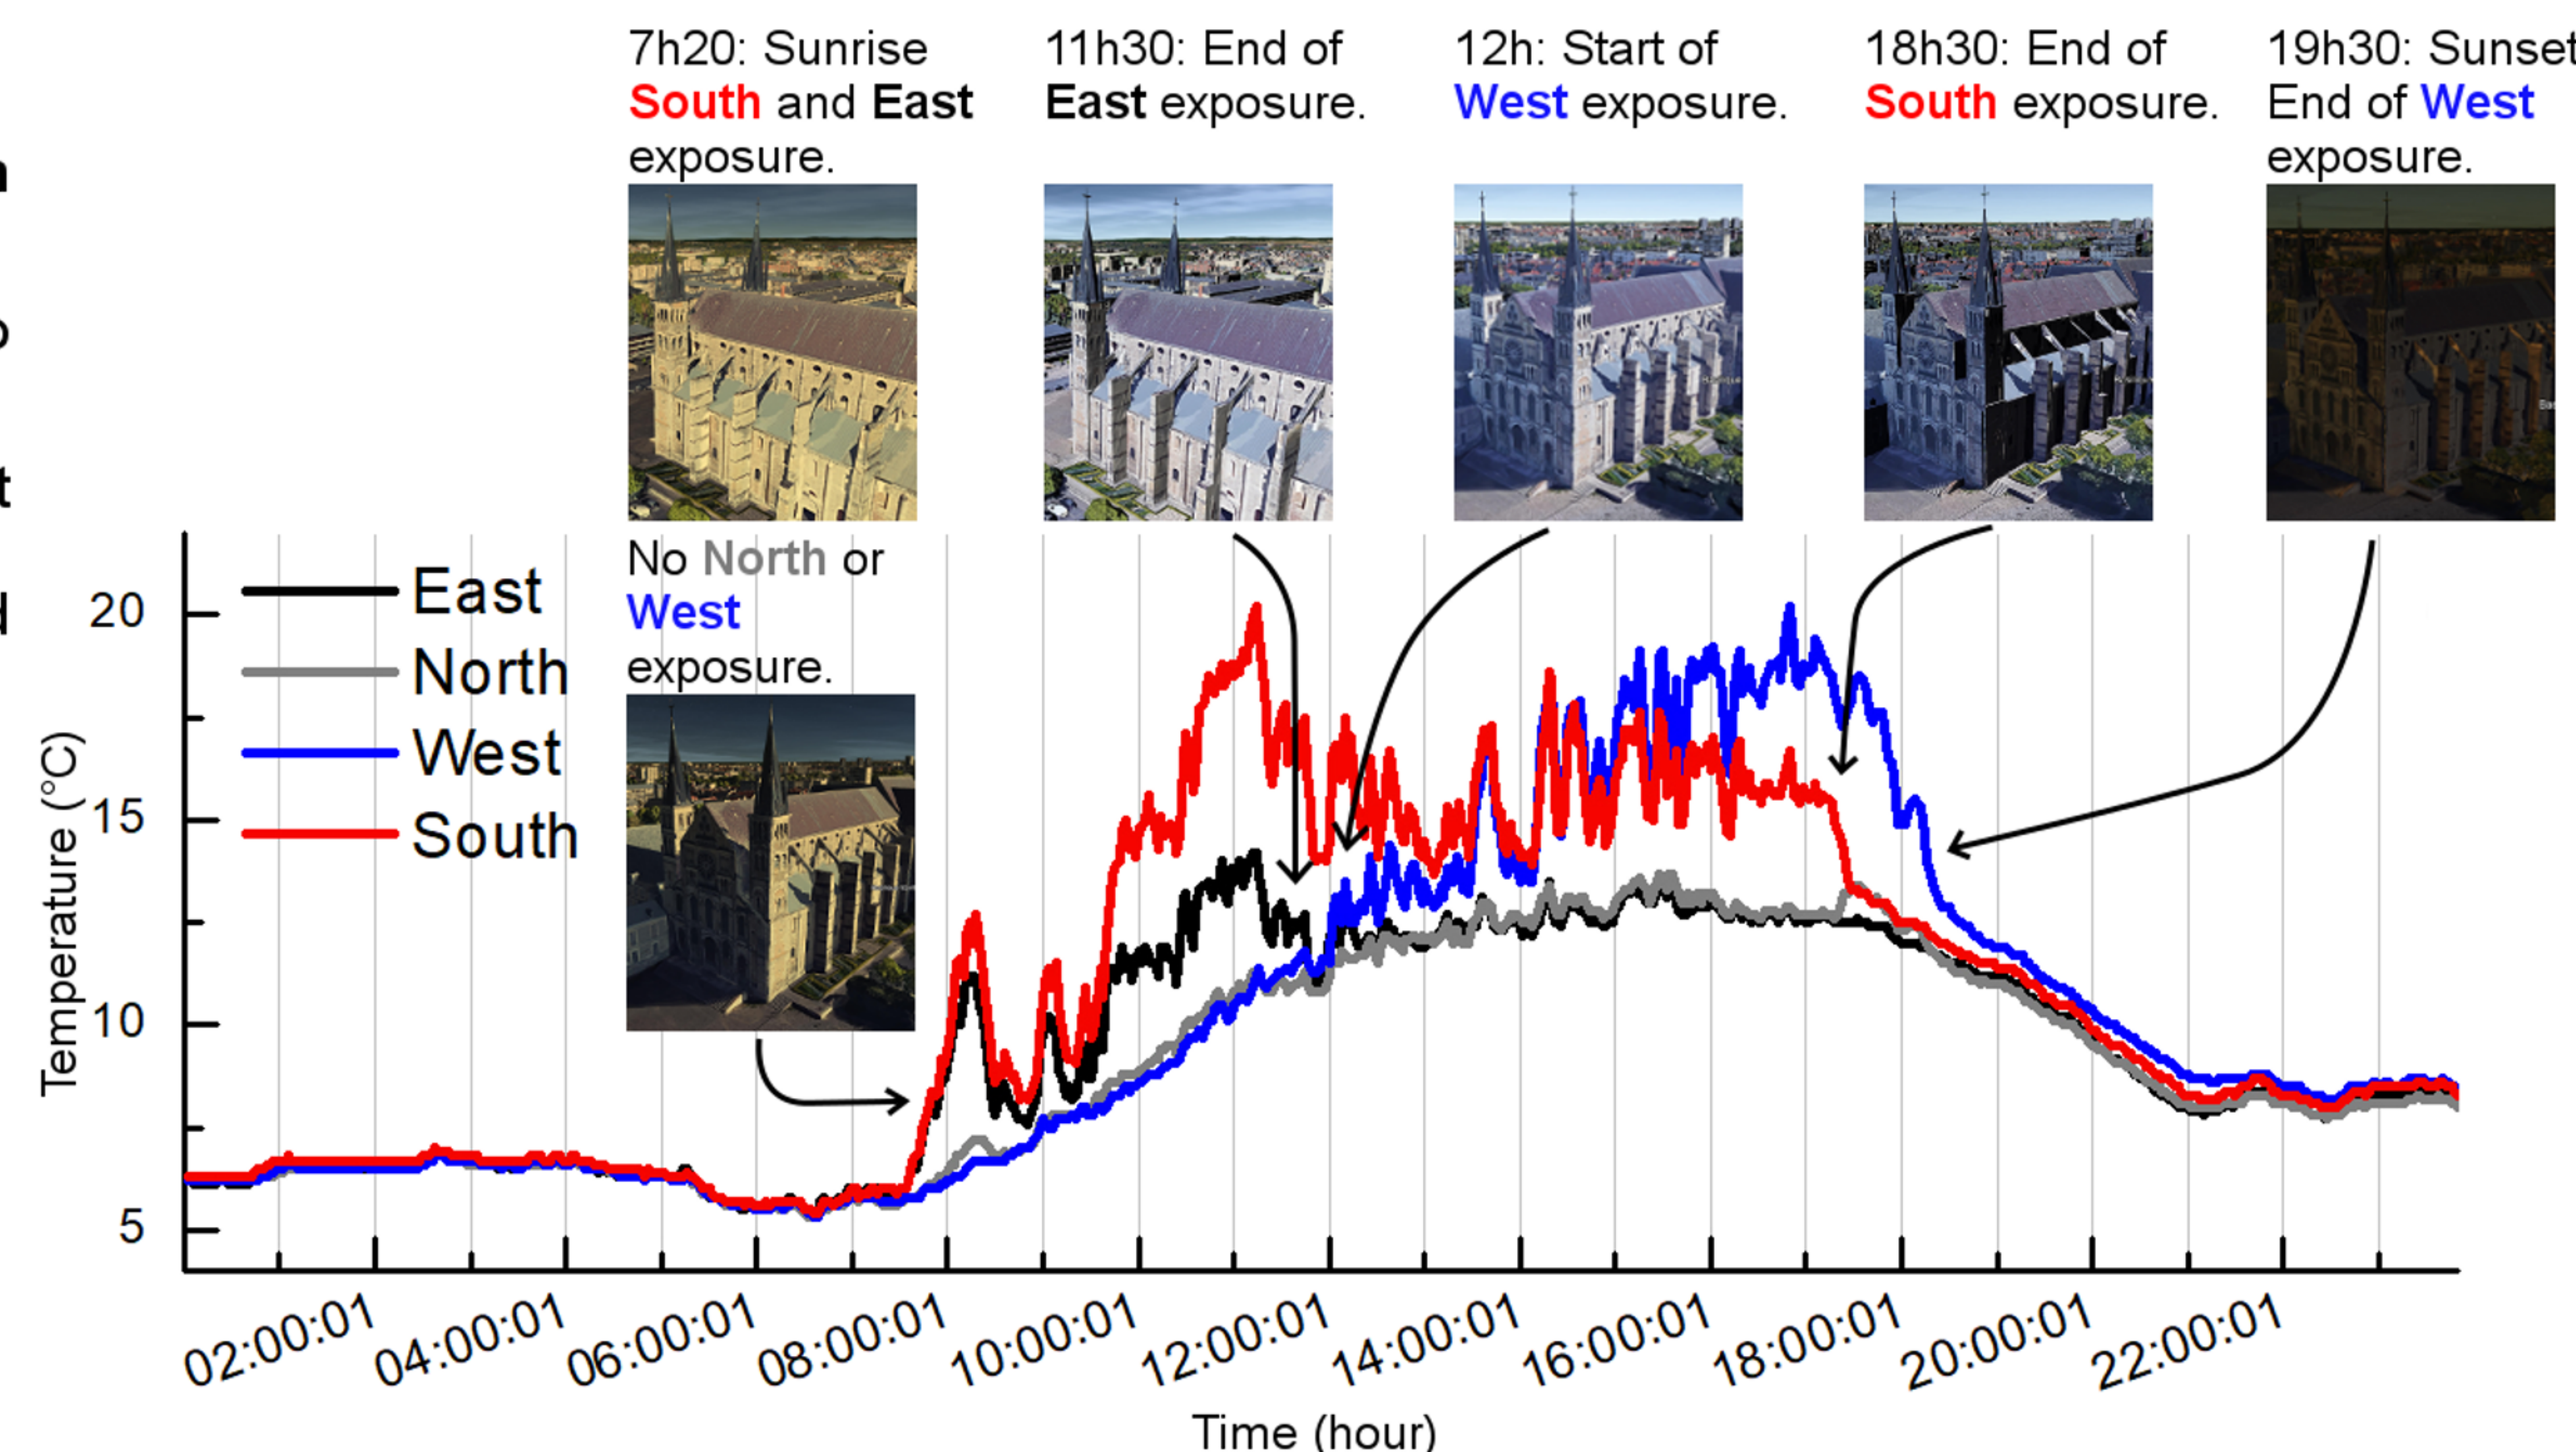
**Recording:** every 2 minutes during one day.

Temperature variations are linked to the **façade sun exposure** throughout the day.

Low rate of temperature variation: **below 1°C/min**. No thermal shock.

Observation of **short cycles of temperature**: short variations of a few degrees, duration of **5 to 40 minutes**.

They are due to quick changes in the environment like cloud cover or windspeed.

These variations also impact humidity to a lesser extent.

Temperature evolution of the upper level of the south tower in the 4 directions through time - Google Earth view.

**Micro-climates** were identified on the Basilica:

- Façades exposed to the sun: **South**, East-morning and **West**-afternoon.

↳ Higher temperatures, short and daily cycles of variations of temperature and humidity.  
⇒ More thermal fatigue and wetting/drying cycles.

- **North** and other shadowed façades during the day.

↳ Higher relative humidity, daily cycles and less intense short cycles.  
⇒ More sensible to frost weathering.

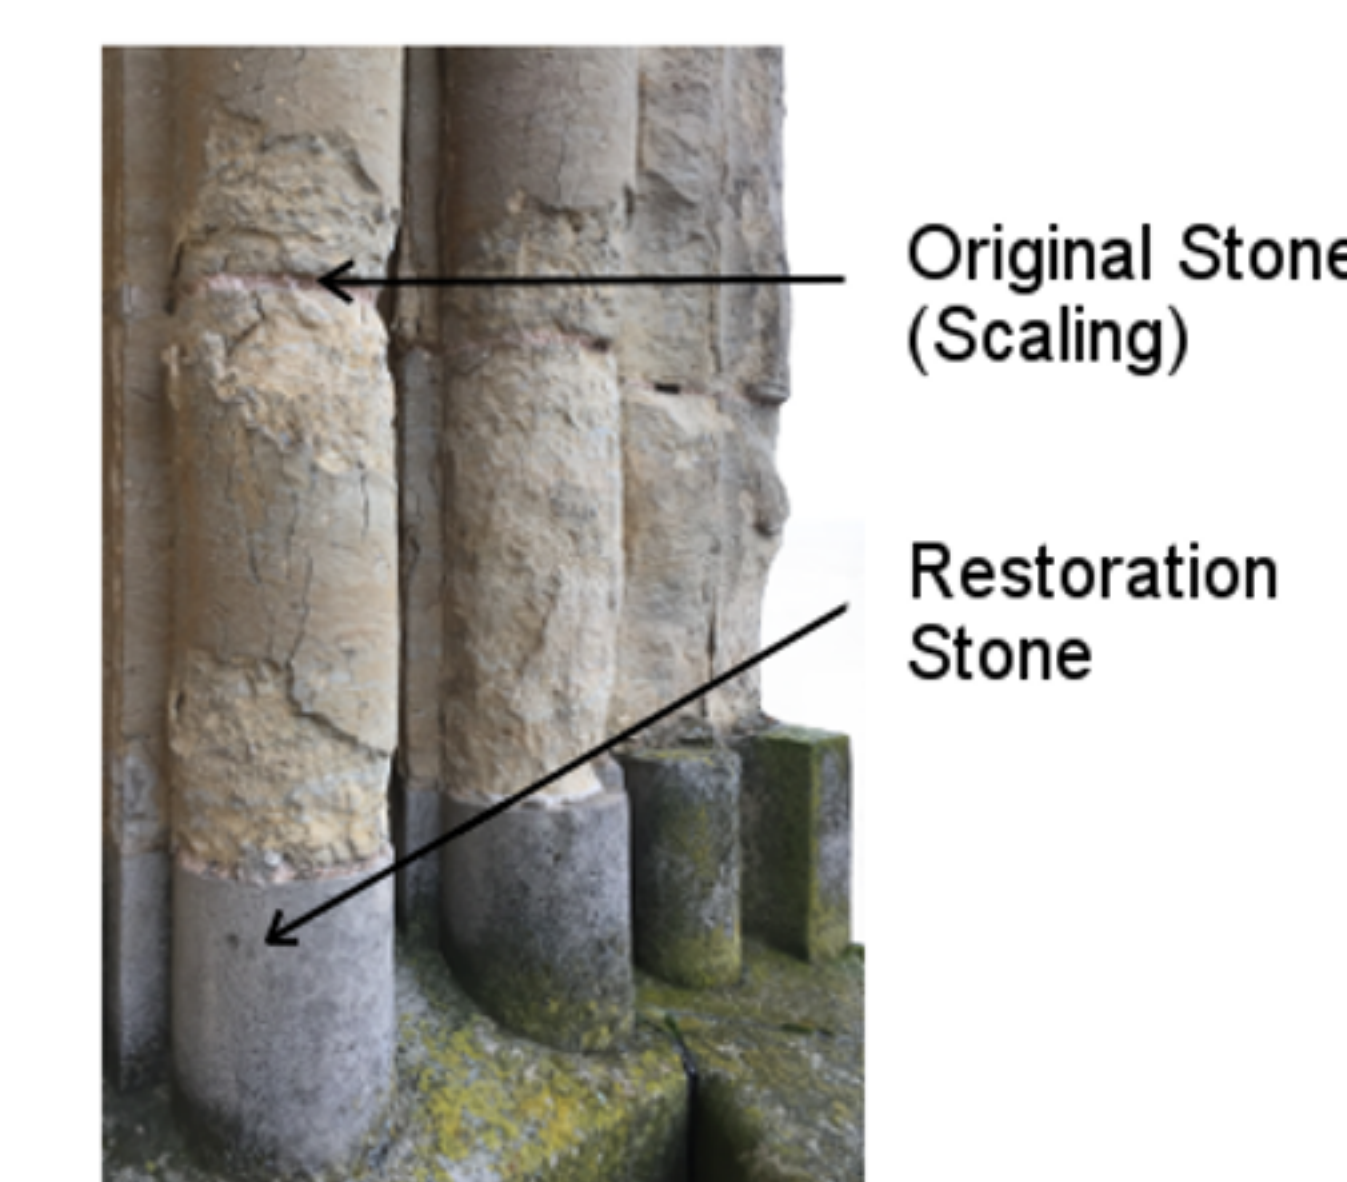
Picture of weathered and restoration stones on the Basilica.
