Bartlomiej Sawicki, Antoine Bassil, Eugen Bruhwiler, Xavier Chapeleau,
Dominique Leduc

Detection and Measurement of Matrix Discontinuities in UHPFRC by Means of Distributed Fiber Optics Sensing

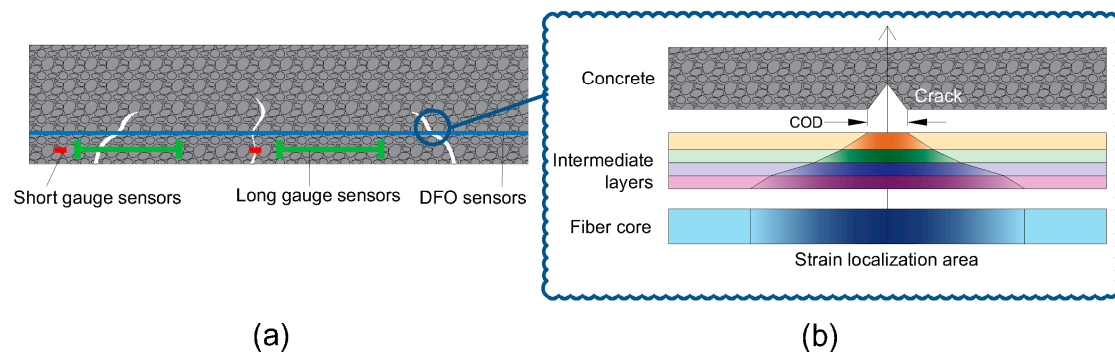
Figure 1. Crack detection in concrete using Distributed Fiber Optics sensing techniques; (a) comparison to traditional sensors, (b) strain transferring between layers.

The DFOs techniques can be used not only to measure strains but also to detect, localize and measure cracks of small openings. DFO sensors allow achieving of an accurate, reliable and quasi real-time crack detection and characterization in concrete structures. They contributed to the detection and localization of cracks in the massive structures, showing supremacy over the short and long gauge sensors (Figure 1a). Actually, any type of discontinuity in the host material, like a crack, can cause a strain localization propagating through the optical fiber layers up to the core of the optical fiber (Figure 1b).

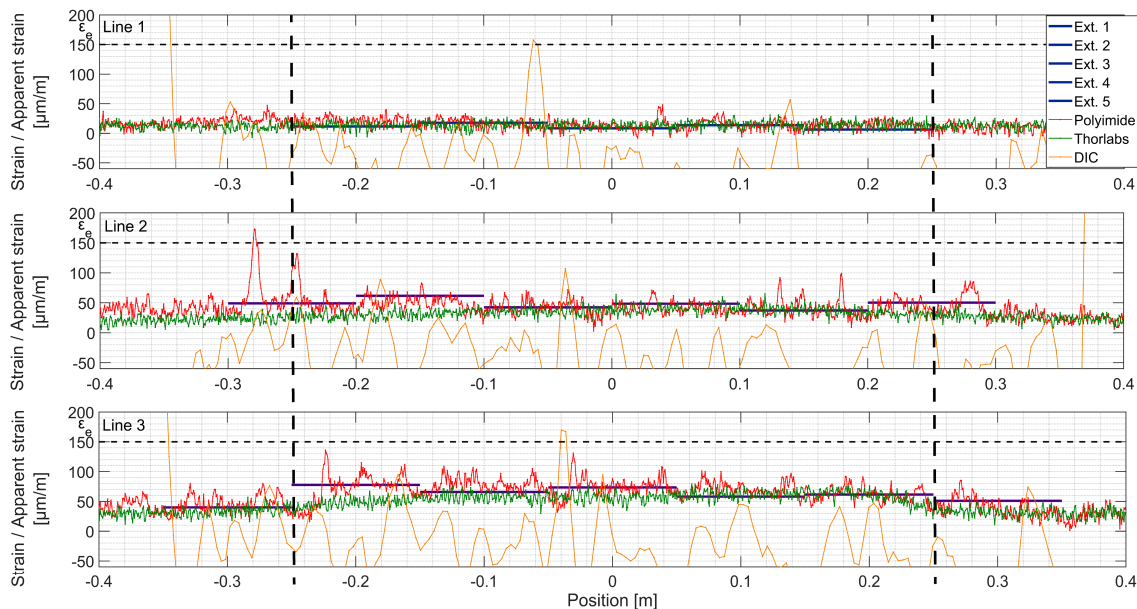
Figure 10. Strains measured with different techniques, load step 1, $F = 20$ kN; the constant bending moment zone is marked with dashed lines.

At load step 1 (LS 1), all systems, except DIC, show good agreement (Figure 10). The strain spatial distribution can be considered as uniform in the constant bending moment zone, between ± 0.25 m from the midspan. The material remains elastic and the structural response is linear. In the bottom line (Line 3), local variations of modulus of elasticity can be visible with extensometers and Polyimide, but not with Thorlabs fiber. Possibly, initial microcracks appear. Two strain peaks are visible at Line 2 position -0.25 m. Apparently, there is a local defect of the UHPFRC material there, possibly due to the fabrication of the beam. It can be considered as a disturbance on the surface, since other measurement techniques do not record it.

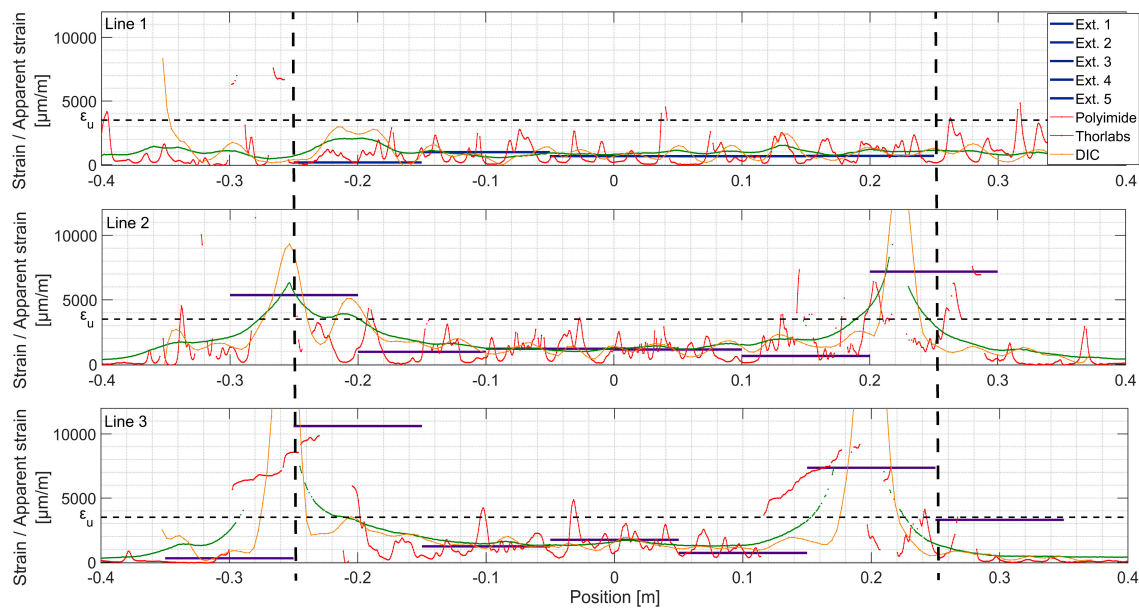
Figure 14. Strains measured with different techniques, load step 5, $F = 205$ kN; the constant bending moment zone is marked with dashed lines.

At LS 5 (Figure 14), both fictitious cracks are clearly formed in Line 3, and UHPFRC is in the softening stage. The DFOs do not work properly in their vicinity anymore. The transversal skewness of fictitious Crack No. 1 can be seen, since the peak of DIC is shifted with respect to the extensometers. Interestingly, it is positioned some 7 cm towards the left regarding the previously observed strain concentration. For both Lines 2 and 3, the clear exponential shapes can be noticed in Thorlabs fiber measurements, but with multiple dropouts. While comparing the measurement Line 1 at the current load step with Line 2 and Line 3 at LS 3, it can be concluded that microcracking is more uniformly spaced for the lines positioned higher on the beam. The reasons might be the nonuniformity of fiber dispersion and discontinuity of strains, both due to the rebar alignment. At this load step, the fictitious cracks are clearly visible to the naked eye, and UHPFRC is in the softening stage (see Figure 9d). The stress transferred by bridging fibers is lower than f_u (see Figure 4), and stress in the neighboring material decreases. Thus, the strain measured at midspan is similar for all the measurement lines.
