Structural health of polymer composites: Non-destructive diagnosis using a hybrid NDT approach

Structural health of polymer composites: non-destructive diagnosis using a hybrid NDT approach

A hybrid non-destructive testing (NDT) approach has been developed to characterize composites damage using simultaneously bulk and guided ultrasonic waves, acoustic emission, and passive and active infrared thermography. Combining multiple NDT techniques makes it possible to optimize the diagnosis of a material's structural health.

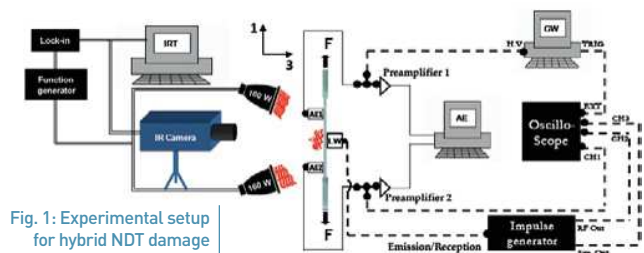
Figure 1 shows the experimental setup including the five NDT measurements in situ and in real-time. Three piezoelectric probes were fixed to the composite sample, named AE1 and AE2 for the two iden-

tical acoustic emission (AE) sensors (125-750 kHz), and longitudinal waves (LW) for the bulk pulse-echo longitudinal wave transducer (5 MHz frequency and 13-mm diameter) placed for a normal beam incidence on the other face of the sample. For acoustic emission, the acquisition threshold of the acoustic events was fixed at 30 dB in order to avoid surrounding noises. The AE1 probe also acts as an emitter, when excited by a high-voltage function generator, in order to generate guided waves (GW), namely the S0 mode, at a frequency of 200 kHz, with the AE2 probe ensuring the reception of the GW. An IR camera (320x240 pixels with a temperature sensitivity of 10 mK) was

Fig. 1: Experimental setup for hybrid NDT damage monitoring

placed in front of the specimen in order to measure its surface temperature in real-time during the mechanical loading (passive thermography, hereafter abbreviated IRT-p) as well as during the heating of the sample by two halogen lamps (320 W, with a three-cycle sinusoidal signal of 0.1 Hz), and then during its cooling (active thermography, hereafter abbreviated IRT-a).

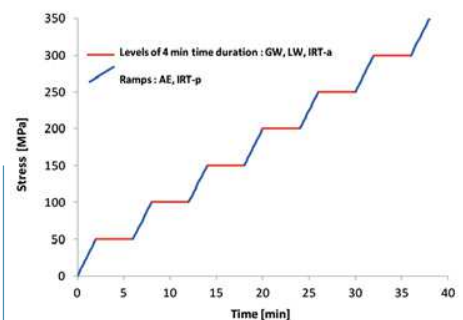
Fig. 2: Step-wise mechanical loading profile with the corresponding NDT techniques implemented during stress ramps or levels

The mechanical loading was applied at room temperature with a cross-head speed of 0.5 mm/min using a standard tensile machine according to the loading profile shown in Figure 2, which consists in a step-wise tensile test of 50 MPa each time (7 ramps and 6 levels of 4 min duration). The thermal scene (specimen under loading, lamps and IR camera) was isolated from the external environment using an opaque and insulating curtain. During the ramps, the AE and passive thermal activity of the composite specimen were acquired in real-time by, respectively, the AE1-AE2 sensors and the IR camera. The GW, LW and IRT-a measurements were applied sequentially (GW before LW, then IRT-a to avoid potential harmful interference) during the constant stress levels and before the first ramp. The sample cooling phase under constant stress, for 125 s after heating by the lamps, was monitored by the infrared camera and the cooling rate was measured for each constant applied stress.

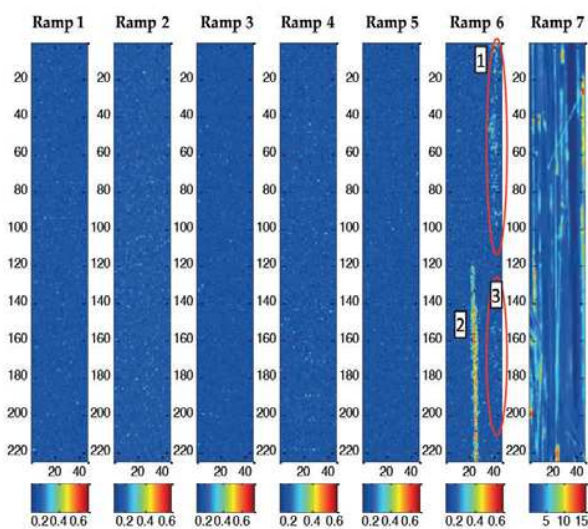
Glass fibre-reinforced plastics are not very heat-dissipative under static tensile loading (see Figure 3). During the first five loading ramps, almost no damage was detected on the thermal maps, which were uniform over the entire surface of the specimen. During the 6th ramp, three damaged areas were identified, labelled 1, 2 and 3 on the corresponding thermal map. Both areas 1 and 3 were rather large and diffused heat for a long time (over 102 seconds), while area 2 was thin with very brief heat diffusion (flash lighting for about 4 seconds). The two damaged zones 1 and 3 may be ascribed to localized delamination between the 0° and 90° plies, whereas the longitudinal damaged zone

Fig. 3: Thermal maps under the applied tensile stress ramps

2 corresponds to a fibre/matrix debonding area located on the 0° ply on the rear face of the specimen. During the 7th ramp, the final failure of the specimen gave rise to a very high heat emission.

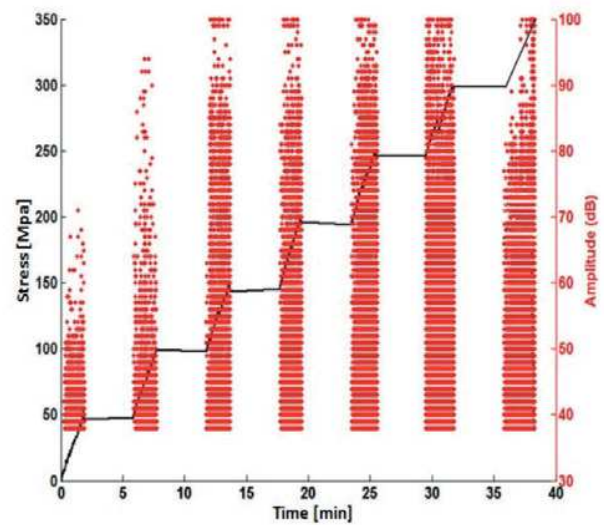
Fig. 4: Acoustic emission amplitude under the applied tensile stress ramps

The acoustic activity during the applied stress ramps is illustrated in Figure 4 in terms of amplitude vs time. Once loading started, the acoustic emission began with low amplitudes (38 to 50 dB) and gradually became denser and higher as the load increased. The growth of the acoustic emission events in terms of quantity and amplitude indicates that the damage induced in the material was heterogeneous, including different mechanisms such as matrix cracking, fibre/matrix debonding, delamination and fibre rupture [12].

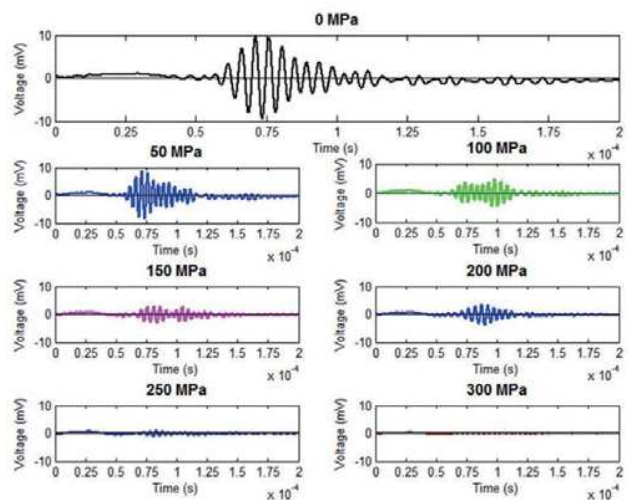
The guided wave signals (S0 Lamb mode) are shown in Figure 5 for stress-free conditions and for the six applied stress levels. The signal amplitudes decrease sharply and continually until the transmitted ultrasonic energy at the highest stress level totally disappears. This amplitude decrease is due to the damage induced in the material, result-

Fig. 5: Guided waves during the applied tensile stress levels

ing in multiple scatters that certainly weaken the signals. A global characterization of the material damage and its quantitative monitoring under different mechanical loading further requires the calculation of certain damage indicators.

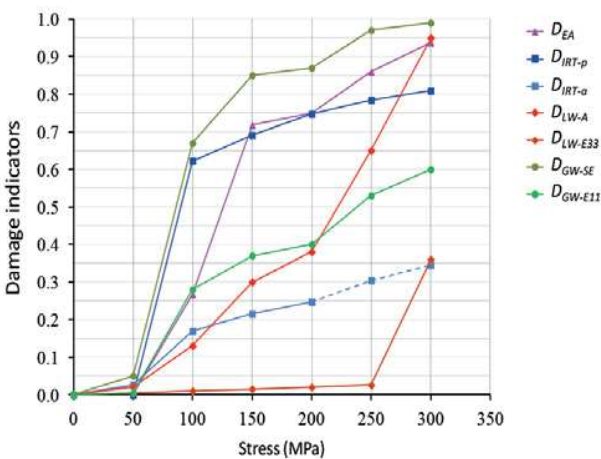
Figure 6 shows the evolution of the previously defined damage indicators versus applied stresses. Each damage indicator value corresponds to the mean of five measurements obtained on five samples with a maximum standard deviation of 1%. These damage indicator evolutions indicate the damage initiation from the same stress value (50 MPa), which can be considered as a damage threshold of the tested material. They also indicate that damage increases as the stress increases, but with different sensitivities, which are due to the anisotropic and multi-scale features of the induced damage.

Fig. 6: Evolution of the damage indicators versus applied stresses

Actually, the GW used in the axial direction is more sensitive to the damage that occurs parallel to the loading direction. This axial dam-

age was evaluated by measuring both the variations of the spectrum energy (D^{GW-SE}) and the axial elastic modulus (D^{GW-E11}), which reach respectively 100% and 60% at the material failure. The LW propagating in the through-thickness direction examines the material perpendicularly to the loading direction, where the variation due to the elastic constant (E_{33}) versus the applied stress is very small [12]. Therefore, this small variation may not reflect the real extent of the induced damage. However, the measured attenuation of the LW in the thickness direction becomes increasingly higher as the stress increases. This attenuation could be due to multiple reflections of the ultrasonic beam with the discontinuities created in the material, which grow more and more as the stress increases. Therefore, the defined damage indicator, D^{LW-A} associated with the maximum back-wall amplitude variation of the LW, allows a more realistic evaluation of the damage induced in the thickness direction.

On the other hand, the AE sensors can detect signals coming from any direction and take into account all damage mechanisms from the microscopic (matrix cracking, matrix/fibre debonding, fibre breakage) to the macroscopic (delamination) scale. These are the reasons why the associated damage indicator (D^{AE}) is higher.

At last, the thermography measurements are exploited differently when compared with previous conventional analyses (based on thermal images or temperature variation curves). Concerning passive thermography, the thermoelastic coefficient (K) is measured as well as its variation for each applied stress interval of 50 MPa up to failure. The associated damage indicator (D^{IRT-p}) increases continuously when the stress increases. Concerning the active infrared thermography measurement, the associated damage indicator (D^{IRT-a}) also increases continuously when the stress level increases. This means that the material cools more and more quickly when the damage increases.
