Conference Paper · August 2019

STRUCTURAL HEALTH MONITORING OF SMART POLYMER-MATRIX COMPOSITE DURING CYCLIC LOADING USING AN IN-SITU PIEZOELECTRIC SENSOR

Keywords: Polymer-matrix composites, In-situ piezoelectric sensor, Structural health monitoring, Smart materials

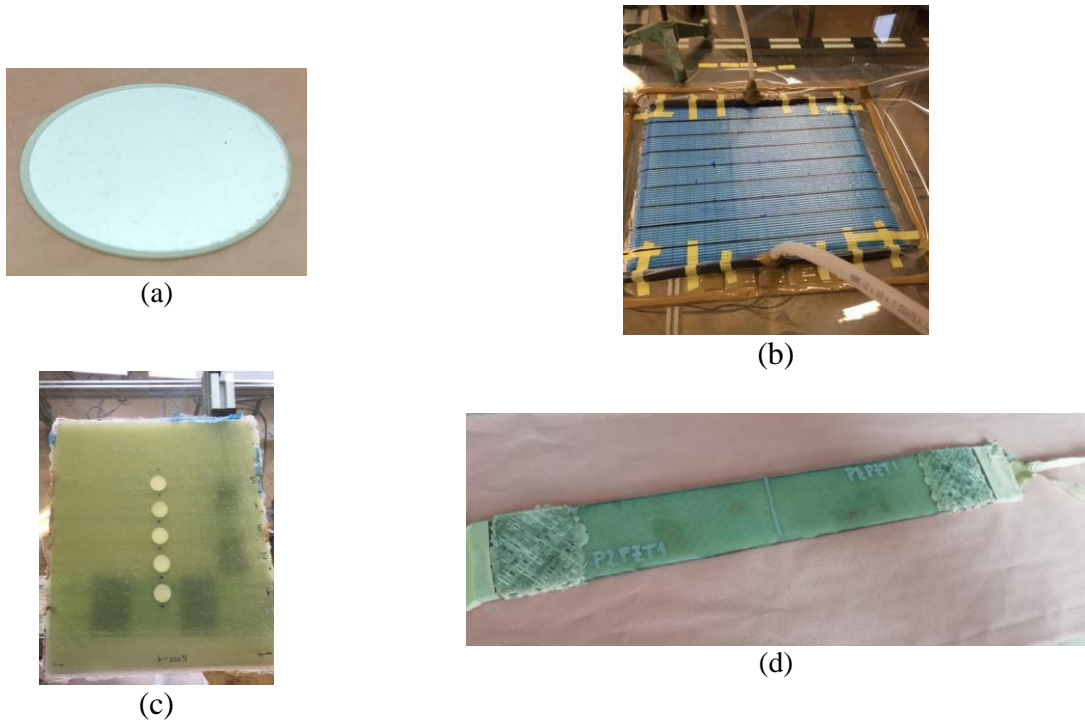
Figure 1: (a) PZT disc – (b) Manufacturing of one plate using LRI – (c) one obtained plate, with 5 embedded PZTs – (d) one “smart” sample with glued PMC heels and isolated exiting wires

Piezoceramic PZT disks (Wealthland) with 25mm diameter and 0.135mm in thickness (Fig. 1 a) are used in this study. After testing their static capacitance with a digital multimeter (Keithley DMM7510), they were embedded in the middle plane of a 2/2 twill glass fiber preform (symmetric and balanced stacking) composed of 22 plies. Their electrical connection was realized using tinned copper wires of 210 μ m in diameter. Manufacturing of the “smart” plates, containing 5 PZT each is then performed using LRI manufacturing (Fig. 1 b), injecting an unsaturated polyester resin (Norester 822 Infusion) mixed with 2.5% wt hardener (Methyl Ethyl Ketone Peroxide MEKP, Butanox M50) through the dry preform. The resulting plates (Fig. 1 c) were unmolded and cut into samples of 300mm*40mm*5mm, each one containing 1 PZT sensor located in its mass center. Four PMC heels were then glued on the four ends of each sample, using bi-components Araldite 2015 A/B glue. One of the resulting tensile specimen is shown on Fig. 1 d.

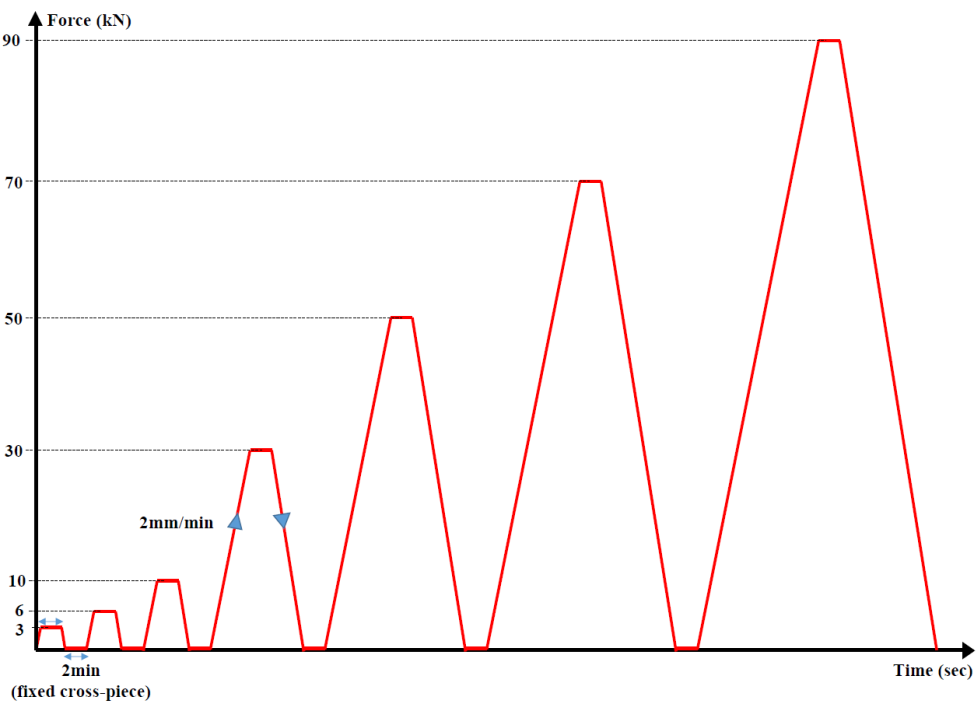
Figure 2: Schematic representation of the mechanical loading profile

Cyclic (unloading-bear-loading) incremental tensile-tensile tests are conducted on the embedded samples, acquiring in-situ PZT electrical capacitance in real-time using the digital multimeter. During these tests (loading scheme in Fig. 2), samples are also surrounded by several ex-situ NDT systems: 2 S-DIC systems composed of 2 high resolution Pike cameras each (VIC3D software), one system focused on a face of the sample and the other on its thickness, and two wideband AE sensors PAC Micro80 (200-900 kHz, amplitude threshold = 35dB). The positioning of the whole multi-instrumentation is presented on Fig. 3. Results are presented and discussed in the next section.

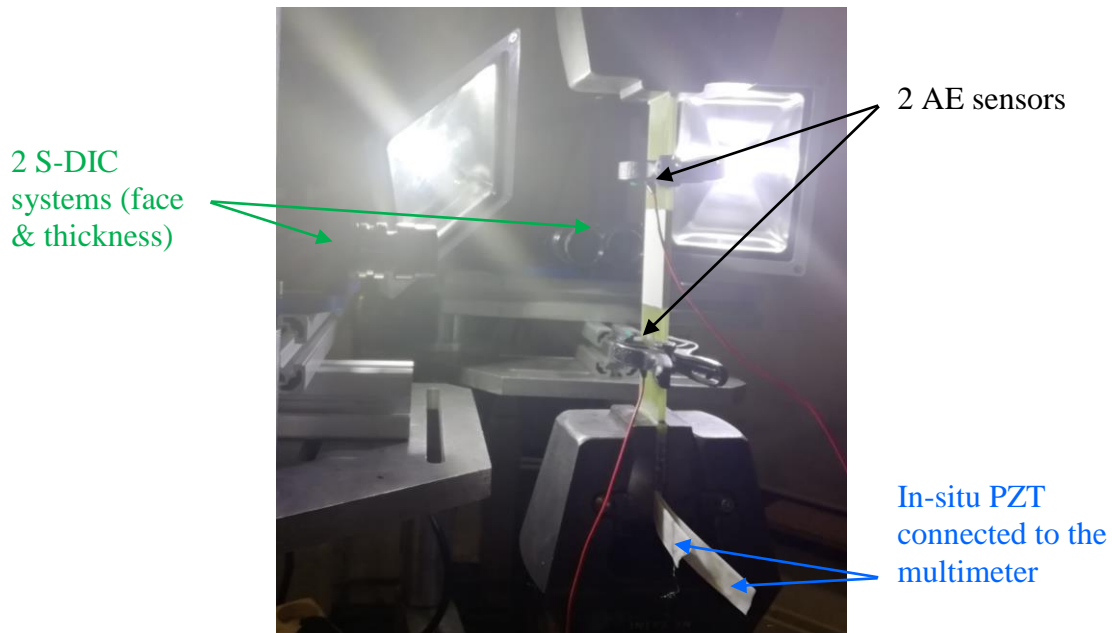
Figure 3: The multi-instrumented test

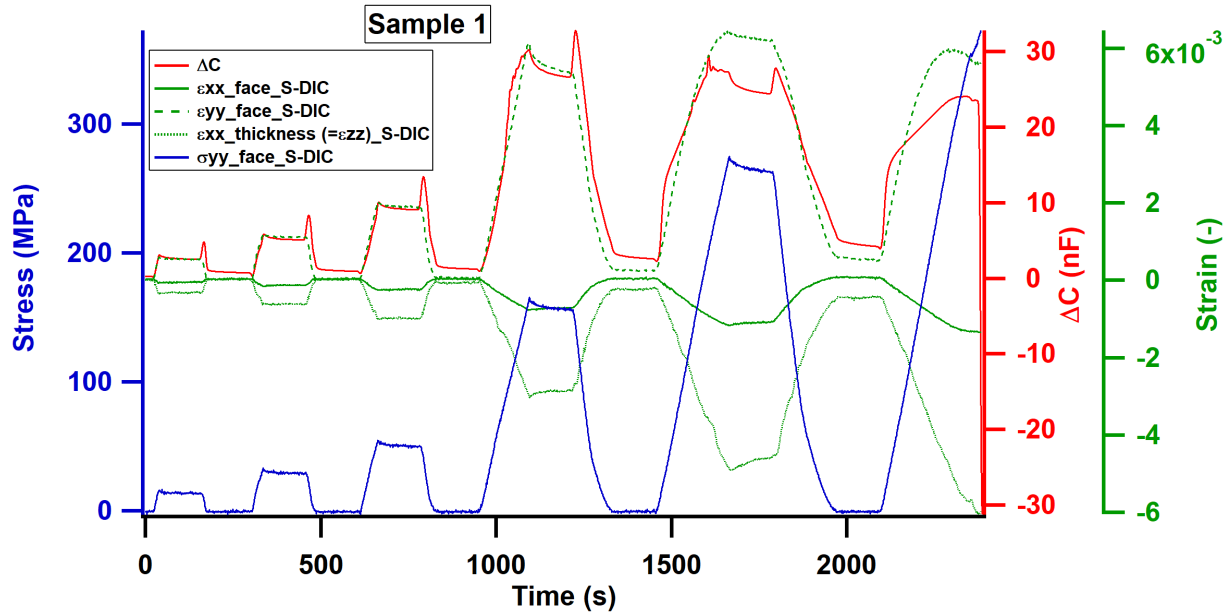
Figure 4 : Results for the multi-instrumented cyclic test performed on Sample 1

Fig. 4 exposes the obtained results for the “smart” Sample 1. It is important to point out that the strain curves have been computed on the whole speckled zones (face & thickness), this zone (60mm in length) ‘containing’ the embedded PZT transducer area. One can notice that the in-situ PZT electrical capacitance (ΔC) follows well each load-bearing-unload cycle. This behavior is linked to the fact that constraining more or less a piezoelectric material in its environment induces variations of its electrical capacitance [25]. This statement can be correlated to the S-DIC measurements, as it can be seen that the negative ε_{xx} (strain along sample width) and ε_{zz} (strain along sample thickness) are contributing to a Poisson’s effect in both these directions. Looking closer at the capacitance curve, some special tendencies can be extracted from it. First, ΔC progressively recedes from zero during unloading phases, as loading cycles go by and increase. The main hypothesis explaining this behavior is that as loading becomes higher and higher, the charge phases create and enlarge the walls of a cavity inside which the PZT is inserted, this cavity being created in the first place due to PZT/composite interfacial shear. As these walls enlarge themselves, bringing them closer to each other during each progressive unloading step becomes more and more difficult. The PZT becoming thus less and less compressed at the end of each unloading cycle compared to its initial state, it explains the drift as compression induces capacitance decrease. A second interesting point is the progressive change in ΔC slopes (both increasing and decreasing ones) and amplitudes as loading cycles go by. One can also notice other kinds of capacitance slope variations, these ones occurring during a loading step and start from the 5th block to the end of the test. All these variations and changes could advise on damage initiation and progression when confronted to AE data (such as signals amplitude, energy or time of occurrence and signals location & labeling) and SDIC information (stress and strain maps & curves computed in precise spots of the sample) taken at the same time. A last thing to observe is the presence of spikes of ΔC framing each loading plateau, which are still under investigation. However, one remarkable thing about these spikes is that the ones framing the left sides of the bearings only appear from the 4th block, the following block starting to have a capacitance slope change during its loading phase: this phenomenon could also be an information carrier about damage initiation, and will be coupled with S-DIC and AE data for deepening.
