STRUCTURAL HEALTH MONITORING OF SMART POLYMER-MATRIX COMPOSITE DURING CYCLIC LOADING USING AN IN-SITU PIEZOELECTRIC SENSOR

C. Tuloup^{1*}, W. Harizi¹, Z. Aboura¹ and Y. Meyer^{1,2}

Keywords: Polymer-matrix composites, In-situ piezoelectric sensor, Structural health monitoring, Smart materials

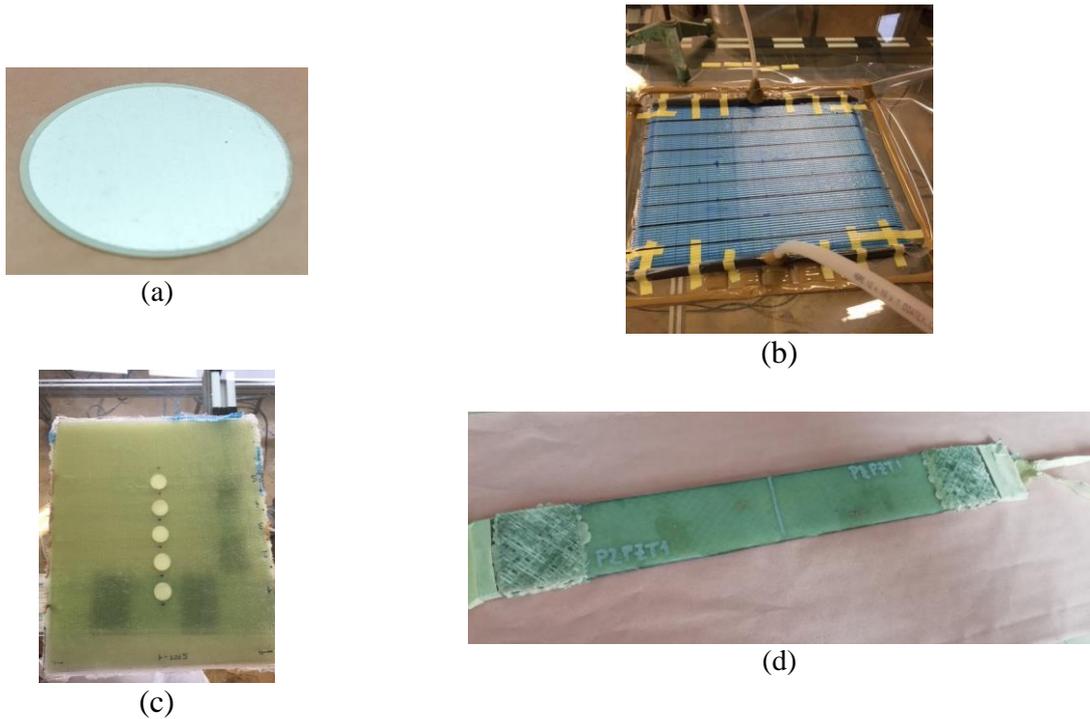
Figure 1: (a) PZT disc – (b) Manufacturing of one plate using LRI – (c) one obtained plate, with 5 embedded PZTs – (d) one “smart” sample with glued PMC heels and isolated exiting wires

Piezoceramic PZT disks (Wealthland) with 25mm diameter and 0.135mm in thickness (Fig. 1 a) are used in this study. After testing their static capacitance with a digital multimeter (Keithley DMM7510), they were embedded in the middle plane of a 2/2 twill glass fiber preform (symmetric and balanced stacking) composed of 22 plies. Their electrical connection was realized using tinned copper wires of 210 μ m in diameter. Manufacturing of the “smart” plates, containing 5 PZT each is then performed using LRI manufacturing (Fig. 1 b), injecting an unsaturated polyester resin (Norester 822 Infusion) mixed with 2.5% wt hardener (Methyl Ethyl Ketone Peroxide MEKP, Butanox M50) through the dry preform. The resulting plates (Fig. 1 c) were unmolded and cut into samples of 300mm*40mm*5mm, each one containing 1 PZT sensor located in its mass center. Four PMC heels were then glued on the four ends of each sample, using bi-components Araldite 2015 A/B glue. One of the resulting tensile specimen is shown on Fig. 1 d.

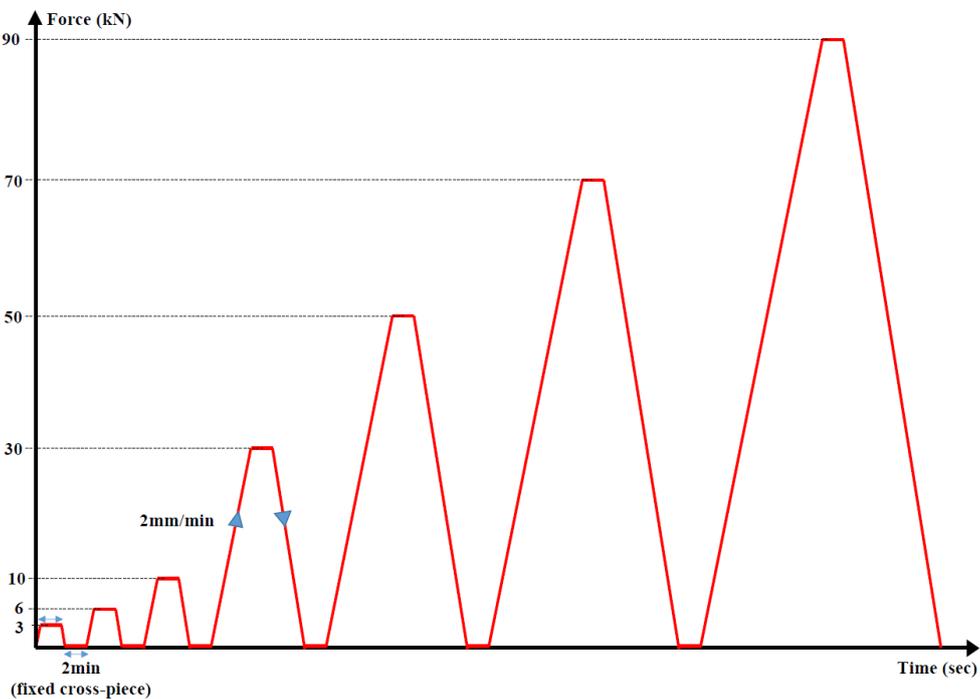
Figure 2: Schematic representation of the mechanical loading profile

Cyclic (unloading-bear-loading) incremental tensile-tensile tests are conducted on the embedded samples, acquiring in-situ PZT electrical capacitance in real-time using the digital multimeter. During these tests (loading scheme in Fig. 2), samples are also surrounded by several ex-situ NDT systems: 2 S-DIC systems composed of 2 high resolution Pike cameras each (VIC3D software), one system focused on a face of the sample and the other on its thickness, and two wideband AE sensors PAC Micro80 (200-900 kHz, amplitude threshold = 35dB). The positioning of the whole multi-instrumentation is presented on Fig. 3. Results are presented and discussed in the next section.

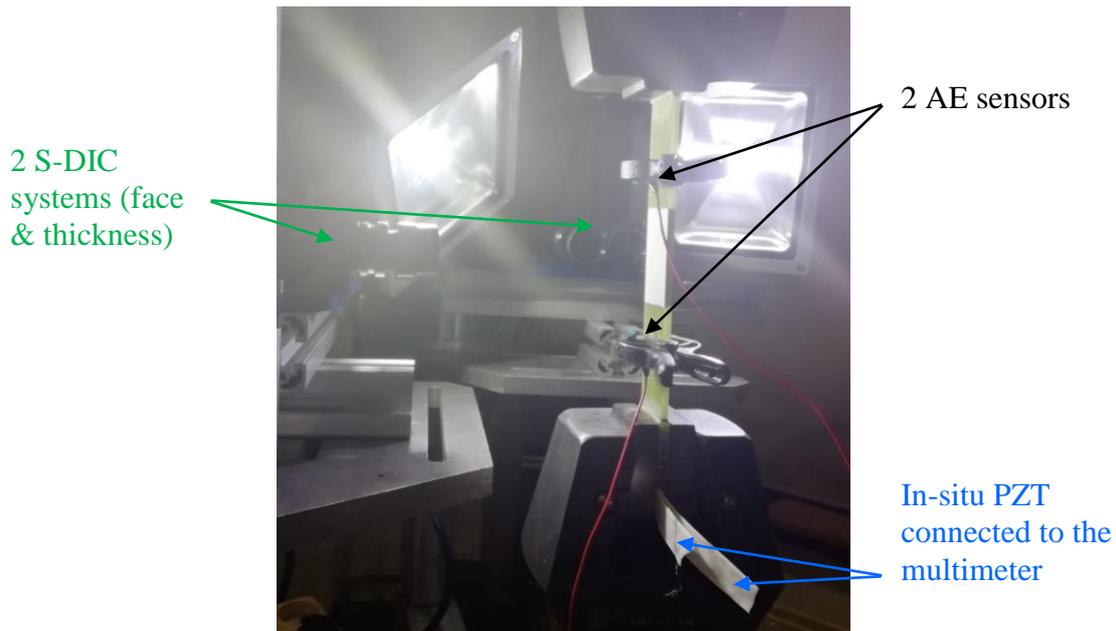
Figure 3: The multi-instrumented test

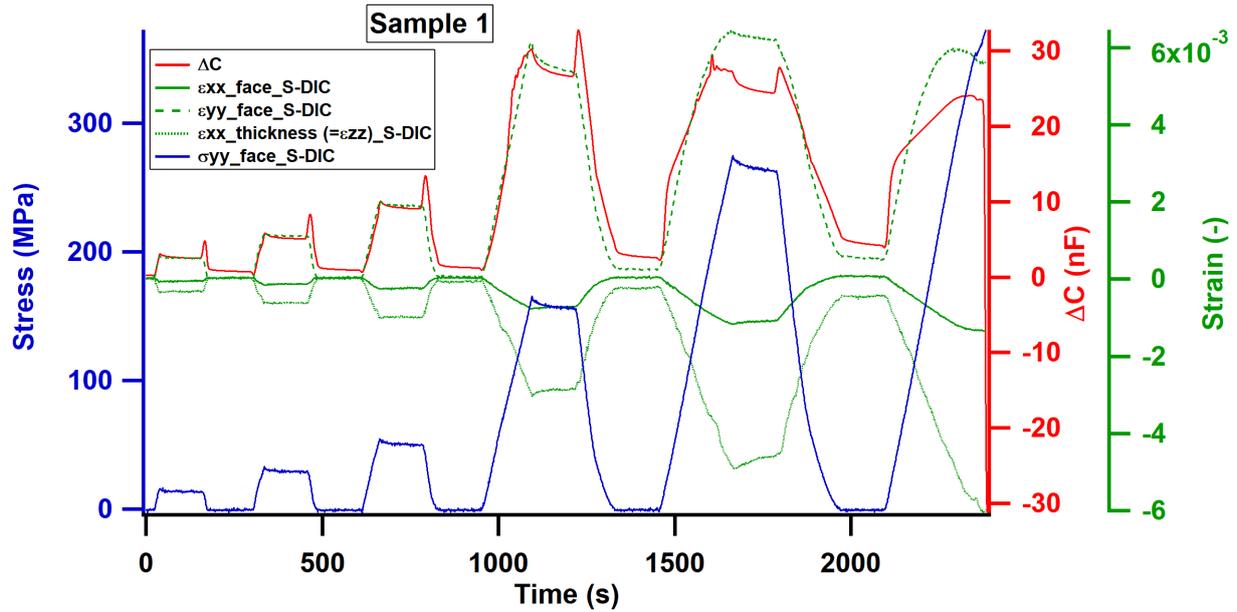
Figure 4 : Results for the multi-instrumented cyclic test performed on Sample 1

Fig. 4 exposes the obtained results for the “smart” Sample 1. It is important to point out that the strain curves have been computed on the whole speckled zones (face & thickness), this zone (60mm in length) ‘containing’ the embedded PZT transducer area. One can notice that the in-situ PZT electrical capacitance (ΔC) follows well each load-bearing-unload cycle. This behavior is linked to the fact that constraining more or less a piezoelectric material in its environment induces variations of its electrical capacitance [25]. This statement can be correlated to the S-DIC measurements, as it can be seen that the negative ε_{xx} (strain along sample width) and ε_{zz} (strain along sample thickness) are contributing to a Poisson’s effect in both these directions. Looking closer at the capacitance curve, some special tendencies can be extracted from it. First, ΔC progressively recedes from zero during unloading phases, as loading cycles go by and increase. The main hypothesis explaining this behavior is that as loading becomes higher and higher, the charge phases create and enlarge the walls of a cavity inside which the PZT is inserted, this cavity being created in the first place due to PZT/composite interfacial shear. As these walls enlarge themselves, bringing them closer to each other during each progressive unloading step becomes more and more difficult. The PZT becoming thus less and less compressed at the end of each unloading cycle compared to its initial state, it explains the drift as compression induces capacitance decrease. A second interesting point is the progressive change in ΔC slopes (both increasing and decreasing ones) and amplitudes as loading cycles go by. One can also notice other kinds of capacitance slope variations, these ones occurring during a loading step and start from the 5th block to the end of the test. All these variations and changes could advise on damage initiation and progression when confronted to AE data (such as signals amplitude, energy or time of occurrence and signals location & labeling) and SDIC information (stress and strain maps & curves computed in precise spots of the sample) taken at the same time. A last thing to observe is the presence of spikes of ΔC framing each loading plateau, which are still under investigation. However, one remarkable thing about these spikes is that the ones framing the left sides of the bearings only appear from the 4th block, the following block starting to have a capacitance slope change during its loading phase: this phenomenon could also be an information carrier about damage initiation, and will be coupled with S-DIC and AE data for deepening.
