Fatigue Strengthening of Steel Bridges with Adhesively Bonded CFRP Laminates: Case Study

Journal of Composites for construction, ASCE, 24, 3 (2020)
[https://doi.org/10.1061/\(ASCE\)CC.1943-5614.0001014](https://doi.org/10.1061/(ASCE)CC.1943-5614.0001014)

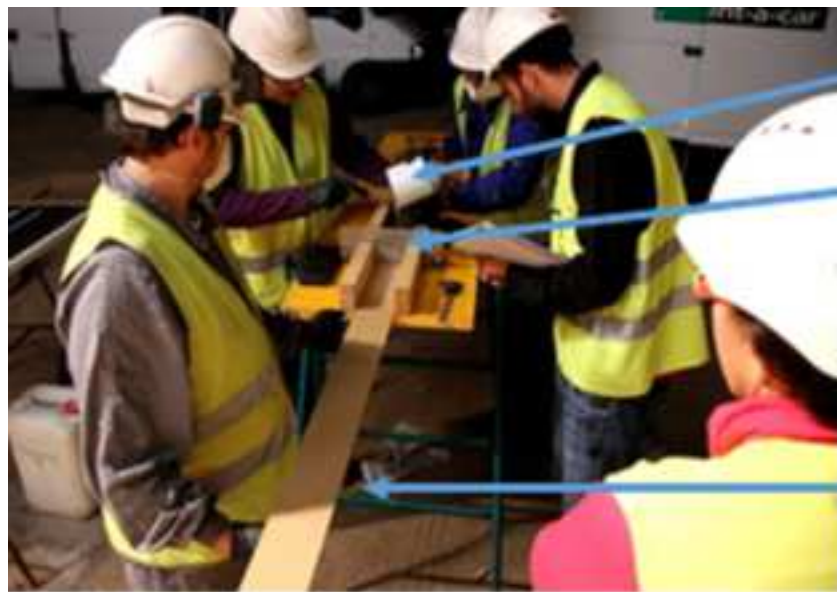
a)

Adhesive application

Roller to apply pressure

CFRP plate

316 In the case of the Jarama Bridge, it was decided to retrofit the bottom flange of the girders which are in
317 tension and therefore susceptible to fatigue cycles. Since the CFRP plates are to be installed underneath
318 the girders, it was necessary to use a fixation system that would be able to keep the plates in place during
319 the curing and hardening of the adhesive. First, the adhesive mix was applied directly to the surface of
320 the CFRP plate after removal of the peel-ply. To spread the adhesive uniformly, a device similar to a
321 trowel with a v-notch was used (Figure 6a). In the case of the multi-layer configurations, the
322 prefabrication option was selected. Previously, at the workshop or on-site, the layers were attached to
323 each other in the predefined arrangement, and pressure was then applied with small rollers to ensure all
324 air bubbles or gaps were removed (Figure 6b). The CFRP plate with the adhesive on one side must be

325 pressed into the steel starting from one end and gradually moving towards the other to allow air to
326 escape. A laminate roller was used from the center of the plate towards the ends to remove as much air
327 as possible and ensure good contact between the CFRP, adhesive and steel substrate. The excess resin
328 that escaped during pressing was removed, leaving a 45° fillet as recommended in Schnerch et al. (2007).
329 Care was taken to ensure that not too much adhesive would be pressed out from the joint at the plate

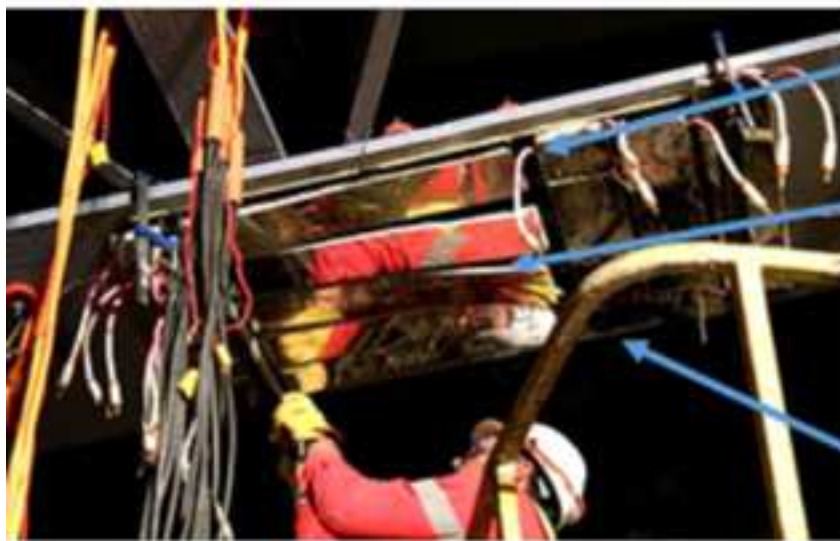
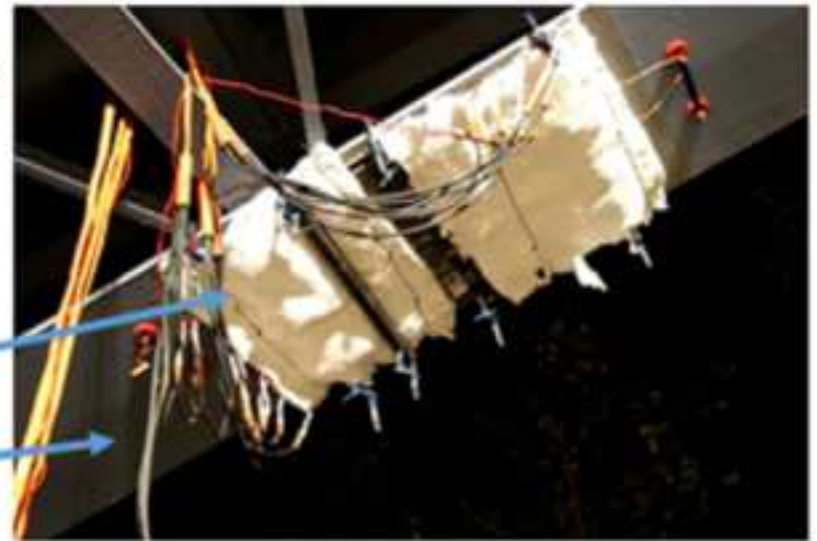
Adhesively bonded CFRP

Heating pads

Insulation

Steel structure

334 As described in Chataigner et al. (2018), a post-curing of the system is needed (one hour at 80 °C) in
335 order for the adhesive's glass transition temperature to reach the required value of 71 °C without losing
336 properties. Ceramic pads were used to transfer the heat to the system to reach the target curing
337 temperature of 80 °C and maintain it constant during the curing time (one hour). The ceramic pads were
338 placed to completely cover the surface of the CFRP plates (Figure 7). Thermocouples were installed on
339 the steel surface close to the CFRP plates and were used to control the curing temperature. Isolation
340 blankets were also used to reduce heat loss, maintain the required temperature inside the system, and
341 improve energy efficiency. The post-curing process started a minimum of two hours after installation of
342 the CFRP plates.

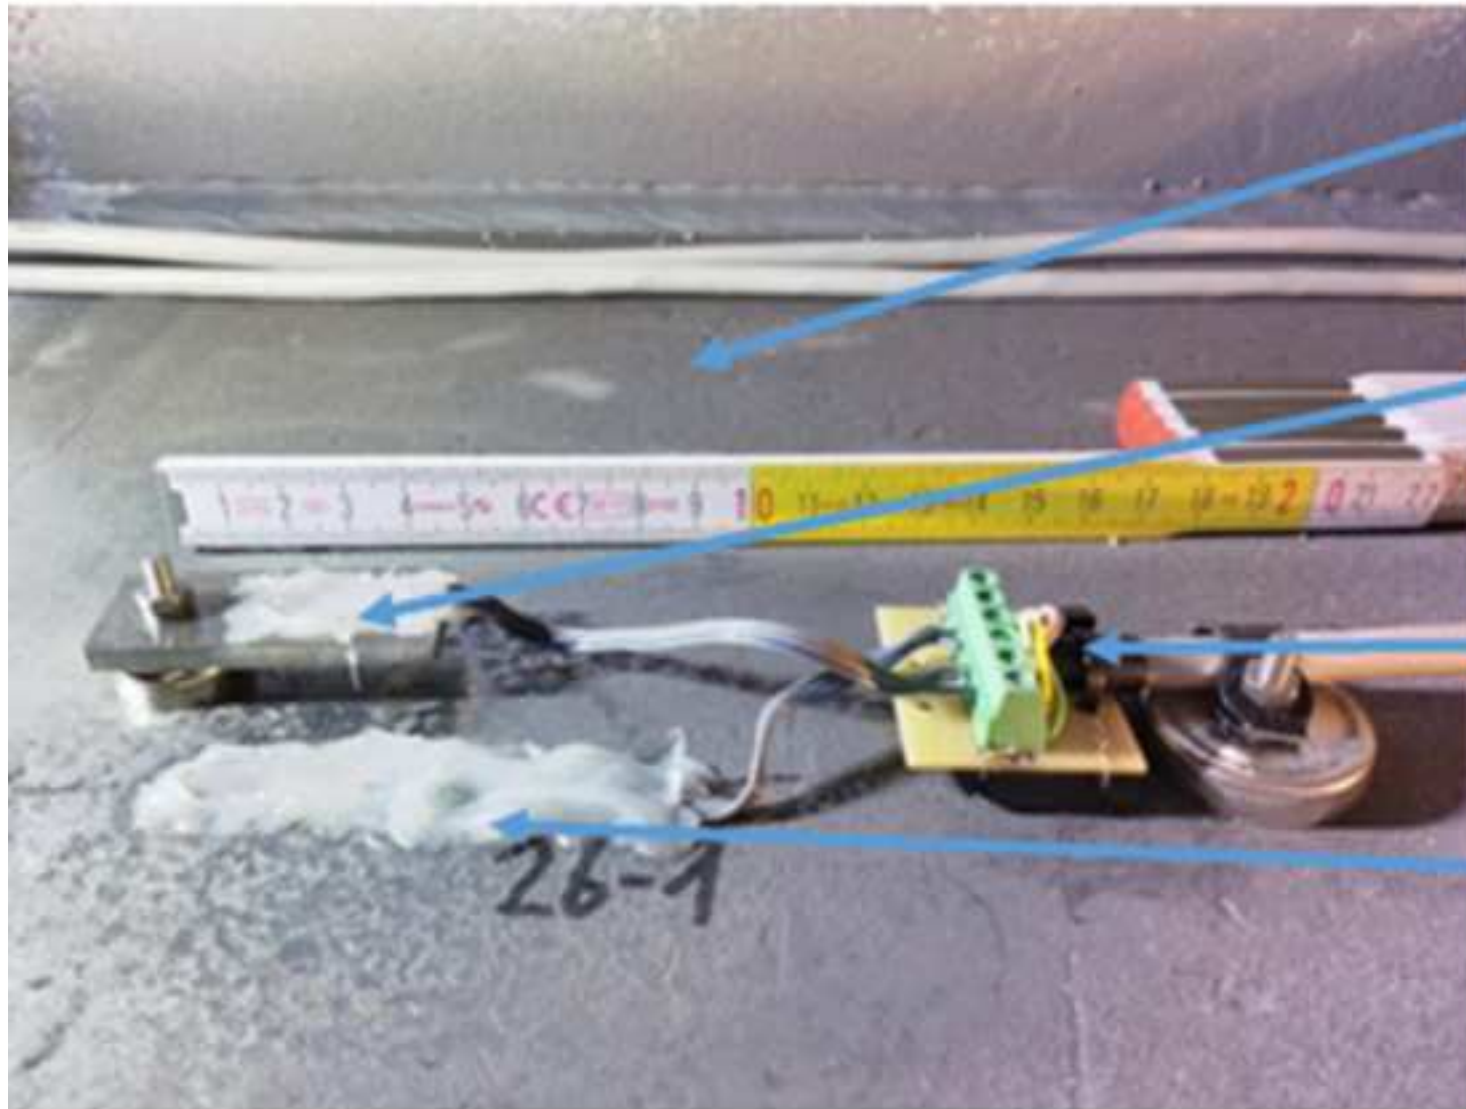
*Steel
bottom
flange*

*Temperature
compensation*

*Connection to
acquisition*

*Strain
measurement*

Before applying the reinforcement, electro-mechanic strain gauges were installed at the six studied locations. For each location, four strain gauges were installed on top of the bottom flange in the longitudinal direction. A first pair of strain gauges was installed 80 mm from the studied butt weld. One of the gauges was bonded to the flange, while the second was bonded to a separate piece of metal to compensate for temperature effects due to a half-bridge circuit (Figure 8). The second pair was installed 950 mm from the studied butt weld, outside of the reinforced zone. The denomination of the strain gauges in the rest of the article will be X-1 and X-2, corresponding respectively to the first axial strain at 80 mm from the studied weld and the second axial strain at 950 mm from the studied weld, and X corresponding the weld number. The strain gauges received a silicone protective cover to shield them from adventitious mechanical interaction (i.e. impact, bump) during the strengthening intervention. An HBM Spider8 data acquisition system with a 200 Hz measurement rate was used, which allowed the simultaneous recording of all 12 half-bridge circuits. All strain data were recorded with reference to the bridge state without traffic loads (“differential strain”). “Positive” strains correspond to additional tension, while “negative” strains correspond to reduced tension in the girders with respect to the initial condition.

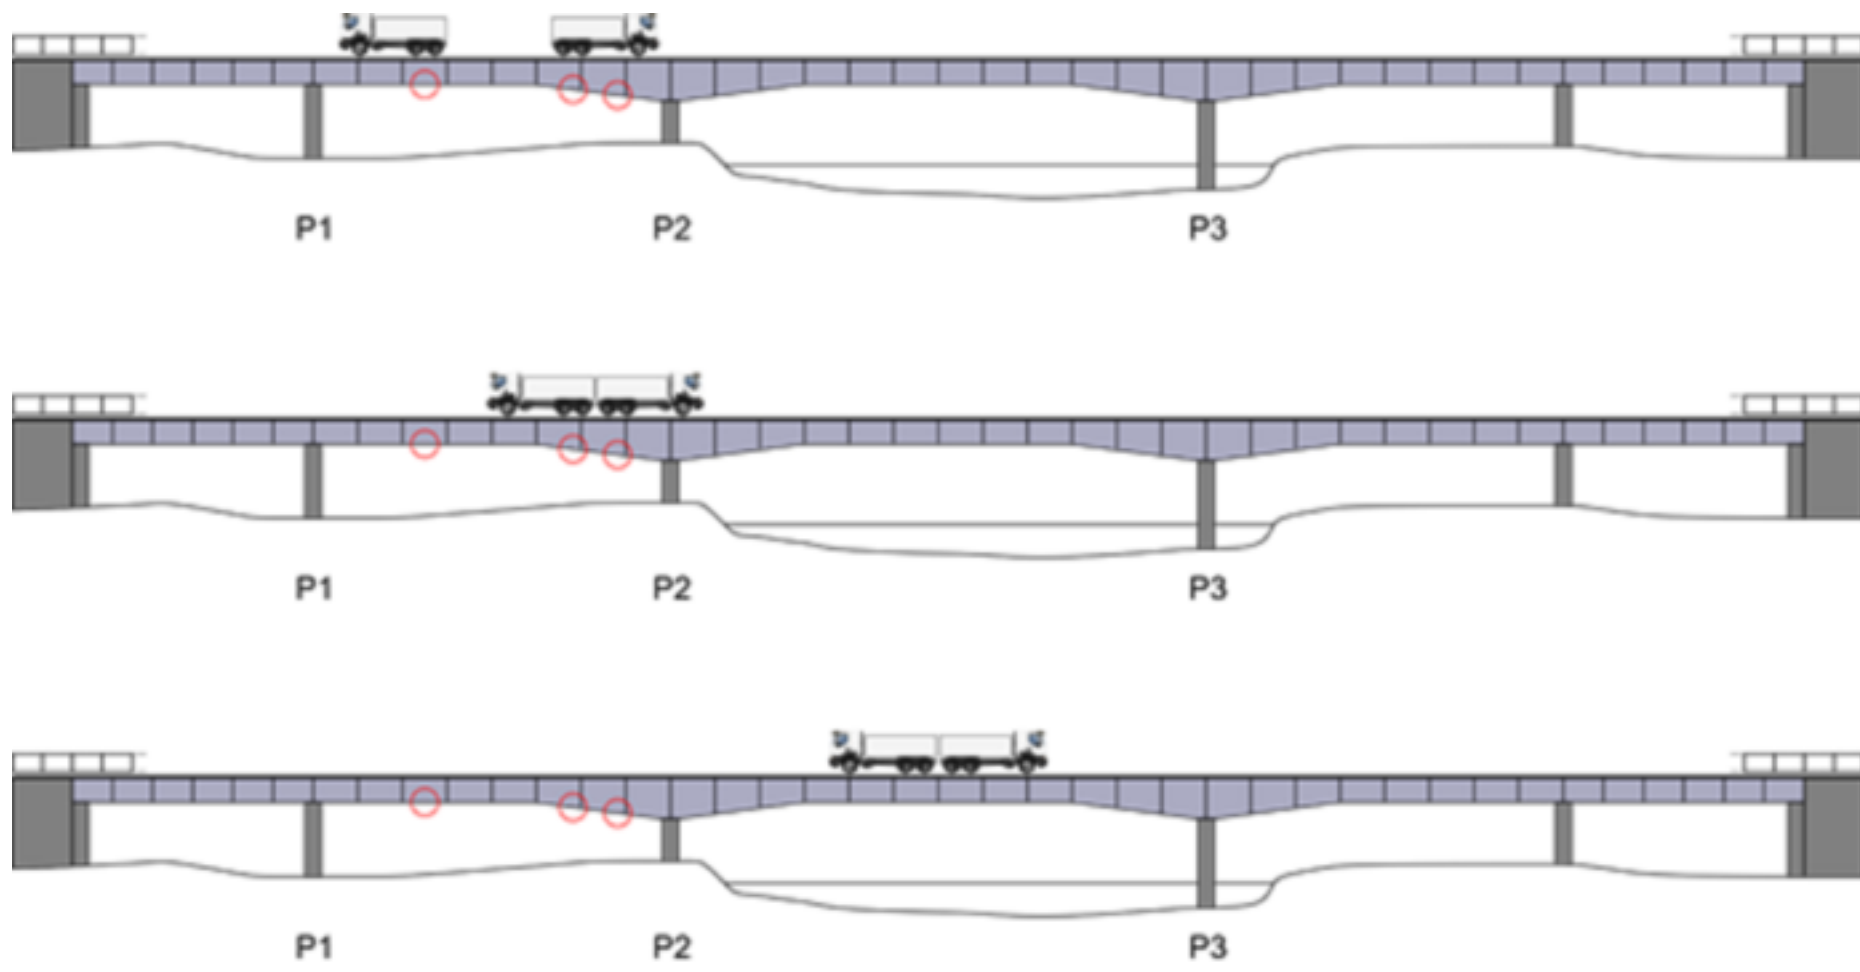
Figure 10

622 **Fig. 1.** General layout of the Jarama Bridge (dimensions in m)
623
624 **Fig.2.** General views of Jarama Bridge
625
626 **Fig. 3.** Location of the selected butt-weld splices for CFRP strengthening (dimensions in m)
627
628 **Fig. 4.** Flowchart demonstrating the different components of fatigue assessment questionnaire
629
630 **Fig. 5.** CFRP strengthening configurations for the six studied locations (dimensions in m)
631
632 **Fig. 6.** a) Application of the adhesive on the plate. b) Pressure application with rollers.
633
634 **Fig.7.** Pictures of the heating system used for post-curing operation
635
636 **Fig. 8.** Picture of a pair of strain gauges installed on the bridge
637
638 **Fig. 9.** Picture of the debonding sensor applied on the edge before application of the adhesive
639
640 **Fig. 10.** The three studied static positions on the bridge during the load tests (circles correspond to the

394 First, a static fixed load test was performed including three different truck positions. The static test was
395 performed by placing two 27-ton trucks (Renault Kerax) in three predefined positions (Figure 10),
396 carrying out the strain measurements after stabilizing the load. The initial position was chosen to obtain
397 maximum strains in welds 17, 20, 26 and 29. The second position was chosen to obtain maximum
398 positive strains in welds 16, 17, 25 and 26. The third position was chosen to obtain maximum negative
399 strains in the studied welds.

410 An example of strain recording during the positioning of the two trucks on the bridge for a static load
411 test is provided in Figure 12 (the first position load case is given in figure 10). As anticipated, the first
412 studied position, welds 20, 29, 26 and 17 are subject to the highest strain. Since only one side of the
413 bridge was blocked to traffic, there are some small perturbations of the measurement due to the traffic
