Fatigue Strengthening of Steel Bridges with Adhesively Bonded CFRP Laminates: Case Study

Journal of Composites for construction, ASCE, 24, 3 (2020)
[https://doi.org/10.1061/\(ASCE\)CC.1943-5614.0001014](https://doi.org/10.1061/(ASCE)CC.1943-5614.0001014)

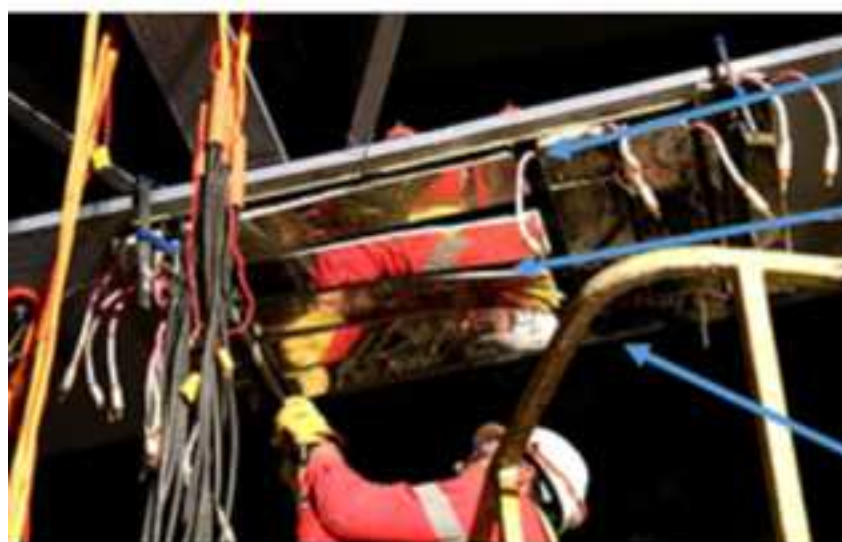
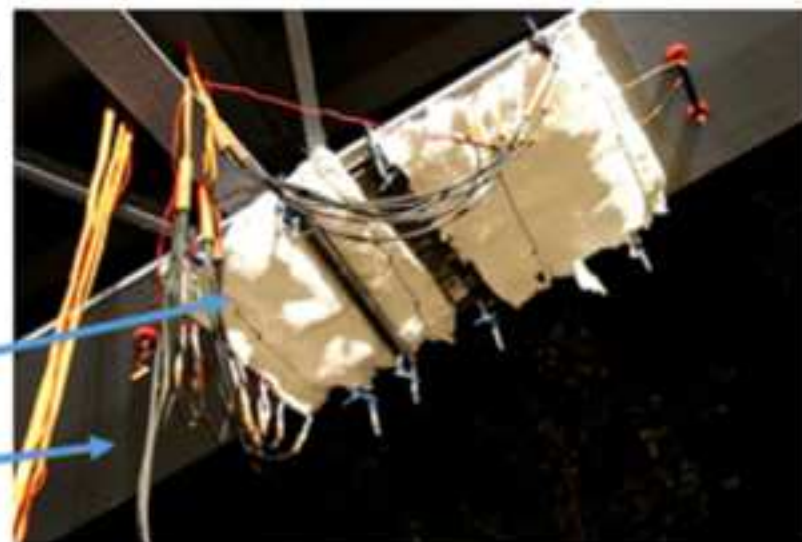
b)

334 As described in Chataigner et al. (2018), a post-curing of the system is needed (one hour at 80 °C) in
335 order for the adhesive's glass transition temperature to reach the required value of 71 °C without losing
336 properties. Ceramic pads were used to transfer the heat to the system to reach the target curing
337 temperature of 80 °C and maintain it constant during the curing time (one hour). The ceramic pads were
338 placed to completely cover the surface of the CFRP plates (Figure 7). Thermocouples were installed on
339 the steel surface close to the CFRP plates and were used to control the curing temperature. Isolation
340 blankets were also used to reduce heat loss, maintain the required temperature inside the system, and
341 improve energy efficiency. The post-curing process started a minimum of two hours after installation of
342 the CFRP plates.

Adhesively bonded CFRP

Heating pads

Insulation

Steel structure
