Gate-damage accumulation and off-line recovery in SiC power MOSFETs with soft short-circuit failure mode

Abstract –This paper proposes the detailed analysis of the short-circuit failure mechanism of a particular class of silicon carbide (SiC) power MOSFETs, exhibiting a safe fail-to-open-circuit type signature. The results are based on extensive experimental testing, including both functional and structural characterisation of the transistors, specifically devised to bring along gradual degradation and progressive damage accumulation. It is shown that the soft failure feature is associated with degradation and eventual partial shorting of the gate-source structure. Moreover, partial recovery, induced here by ad-hoc off-line biasing, is observed on degraded components. The results indicate that it is a realistic new option for deployment in the application to yield enhanced system level robustness and system-level hopping-home operational mode capability, of great importance in a number of reliability critical domains, such as, for instance, transportation.

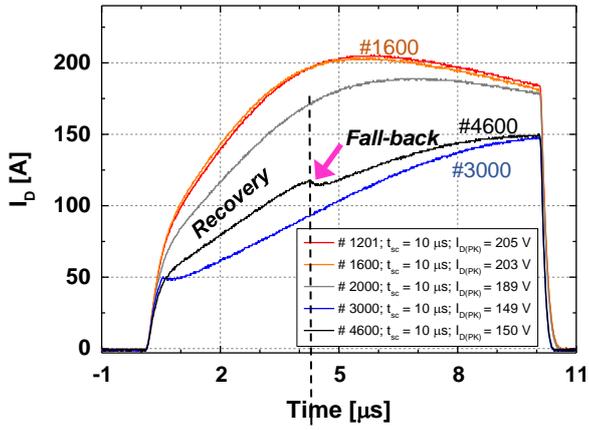
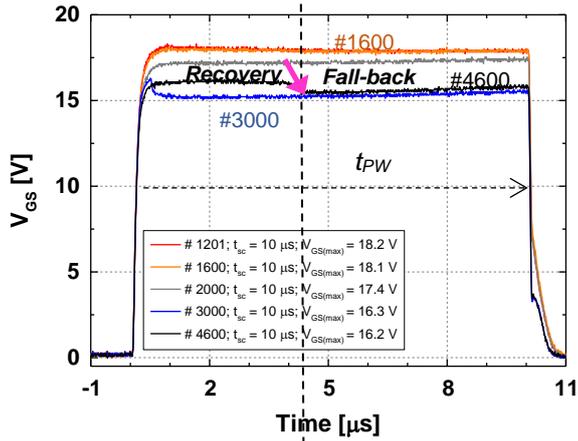
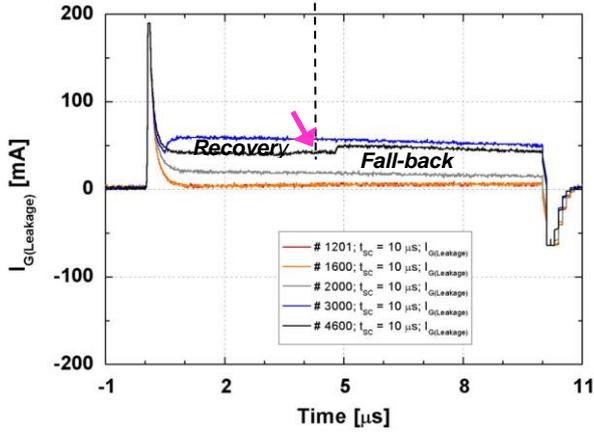
Short-circuit robustness is a key application requirement for semiconductor power devices. The relative performance of silicon carbide (SiC) MOSFETs and silicon (Si) IGBTs has been amply discussed and compared in a number of studies (see [1-3], for example), which have pointed out a somewhat weaker withstand capability of SiC, as opposed to Si, and differing failure mechanisms. In particular, a twofold failure mechanism was highlighted in [4] for SiC, yielding either a fail-to-open-circuit (FTO, or *soft*) or fail-to-short-circuit (FTS, or *hard*) signature, depending on the energy dissipation rate and related temperature increase within the device.

Fig. 1. a), repetitive SC DUT progressive degradation, manifest as a decrease of I_D after #1600 pulses with $t_{PW}=10 \mu s$ @ $V_{DS}=610 \text{ V}$ - $V_{GATE \text{ DRIVE}}=18 \text{ V}$ - $R_{GATE \text{ EXT.}}=47 \Omega$ - $T_{CASE}=25 \text{ }^\circ\text{C}$; b), corresponding V_{GS} waveform; c) corresponding I_{GS} waveform. In the results corresponding to pulse #4600, the device initially exhibits partial recovery, followed by degradation.

On the side of the gate ageing observation, a new observation can be made in the results of Fig. 1: a partial recovery effect can be observed in going from pulse #3000 to pulse #4600 (in these tests, a KeysightTM B1505A source-meter-unit was used). Here, the recovery is not stable, and half-way through the pulse the device characteristics fall back to the previous degraded status. Because of its potential relevance for the application, this observation triggered further detailed analysis of the effect, specifically of the possibility to *force and control* the recovery and stabilise the device characteristics, even if at a slightly degraded level.

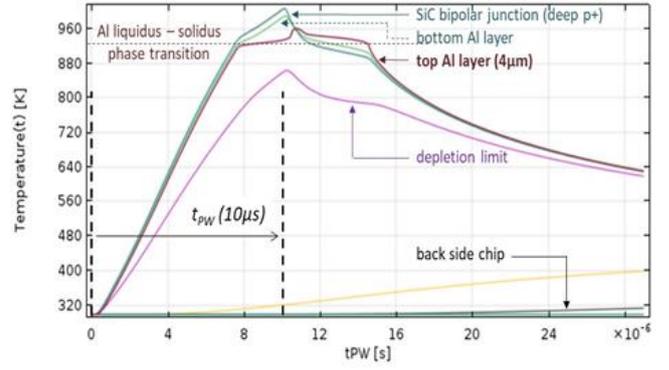
Fig. 2. Fig. 2 1D chip temperature simulation in short-circuit operation for #1600: $t_{PW}=10 \mu s$ @ $V_{DS}=610 \text{ V}$ - $V_{GATE \text{ DRIVE}}=18 \text{ V}$ - $R_{GATE \text{ EXT.}}=47 \Omega$ - $T_{CASE}=25 \text{ }^\circ\text{C}$.

temperature dependence of the conductivity and the mass heat of SiC and aluminium, as well as the solid-liquid phase transition of the Al top layer. Using structural computer aided design tools (specifically, ComsolTM was used here), the model received as input $I_D(t)$ waveform of Fig. 1a), with a constant V_{DS} value of 600 V. Considering pulse number #1600, Fig. 2 shows the temperature rise of all the main layers of the chip during the short circuit. It is clearly visible that the Al layer is above its melting point with a high thermal energy injected into its liquid phase. Furthermore, according to [10], at the Al melting temperature, the thick oxide is already cracked because the mechanical stress at the upper corner greatly exceeds its mechanical strength.

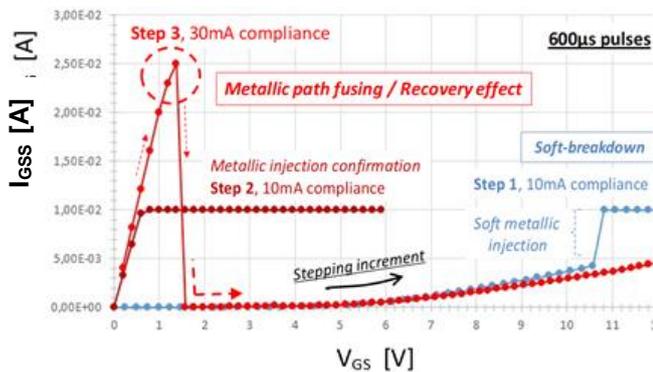
- *Step 1* (blue curve) corresponds to the first traced curve, in which the gate current was limited at 10 mA: here, as V_{GS} is increased beyond about 10.8 V, a sudden breakdown like characteristics is entered, with a steep increase of I_{GSS} ;
- *Step 2* (brown curve) is a second sweep carried out straight

after *Step 1* to confirm the breakdown status;

- Step 3 (red curve) is a sweep with increased I_{GSS} limit value

Fig. 3. Static characteristics of device degraded by repetitive short-circuit: first sweeping biasing-gate test highlighting breakdown and recovery effects.

to 30 mA: here, as V_{GS} is increased beyond just 1 V a recovery effect is manifest, with I_G dropping suddenly again.

These results point out that the device gate characteristics can be partially recovered by producing moderate heat generation in the gate region, which is ascribed to a fusing effect taking place, which effectively disconnects degraded portions of the chip from the remaining cells; in this case, the device reaches a new stable, though slightly degraded state. However, if the pulse width t_{PW} is increased closer to the maximum duration $T_{sc\ max}$ of the DUT, the level of damage accumulation is greater and for some devices analysed, the I_G value after recovery was found to be too high for them to be still usable with typical gate-driver designs. In Fig. 3), at the end of the first series of low-voltage gate sweeping, the measured equivalent gate-source resistance was $2.4\ k\Omega$, corresponding to a gate-drive supply of 135 mW at 18 V.

Based on the aforementioned findings of [6], a first attempt was made by statically sweep-biasing the degraded transistor (same device used previously for the tests of Fig. 1) in a V_{GS} range $\leq 12 \text{ V}$, with different limit values of gate pulsed current I_{GSS} . Fig. 3) summarises the results:

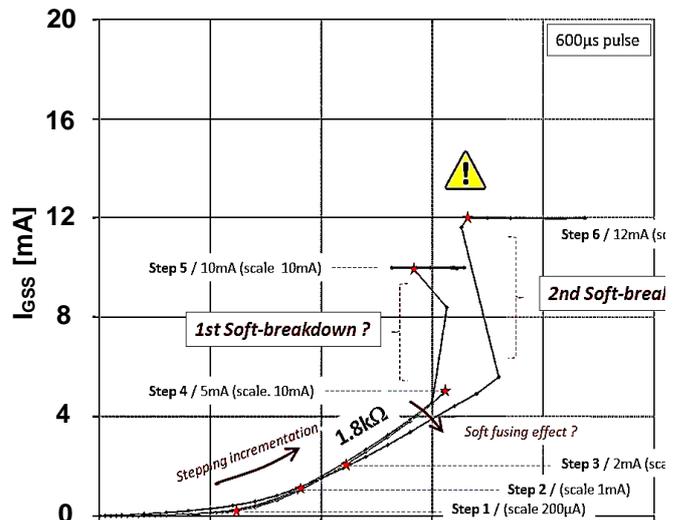
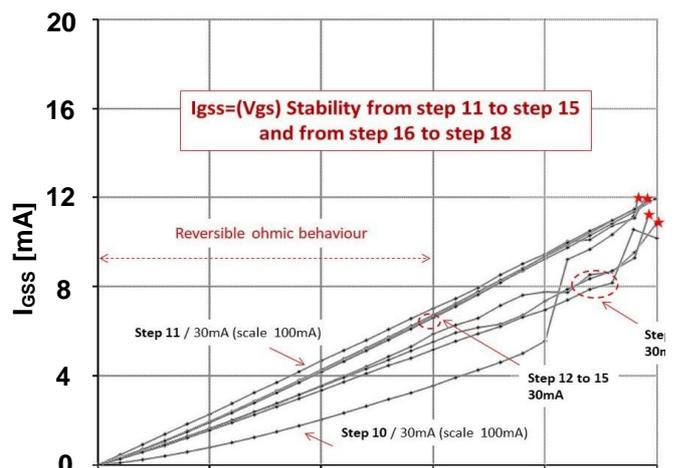
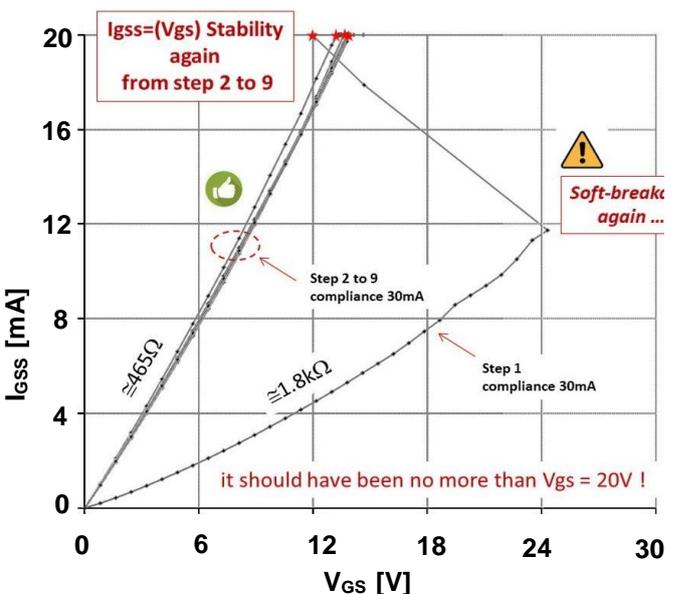
Fig. 4a) shows that, for V_{GS} higher than 12 V and lower than 16 V, a chaotic transient behaviour appears when the limit gate current is moved from 5 to 12 mA (step 1 to step 6): a first metallic injection effect appears in the form of a soft breakdown of the oxide, following a fusing effect and a second metallic injection effect.

In Fig. 4b), by gradually increasing the limit gate current up to 30 mA and increasing the bias voltage from 16 V to 30 V, the chaotic behaviour disappears, giving way to a stable ohmic transfer characteristics. From an equivalent $R_{GATE} \cong 1.8\ k\Omega$ at 12 V in step 1, $R_{GATE} \cong 1.3\ k\Omega$ at 18 V in step 18, giving an acceptable gate-drive over-supply of 250 mW at 18 V to continue operation of the device in *hopping-home* mode.

Fig. 4 $I_{GSS}(V_{GS})$ gate ohmic restoration analysis: a) 5 mA to 12 mA, b) 30 mA, c) high gate-source bias and final metallic crack. All graphs share the bottom x-axis and scaling, not repeated for better readability.

However, in Fig. 4c), in an attempt to further restore the gate oxide, the sweeping was repeated with a voltage bias higher than 18 V up to 30 V. A new stable ohmic state appears in this case with a lower $R_{GATE} \cong 465\Omega$ at 15V. Unfortunately, such value is too low, giving a gate-drive over-supply of 480mW at 15V. The preliminary qualitative conclusion can be drawn that the bias voltage and injected restoration energy values should be high enough to eliminate the main ohmic paths for the device to be usable at nominal gate voltage, but they should not be too high, so as not to re-metallize again the cracked oxide.

To try and get the entire gate recovery, a second series of transfer characteristics sweeping was carried out, the results of which are given in Fig. 4. Here, the gate bias voltage is increased up to the nominal voltage of 18 V at first and beyond such value subsequently. For reference, a Keysight™ B2902A SMU with 600 μ s pulse duration was used for these tests; the effect of the pulse duration is discussed at the end of this section.

Finally, in Fig. 4c), a final attempt was made to induce gate recovery by increasing the pulse duration from 600 μs to 600 ms. Even in this case of high energy injection, the ohmic state of the gate remains stable and, although the equivalent gate resistance is lower in this case, it remains nevertheless at a value which makes the device further use in a real circuit still possible,

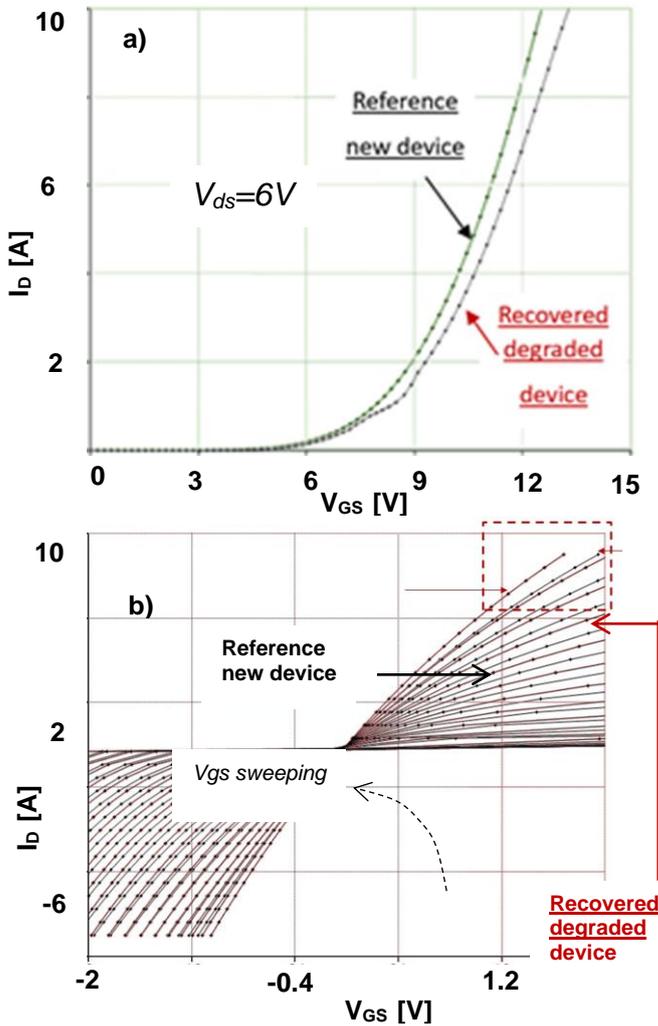
Fig. 5 Transfer and direct behaviour comparison @ $T_{CASE} = 25^\circ C$: a) $I_{DS}(V_{GS})$ @ $V_{DS} = 6 V$, b) $I_{DS}(V_{DS})$ curve.

The device was then characterized with the same SMU for re-using. Fig. 5a) shows the transfer characteristics at $V_{DS} = 6 V$, comparing a new device and the recovered device from Fig. 4c). For illustration, at $V_{GS} = 12 V$, the comparison shows a decrease of only 20 % in I_D for the recovered device. The same behaviour is visible in Fig. 5b) on the output characteristics, which proves the potential re-usability of the device.

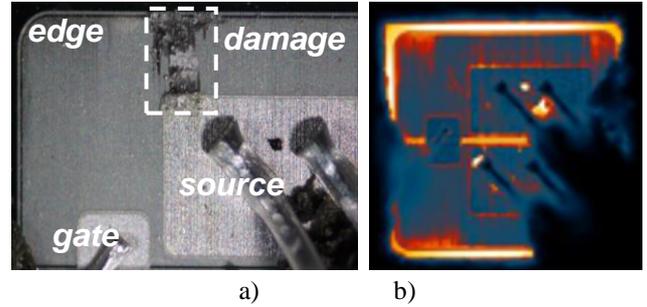
Fig. 6 a) Photograph of degraded device chip featuring damage accumulation at the boundary between gate-ring and source metal, b) LIT analysis @ $V_{GS} = 10 V$, $I_{GSS} = 10 mA$, $I_{DS} = 1 A - 25 Hz$.

The plastic case of the device was opened by laser ablation followed by terminal chemical etching on the encapsulation resin. Fig. 6 a) shows the degraded die, with a very clear indication of severe damage to the top metal having accumulated in the proximity of the external gate-ring source-metal structural boundary. Lock-in-thermography analysis was also carried out, Fig. 6 b), which confirmed the abnormal heating of the cracked gate fingers around the corner region, where mechanical stresses are likely to be highest during the short-circuit. After opening, the device was re-used within a circuit, at reduced drain-source bias, and it was still able of correct transient operation, as demonstrated by the results in Fig. 7, which refer to a single short-circuit pulse. It can be seen that the channel saturation current is reduced of 37 % after the recovery gate-source process described above, as a result of the lowering of the $I_{DS}(V_{GS})$ curve presented in Fig. 5 a).

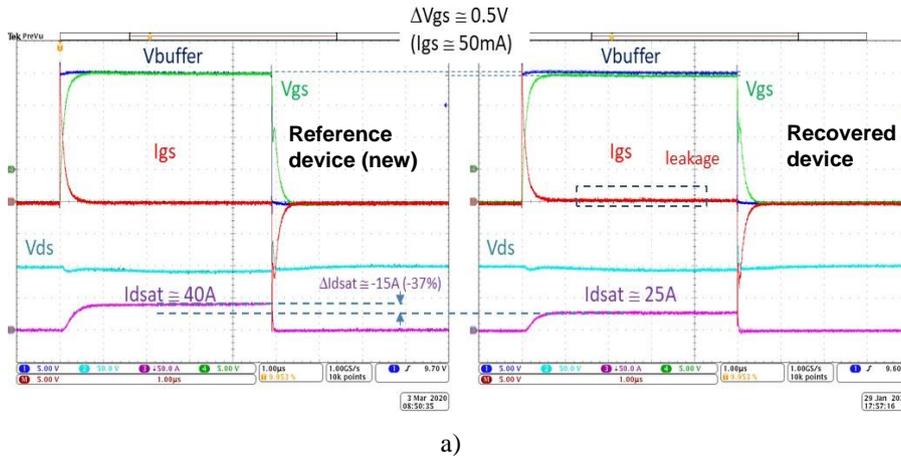
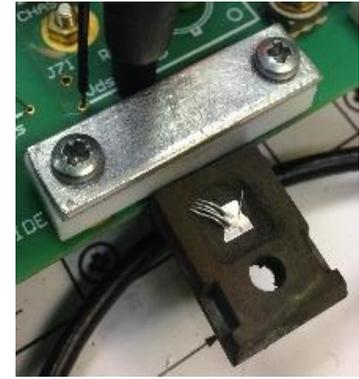
Fig. 7 Single-pulse short-circuit test ($V_{DS} = 100\text{ V}$; $V_{GS} = 15\text{ V}$, $R_{GATE} = 10\ \Omega$, $T_{CASE} = 25\text{ }^\circ\text{C}$): a), comparison of new reference device (left) and degradation-recovered device (right); b), photograph of recovered device in partly decapsulated TO247 package.

accumulation, it is still possible to partially restore the integrity of the gate structure by proper electrical biasing for a particular class of devices and contained stress and damage levels. Here, device recovery was implemented in an off-line setup by means of a simple pulsed mode source-meter-unit, by progressively increasing the gate current limit. This operation is only possible if the gate is not already damaged too severely. In addition, it was shown that the voltage and injected recovery energy should be high enough to eliminate the main ohmic paths to be used at nominal gate voltage, but not so high as to cause excessive metal diffusion within the cracked oxide, which would yield a permanent short-circuit between the control terminals. Further studies are being dedicated to the online implementation of the recovery capability in a real power conversion system.
