THE USE OF TRADITIONAL MUD-BASED MASONRY IN THE RESTORATION OF THE IRON AGE SITE OF SALŪT (OMAN). A WAY TOWARDS MUTUAL PRESERVATION

S. Bizzarri ^{1,2,*}, M. Degli Esposti ^{1,3}, C. Careccia ^{1,4}, T. De Gennaro ^{1,4}, E. Tangheroni ¹, N. Avanzini ^{1,5}

KEY WORDS: Mudbrick walls, Traditional masonry, Mud plaster, Earthen heritage

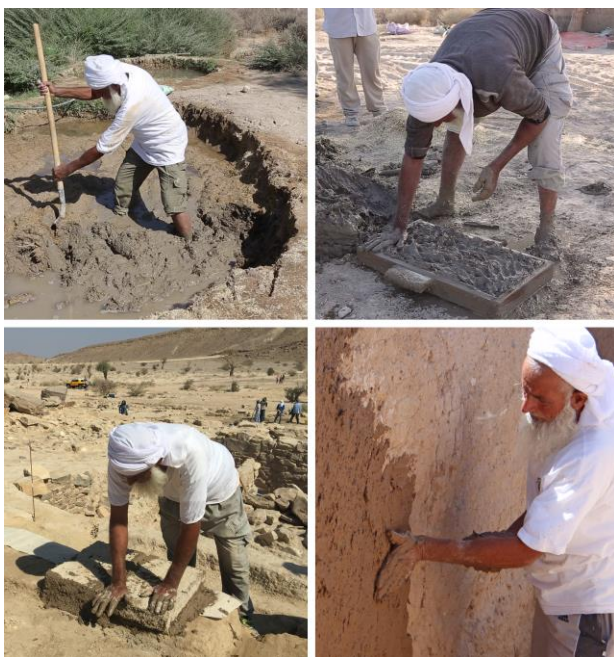
Figure 4. Mudbricks preparation, laying and wall plastering.

Together with the use of point clouds-based modelling, video footage was identified as a useful tool for creating a database aimed at the preservation of the technical know-how implied in the hand-made realisation of mudbrick and plaster, now at risk of disappearing. In fact, by implementing a sustainable approach to the conservation of mudbrick walls and floors, over the years we have gained an in-depth view of the local, traditional mud processing techniques for the making of the plaster to protect the walls.

To this end, we accurately documented the work of our local mason by recording some interviews and shooting videos of every step of the production process, taking care to detail the use of the different tools together with the local terminology associated with them. Once re-organized and edited, this material could also support the dissemination of the site.

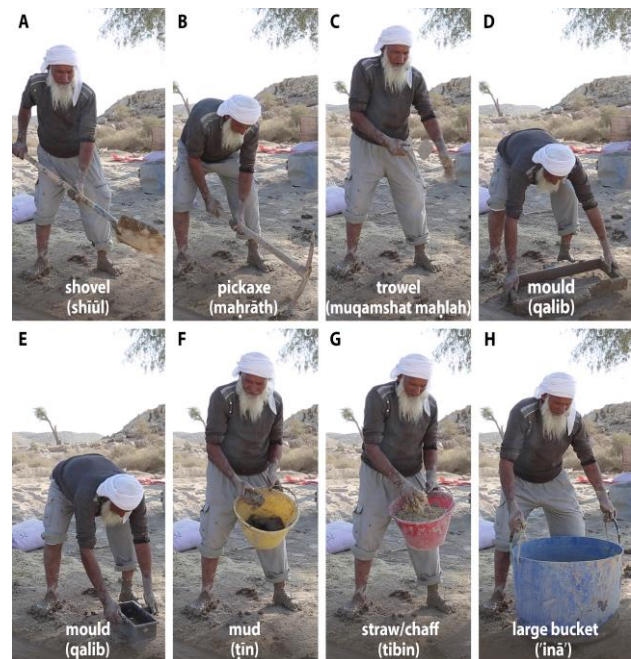
Figure 5. The different tools used throughout the mudbrick production process and their transliterated (local) Arab name.

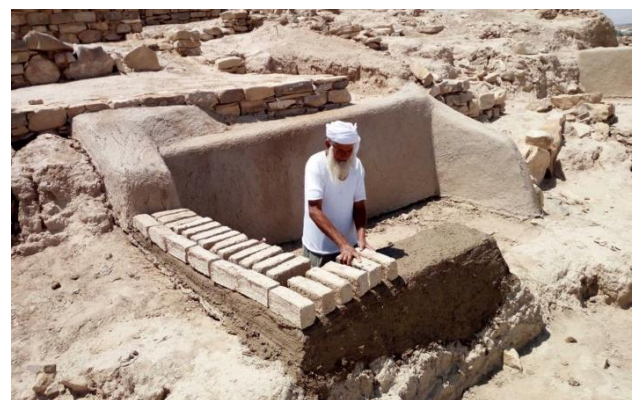
Figure 6. Mr. Massaoud Al-Khīārī rebuilding the missing part of the walls with new mudbricks made on site.

In particular, for steps 3 and 4 the layer of geotextile was covered with a layer of compressed earth, followed by layers of mudbricks and compressed earth up to the required height and the top of the wall was covered with a mud-and-straw plaster layer sloped at the efficient incline to shed water.

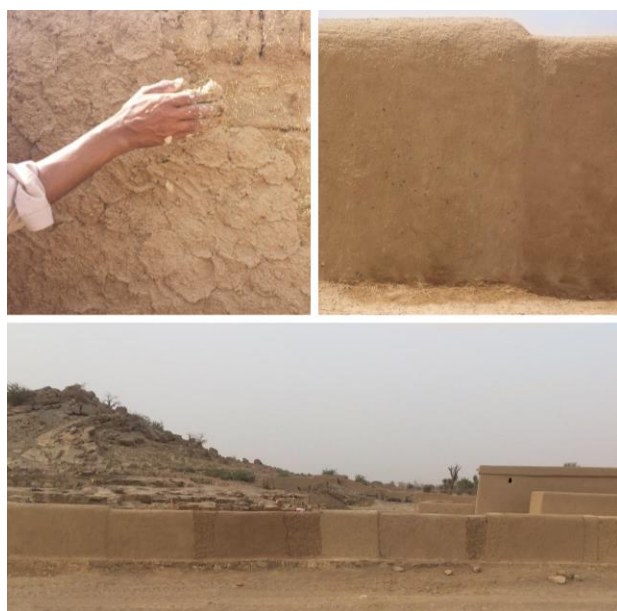
Figure 10. Plaster tests on a new mudbrick structure, from top left: *Sample A, coat 1*; *Sample 1, coat 2*; Samples from the west side of the wall.

First, the wall surface was cleaned and moistened. The first plaster coat was forcefully applied by hand with a thickness of 20 mm, in order to create a naturally wrinkled surface to provide good bonding for the second coat. It was important the plaster was sprayed with a coat twice or three times a day with water during the first days to reduce cracking. Plastic sheets were also used to shade the wall.

For the second coat, a mix with a majority of sand content was used and only applied when the first coat was dry, with a thickness of 10-15 mm and then smoothed by hand to get an even finish. Also, in this case, the plaster was accurately kept wet for a few days and shaded to reduce cracking, especially for samples that tested the addition of binders such as *sarooj* and chalk.
