Historical Earthquake Scenarios for the Middle Strand of the North Anatolian Fault Deduced from Archeo-Damage Inventory and Building Deformation Modeling

1 **Historical earthquake scenarios for the middle strand of the North Anatolian Fault deduced from**
2 **archo-damage inventory and building deformation modeling**

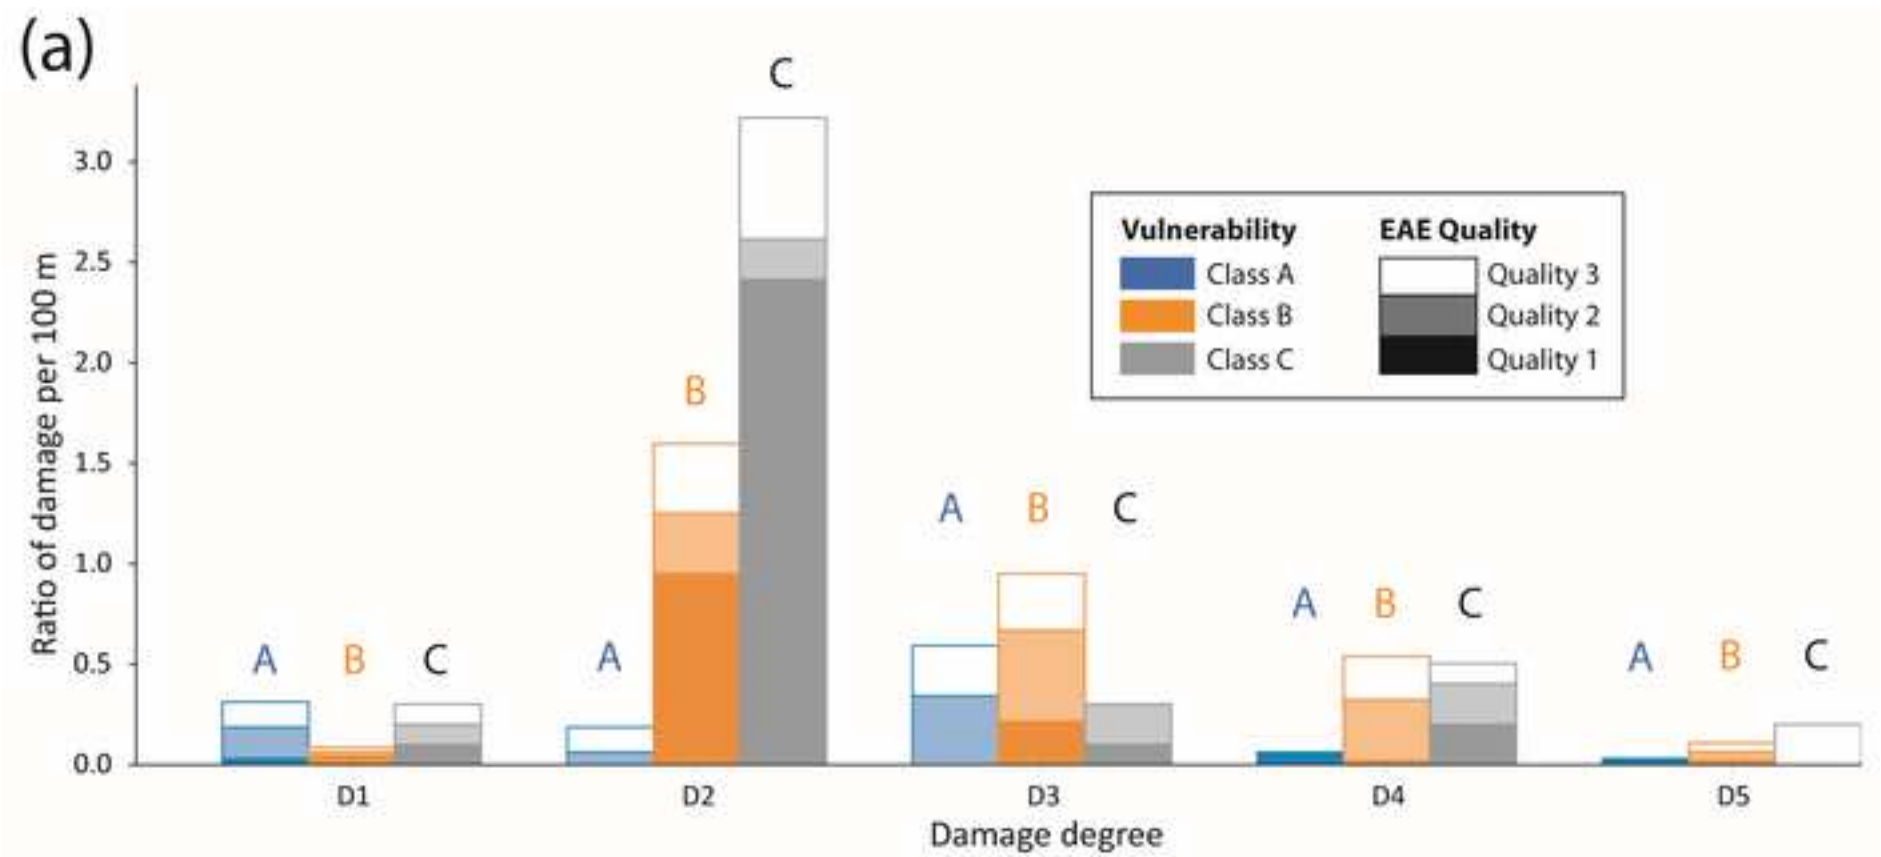
742 **Figure 9:** (a) Distribution of the damage of various grades for the three vulnerability classes of
743 buildings in Iznik. (b) Quantitative translations of the EMS98 damage classification according to
744 vulnerability class and macroseismic intensity, adapted from Riedel (2015). The vulnerability class A
745 to C correspond to the buildings studied in Iznik that use terra cotta, rubble and ashlar. The
746 probability distributions of the different damage grades are shown with different colors. For each
747 vulnerability class, we try to find the intensity which best replicates our observed damage
748 distribution (reported on the graphs as vertical bars). For example, for our vulnerability B buildings,
749 we observe a majority of D2 damage. This is compatible with an intensity VII or VIII. Then, the fact
750 that we have much more D3 than D1 damage rather suggests an intensity VIII.

289 For vulnerability class A, we obtain a flat distribution for quality 1 EAE (Fig. 9a). When lower qualities
290 are included, we observe a larger peak for grade 3 damage and a significant representation of grade 1
291 damage. The grade 3 damage peak points toward a VII-VIII intensity, but our grade 1 damage is
292 overrepresented compared to the DPM in this range. For vulnerability class B, the obtained distribution
293 is more regular and insensitive to EAE quality, with a maximum for grade 2 followed by a progressive
294 decrease for bigger grades. This distribution is most compatible with an intensity VIII. For vulnerability
295 class C, we obtain a similar distribution to class B, with a clear maximum for grade 2 and much lower
296 ratios for the other grades. This suggests a VIII-IX intensity, with an overrepresentation of grade 4
297 damage compared to the DPM in this range. As a result, a minimal intensity VIII seems to account best

298 for the three damage distributions (Fig. 9b).
