# Historical Earthquake Scenarios for the Middle Strand of the North Anatolian Fault Deduced from Archeo-Damage Inventory and Building Deformation Modeling

1 **Historical earthquake scenarios for the middle strand of the North Anatolian Fault deduced from**  
2 **archo-damage inventory and building deformation modeling**

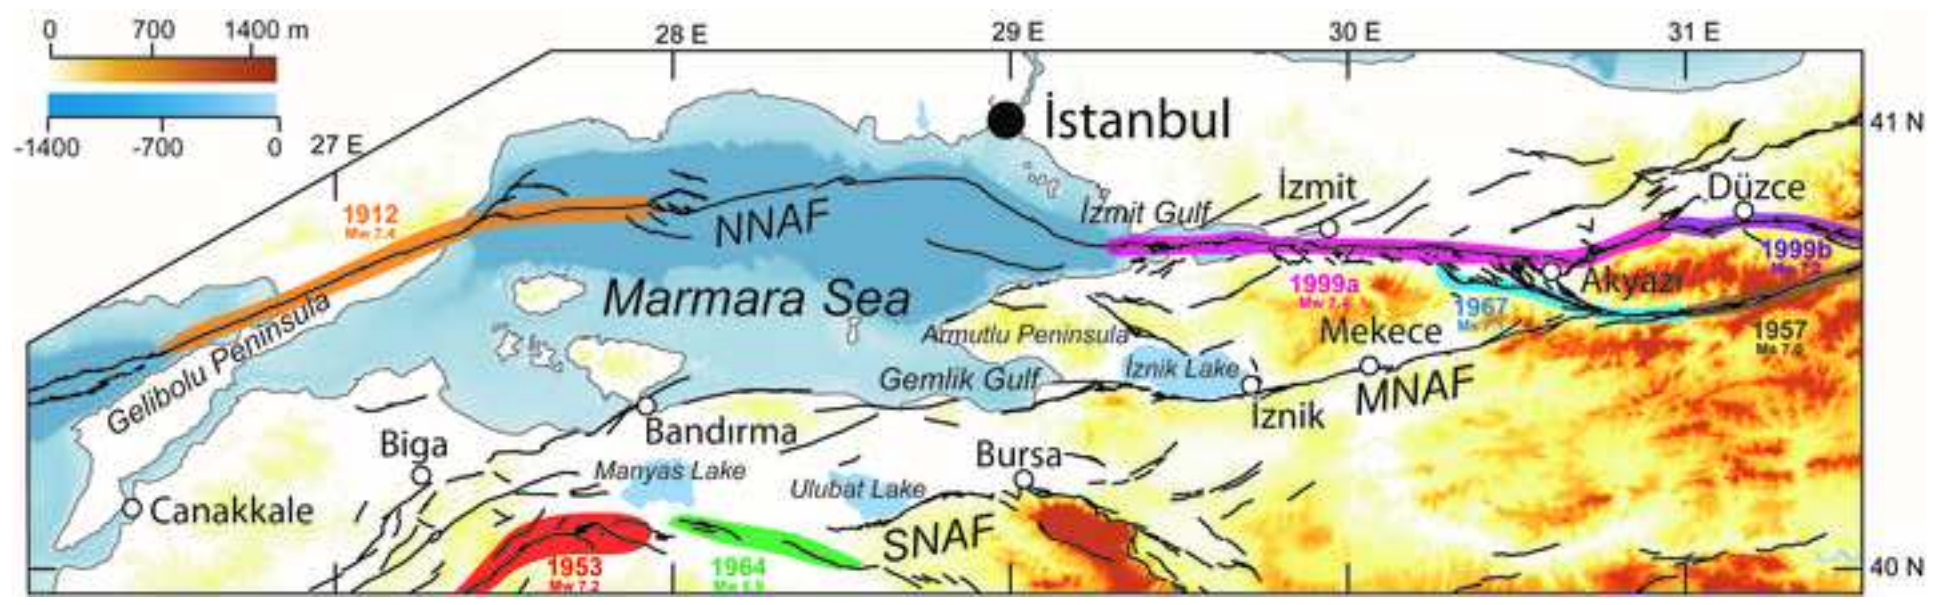
Figure 1

688 **Figure 1:** Morphology and geometry of the NAFZ in the Marmara region. The active fault segments,  
689 drawn in black, were taken from Emre et al. (2011) and Benjelloun et al. (2018). The  $M_w > 6.5$   
690 ruptures during the 20<sup>th</sup> century are shown in colors (Hubert-Ferrari et al., 2000; Pondard et al.,  
691 2007). The main cities are located with dots. NNAF, MNAF and SNAF: northern, middle and southern  
692 branches of the NAF.

83 The study area includes the city of Iznik and its close surroundings, in the southeast of the Marmara  
84 Sea (Fig. 1 and 3a). It is located on the middle branch of the North Anatolian fault. The North Anatolian  
85 Fault zone (NAFZ) is a major tectonic boundary accommodating the relative motion between the  
86 Eurasian and Anatolian plates. It is a 1000-km long, right-lateral strike-slip fault crossing the northern  
87 part of Turkey (Sengör, 1979). This fault zone is associated with a significant seismic hazard and with  
88 several destructive earthquakes since the beginning of the Common Era (Fig. 2).

89 In its western termination, the NAFZ is divided into three strands (Fig. 1). The northern strand (NNAF)  
90 continues along the strike of the main fault zone and crosses the northern part of the Marmara Sea  
91 from Izmit Gulf to Gelibolu Peninsula. This strand was especially involved in the last seismic crisis that  
92 occurred as a succession of ruptures migrating westwards, from Erzincan in 1939 to Izmit in 1999 (Stein  
93 et al., 1997). The middle strand (MNAF) separates from the NNAF in the Akyazi district, borders on the  
94 south two successive basins known as the Geyve-Pamukova Basin and Iznik Lake, reaches the Marmara

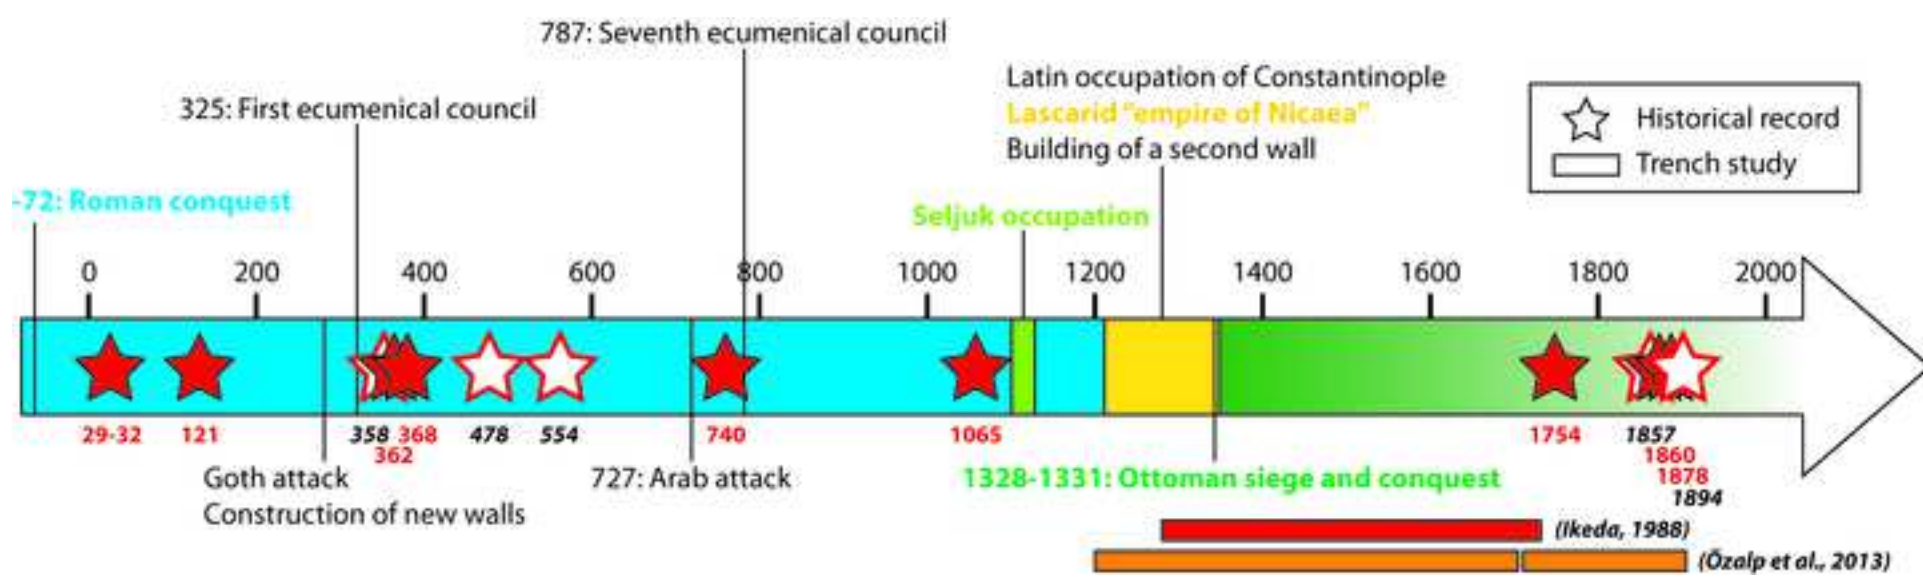
Figure 2

694 **Figure 2:** Chronological frieze of Nicaea's history. The colors show the main historical periods of the  
695 city: Roman (blue), Seljuk and Ottoman Turk (green) and Lascarid (yellow). The red stars correspond  
696 to historical earthquakes having damaged the city according to historical descriptions, and the white  
697 stars indicate the historical events for which the reality or amount of seismic damage is uncertain (for  
698 the complete list, see Table S1 in the electronic supplement). The two bars under the frieze refer to  
699 earthquakes identified in paleoseismological trenches done on the MNAF.

387 This period of time is associated with two historical earthquakes, both of them located on the NNAF  
388 (Fig. 2). In 554 AD, a  $M_s \sim 7$  earthquake severely affected Constantinople and Nicomedia (Izmit). Partial  
389 damage is reported in Iznik, but by one source only. In 740 AD, a major  $M_s$  7.1 event affected the  
390 eastern part of the Marmara Sea and it is reported that “a single church survived” in Iznik which was  
391 totally destroyed. For the same reasons as exposed above, this testimony cannot be taken literally. But  
392 given that no other earthquake is known in the region, the EAE associated to this episode may result  
393 from these earthquakes. It should be emphasized that our constraints for this episode are scarce and  
394 limited to one building only.

414 (1) This damage may have resulted from earthquakes rupturing the NNAF. Several historical  
415 earthquakes with damage reported at Iznik are known (Fig. 2). In 1754 AD, a strong Ms 7 earthquake  
416 affected the region of Izmit on the NNAF, destroying a few houses in Iznik, apparently without  
417 casualties. In 1878 and 1893 AD, two smaller earthquakes in the same area of the NNAF caused slight  
418 damage in Iznik, but with much lower magnitudes, between 5 and 6. Finally, in 1894 AD, a Ms 7.3  
419 earthquake ruptured the Izmit Gulf faults and caused liquefaction and landslides in the epicentral  
420 region and widespread destruction between Istanbul, Gemlik and Sapanca. The effects in Iznik are not  
421 well known.

428 (3) Interestingly, the Ottoman episode matches the paleoseismic evidence of two contemporary  
429 ruptures (Fig. 2), sometime between the 12<sup>th</sup> and 18<sup>th</sup> century AD in Gemlik (Özalp et al., 2013), and  
430 sometime between the 14<sup>th</sup> and 18<sup>th</sup> century AD in the west of Mekece (Ikeda, 1988). It can thus be  
431 proposed that the Ottoman damage in Iznik was caused by one or several earthquakes rupturing the

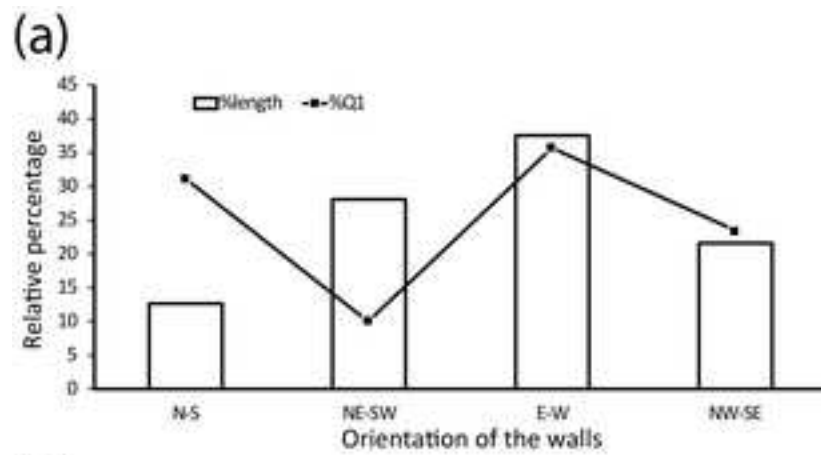
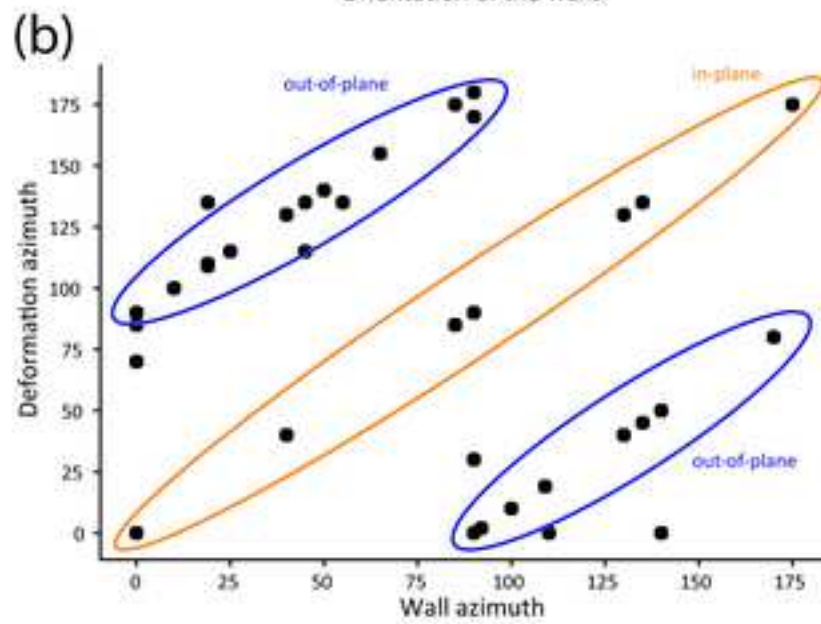
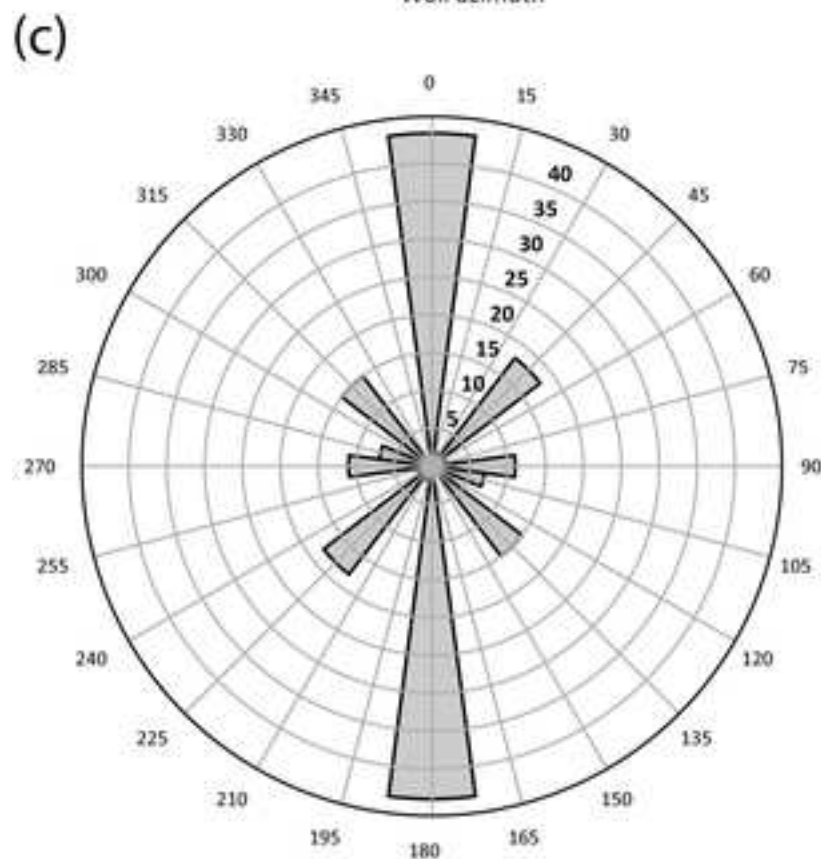
733 **Figure 8:** (a) Comparison between the relative distribution of wall length (bars) and quality 1 EAE  
734 (line) for different wall azimuths. The percentages in length and EAE were computed on the total wall  
735 length and total number of EAE of quality 1, respectively. For the other qualities, see Table S4 in the  
736 electronic supplement. (b) Azimuths of the damage plotted against the azimuths of the wall affected.  
737 Note the general correlations between the two values. This correlation is linear for the in-plane  
738 deformations (i.e. parallel to the wall) and affine with a  $\pm 90$  shift for the out-of-plane deformations  
739 (i.e. perpendicular to the wall). (c) Rose diagrams of the azimuths of damage observed in Iznik (118  
740 EAE). Note the prominent N-S azimuths.

217 The relative repartition of the different wall orientations was compared to the relative number of EAE  
218 found in these different wall azimuth ranges, no matter the azimuth of the deformation (Fig. 8a). The  
219 results do not change significantly when data of lower qualities are included. If all the walls were  
220 affected in the same way whatever their azimuth, the relative amount of EAE and the orientations  
221 should present similar distributions. This is the case for the E-W and NW-SE oriented walls that show  
222 a correspondence between the relative amounts of EAE and the lengths of the walls affected. By  
223 contrast, we can see that the N-S oriented walls bear much more EAE than what could be expected  
224 from their length: they contain a third of the walls' EAE whereas they represent only 12.7% of the total  
225 wall length. Conversely, the NE-SW oriented walls are underrepresented in terms of EAE.
