**HAL**  
open science

# Treatment, Conservation and Restoration of Mudbrick Structures

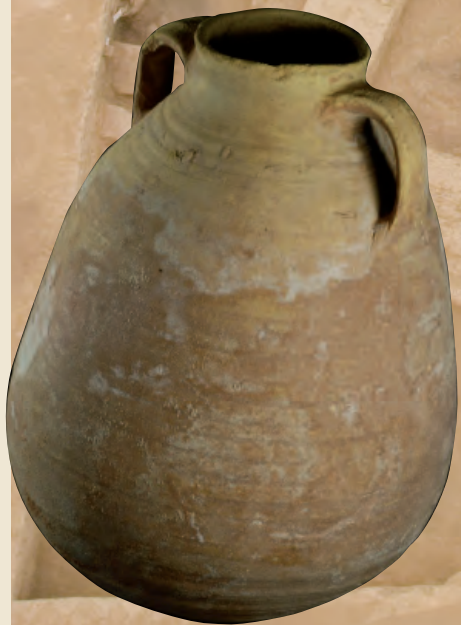
Prepared under the supervision  
of **Laila Nehmé, Daifallah al-Talhi**  
and **François Villeneuve**

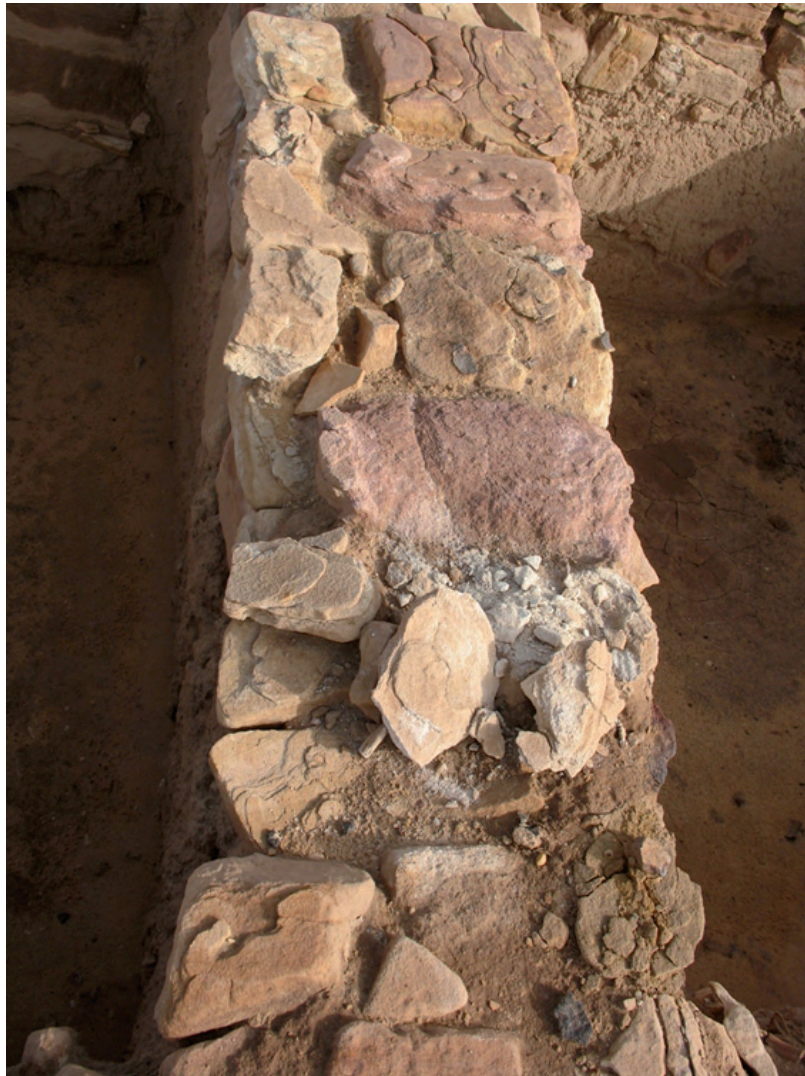
**Fig. 11.** Top of a sandstone wall foundation. The stones are loosened and broken.

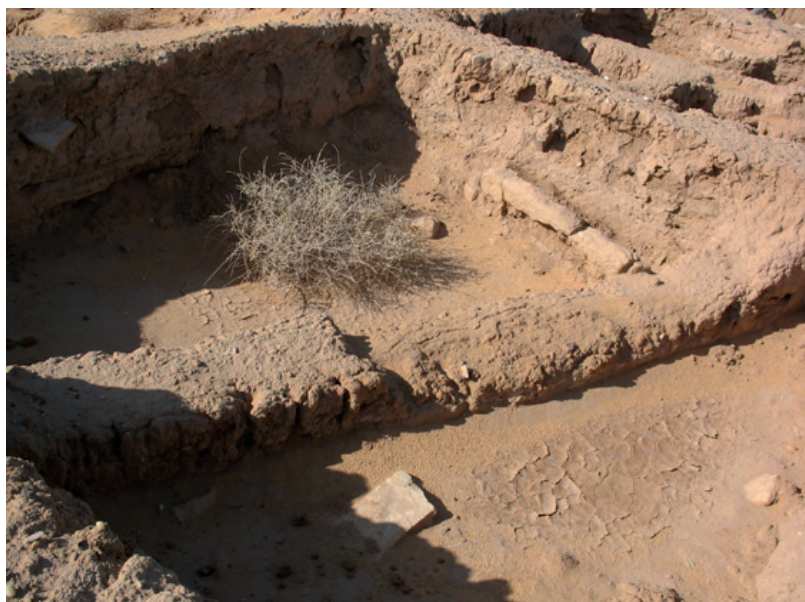
**Fig. 12.** Erosion of a mudbrick wall. Note the vegetation and the traces left by the stagnation of water.

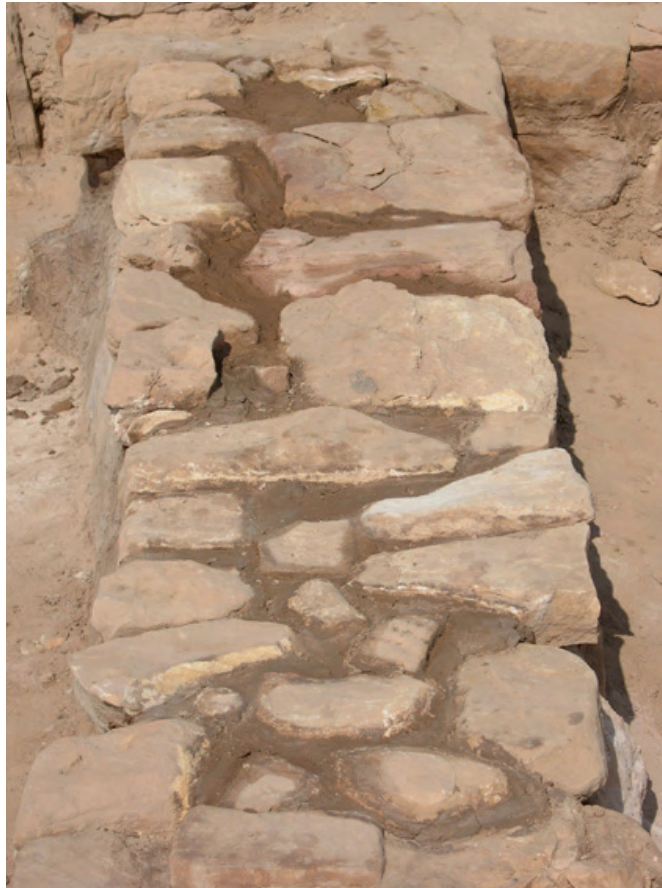
**Fig. 27.** The joints of the top of the wall have been filled with mortar. Some of the missing parts have been rebuilt with the same materials as those used in antiquity.
