HAL
open science

Treatment, Conservation and Restoration of Mudbrick Structures

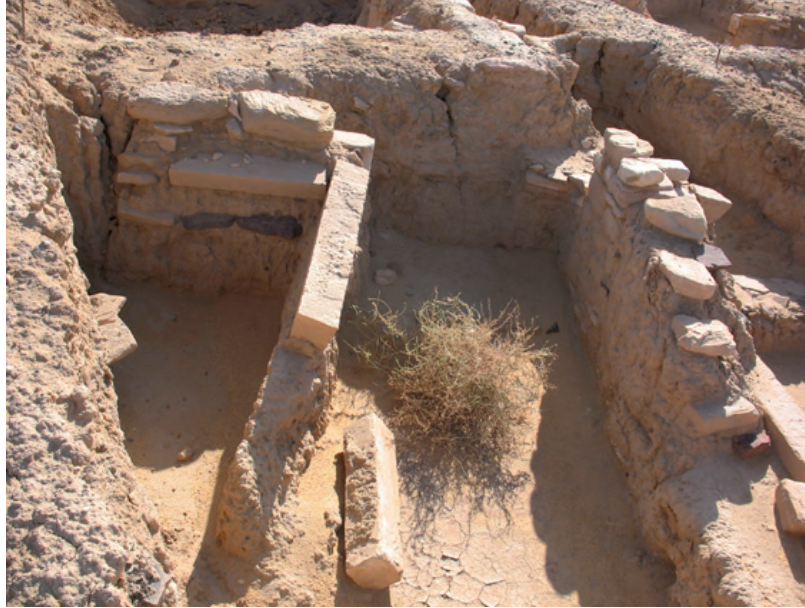
Fig. 10. Undermining below the foundation of the walls leads to their weakening and even to their collapse.

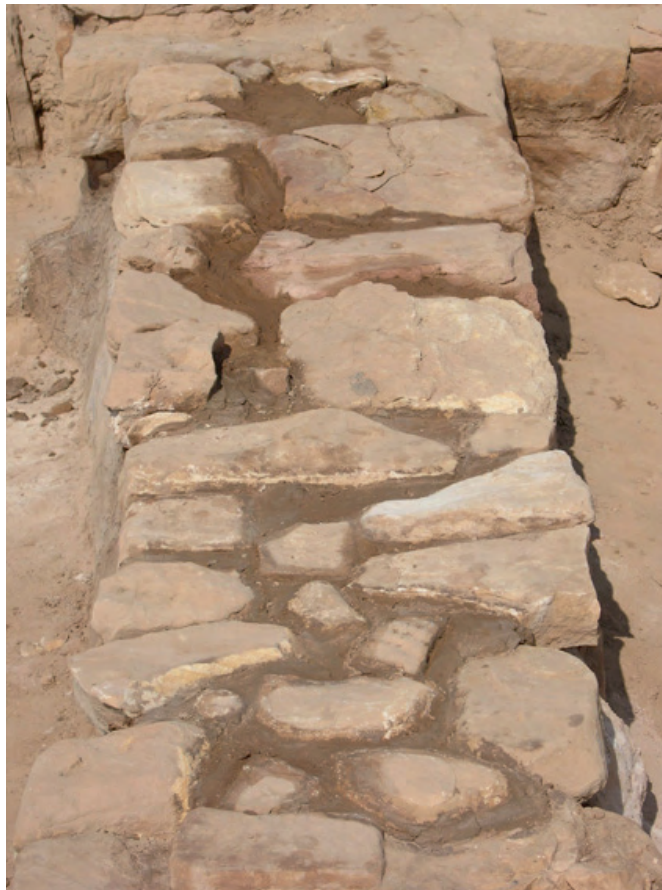
Fig. 27. The joints of the top of the wall have been filled with mortar. Some of the missing parts have been rebuilt with the same materials as those used in antiquity.
