HAL
open science

Treatment, Conservation and Restoration of Mudbrick Structures

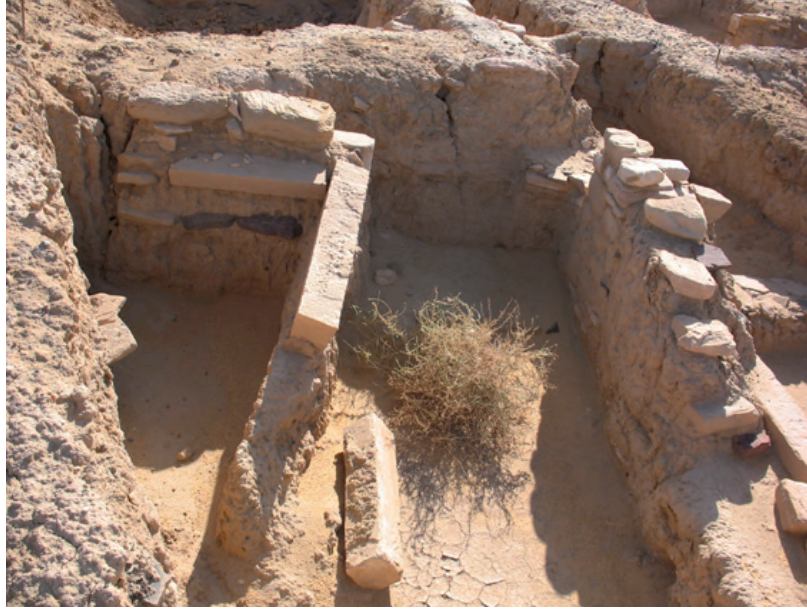
Fig. 10. Undermining below the foundation of the walls leads to their weakening and even to their collapse.

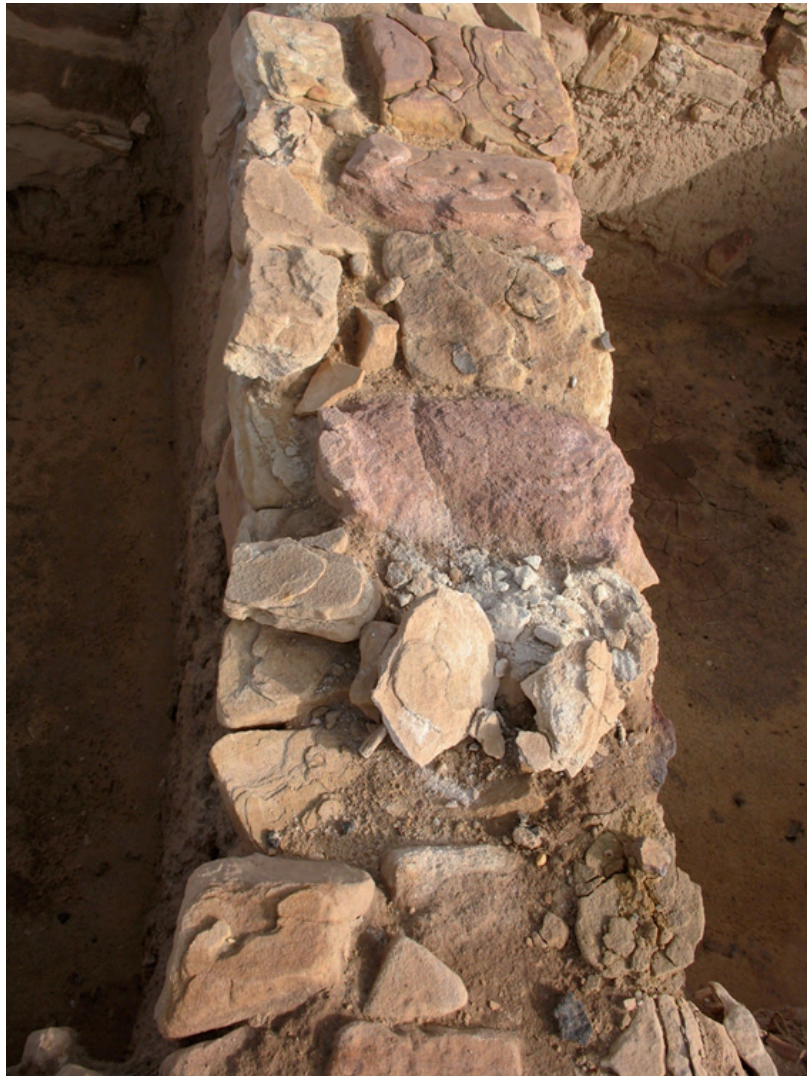
Fig. 11. Top of a sandstone wall foundation. The stones are loosened and broken.

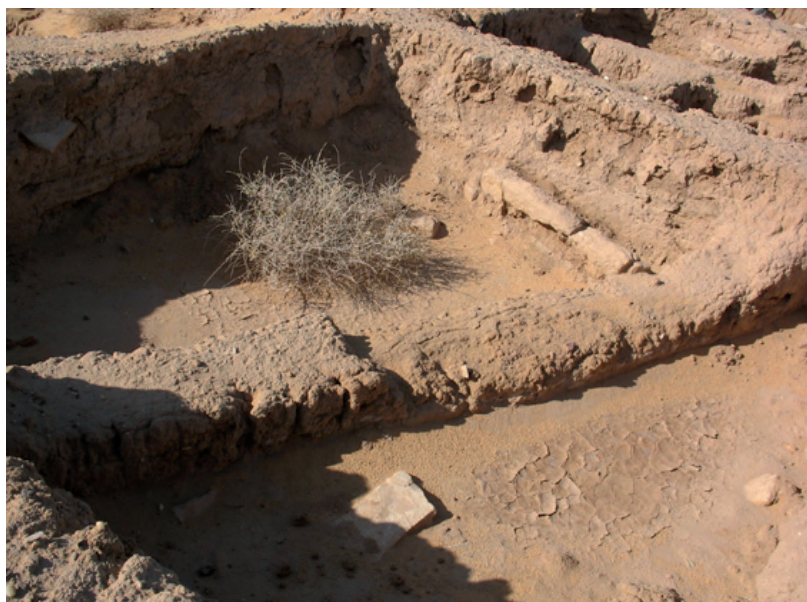
Fig. 12. Erosion of a mudbrick wall. Note the vegetation and the traces left by the stagnation of water.
