Hydrogen - dislocation interactions in a low-copper 7xxx aluminium alloy: About the analysis of interrupted stress corrosion cracking tests

Loïc Oger, Eric Andrieu, Grégory Odemer, Lionel Peguet, Christine Blanc

Loïc Oger, Eric Andrieu, Grégory Odemer, Lionel Peguet, Christine Blanc. Hydrogen - dislocation interactions in a low-copper 7xxx aluminium alloy: About the analysis of interrupted stress corrosion cracking tests. *Materials Science and Engineering: A*, 2020, 790, pp.139654. <10.1016/J.MSEA.2020.139654>. <hal-03033107>

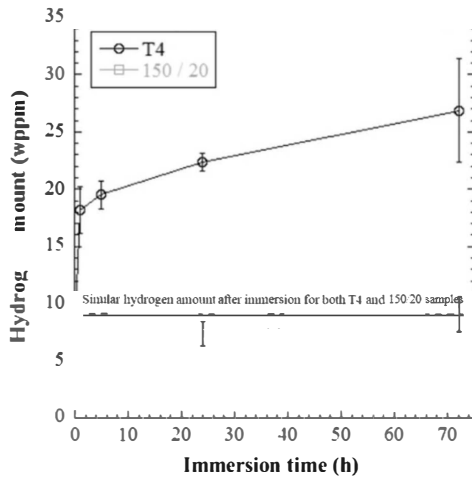
Fig. 3. Hydrogen content versus immersion time in 0.6 M NaCl solution for T4 and 150/20 samples. (Black and white figure; single column).

Fig. 3 shows, for both samples, an increase in the hydrogen content with exposure time to NaCl, confirming that hydrogen uptake occurs due to the corrosion processes. It could be noticed also that the hydrogen amount increased in the first exposure times for both samples, but seemed to stabilise for longer durations, which was in good agreement with pitting corrosion kinetics. Indeed, experimental results obtained by Blanc et al. suggested that the pit propagation followed a time-dependent relationship described by a $t^{1/3}$ law [43]. However, whatever the immersion time in NaCl, the hydrogen content of 150/20 sample was significantly lower than for T4 sample. This result was consistent with the lower corrosion susceptibility previously observed for the 150/20 sample. It was also in agreement with our previous work about the influence of trapping on the hydrogen diffusion in low-copper 7xxx aluminium alloy [8]. Indeed, SKPFM investigations had demonstrated that the hardening incoherent precipitates formed during the ageing treatment at 150 °C acted as hydrogen trapping sites and thus limited the hydrogen diffusion in the alloy. In order to compare the behaviour of both 150/20 and T4 samples during tensile tests in air, it was necessary to introduce the same hydrogen amount inside the samples; therefore, on the basis of the results (Fig. 3), it was decided to immerse T4 and 150/20 samples in 0.6 M NaCl during 1 h and 72 h, respectively, before the tensile tests. With such a pre-corrosion duration time, it was possible to have similar hydrogen contents for both samples, i.e. 9 wppm (Fig. 3). Moreover, because both T4 and 150/20 samples were only susceptible to matrix dissolution or pitting corrosion with shallow pits, and not to intergranular corrosion, it was assumed that the mechanical behaviour of the hydrogen-precharged samples during the tensile tests was mainly affected by hydrogen, and not by the surface corrosion defects.

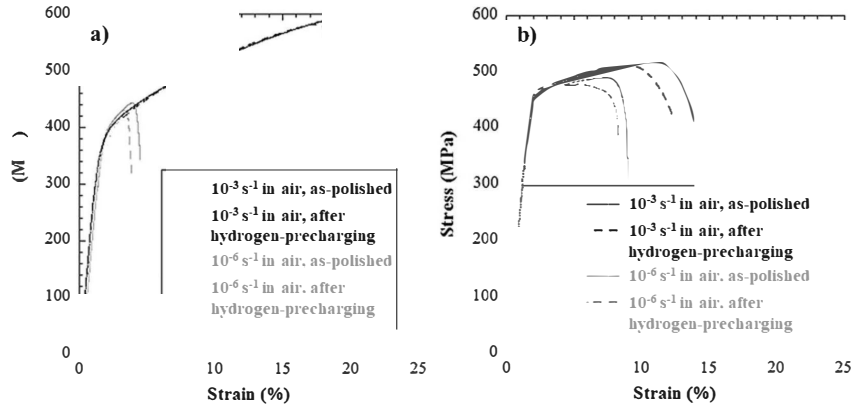
Fig. 4. Tensile curves obtained for a) T4 and b) 150/20 samples. Experiments were performed in laboratory air under controlled moisture, for two strain rates, i.e. 10^{-3} and 10^{-6} s^{-1} , for both as-polished (i.e., without hydrogen-precharging) and hydrogen-precharged samples (i.e., after 1 h and 72 h in 0.6 M NaCl for T4 and 150/20 samples, respectively). All tensile tests were performed using the same test frame (frame capacity of 30 kN). (Black and white figure; two-columns).

Fig. 4a and b shows a comparison of the tensile behaviour in laboratory air under controlled moisture (relative humidity of about 60 %) of T4 and 150/20 samples, respectively, at an intermediate strain rate (10^{-3} s^{-1}) and a slow strain rate (10^{-6} s^{-1}) for as-polished (i.e., without hydrogen-precharging) and hydrogen-precharged (9 wppm of hydrogen) samples. It is reminded here that all the tensile curves were plotted using the same test frame for a relevant comparison of the results. At first, it must be noticed that, for as-polished samples, tensile curves plotted at 10^{-3} s^{-1} logically showed an increase in the yield strength (from 365 MPa for T4 to 435 MPa for 150/20) in parallel to a decrease in the elongation to failure (from 18 % for T4 to 13.5 % for 150/20) for 150/20 sample as compared to T4 sample. This behaviour was consistent with the literature [44,45], and was attributed to the overageing of the 150/20 sample. In their work, Albrecht et al. [21] studied different metallurgical states for an AA 7075 and gave the same conclusions. In particular, the formation of intragranular hardening precipitates, i.e. η' and η -MgZn₂, limited the dislocation motion, which explained the higher yield stress for 150/20 sample, as compared to the T4 sample. Moreover, the dislocations pile-ups around these precipitates led to a premature failure and thus to a lower elongation to failure for

the 150/20 sample as compared to the T4 sample. Surprisingly, the work hardening ($d\sigma/d\varepsilon$) was stronger for the T4 sample than for the 150/20 sample. This could be explained by solute atom-dislocations interactions and the formation of dislocation forests (dislocations threading the glide plane) leading to a strong increase in the hardness of the grains [45]. In the 150/20 sample, the dislocations interacted preferentially with the hardening intragranular precipitates, thus limiting the interactions between dislocations. Moreover, comparison of the curves obtained at 10^{-3} s^{-1} and 10^{-6} s^{-1} , for two given samples, e.g. two as-polished T4 samples, showed that there was no significant change in the constitutive mechanical laws related to the strain rate, considering a cumulated plastic strain lower than 2 %; the major change was a decrease in the elongation to failure that could be attributed either to a purely mechanical effect (strain rate sensitivity and strain localisation) or to an influence of hydrogen from moist air. Indeed, for given samples, the exposure time to moist air was longer during a 10^{-6} s^{-1} test than during a 10^{-3} s^{-1} test.

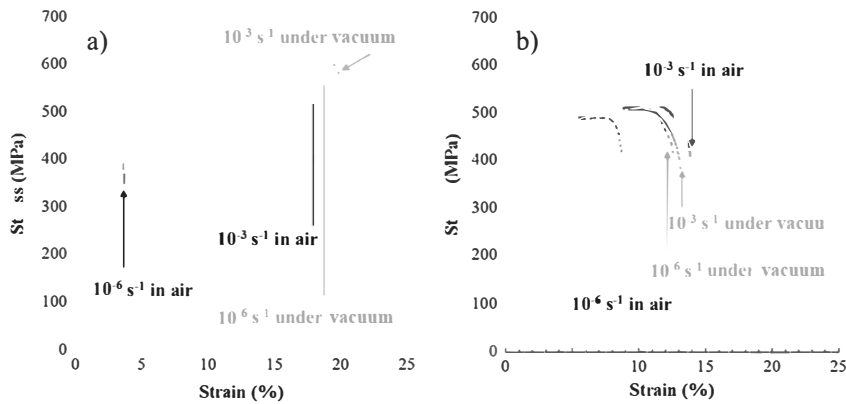
Fig. 8. Tensile curves plotted at 10^{-3} and 10^{-6} s^{-1} under vacuum for as-polished a) T4 and b) 150/20 samples. For a relevant comparison, new tensile tests in laboratory air under controlled moisture were performed for as-polished samples using the same loading frame (frame capacity of 5 kN) as for tensile tests under vacuum. (Black and white figure; two-columns).

Finally, to strengthen the demonstration of the influence of moist air on the tensile behaviour of AA 7046 samples at slow strain rates, complementary tensile tests were carried out under vacuum (10^{-5} mbar) for two strain rates, i.e. 10^{-3} s^{-1} and 10^{-6} s^{-1} , on as-polished T4 (Fig. 8a) and 150/20 (Fig. 8b) samples. In order to allow a relevant comparison with tensile tests performed in laboratory air, a new set of tensile tests were performed in laboratory air for as-polished samples using the same loading frame as for tests under vacuum. One could note that there was no significant difference between the tensile curves plotted in laboratory air using the 30 kN loading frame (Fig. 4) and those plotted with the 5 kN loading frame (Fig. 8). All these experiments aimed in particular to investigate the influence of the sole strain rate on the mechanical response of both metallurgical states. The results showed that, under vacuum, for both T4 and 150/20 samples, the mechanical responses, i.e. the flow rules, were independent of the strain rate. Furthermore, for both samples, the tensile curves plotted at 10^{-3} s^{-1} in laboratory air were similar to those obtained under vacuum. The slight difference in elongation to failure between the tensile curves at 10^{-3} s^{-1} in laboratory air and tensile curves at 10^{-3} s^{-1} under vacuum was due to the difference in precision between the two techniques used to measure the sample strain, i.e. by means of a laser extensometer for under-vacuum tests and by contact extensometers for tests in laboratory air (as indicated in the experimental part). On the contrary, for both samples, significant differences were observed between the tensile curves plotted at 10^{-6} s^{-1} in air and under vacuum. Therefore, the results confirmed the role of hydrogen issued from moist air on the decrease in the elongation to failure previously observed for tensile tests performed at 10^{-6} s^{-1} in laboratory air.

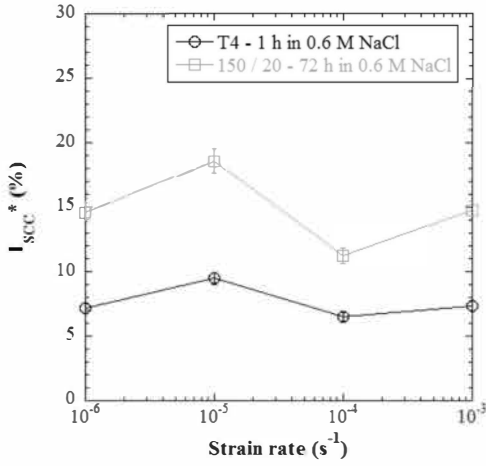
Fig. 10. Corrected stress corrosion cracking factor (I_{SCC}^*) versus the strain rate for both T4 and 150/20 samples. Tensile tests were performed under laboratory air after hydrogen-precharging corresponding to an exposure to 0.6 M NaCl during 1 h and 72 h for T4 and 150/20 samples, respectively. (Black and white figure; two-columns).

With this definition, I_{SCC}^* values reflected the influence on the tensile results of hydrogen from the precharging step only. Such an approach could be related to that previously developed by Holroyd and Hardie, who addressed the same issue using a 'reduction in area' fracture parameter [33]. Fig. 10 shows I_{SCC}^* values as a function of the strain rate for both hydrogen-precharged T4 and 150/20 samples. At first, results clearly showed that I_{SCC}^* values were significantly lower than I_{SISF} values, which confirmed, for these precharging conditions, the major influence of hydrogen from moist air. Then, it could be observed that I_{SCC}^* values were lower for T4 samples than for 150/20 samples, whatever the strain rate, and contrary to I_{SISF} values. Finally, it could be noticed that no significant influence of the strain rate on the I_{SCC}^* values could be highlighted for both T4 and 150/20 samples. For the 150/20 sample, such a result could be explained once more by considering that the corrosion-induced hydrogen was trapped by hardening precipitates, and therefore it was not likely to interact with dislocations. Such a result had already been observed in a previous study: it had been shown that the hydrogen diffusion depth was unchanged after three weeks of desorption [8], suggesting the irreversible nature of the trapping sites at ambient temperature, even though hydrogen uptake might reverse after extended recovery times. However, concerning the T4 samples, the same study showed that the major part of the hydrogen introduced in the alloy
