Bioprecipitation of a calcium carbonate – Biofilm composite on the surface of concrete for the maintenance of nuclear reactor enclosures

C. Lors, Denis Damidot, Laurent Petit, A. Legrix, N.C. Tran, B. Masson

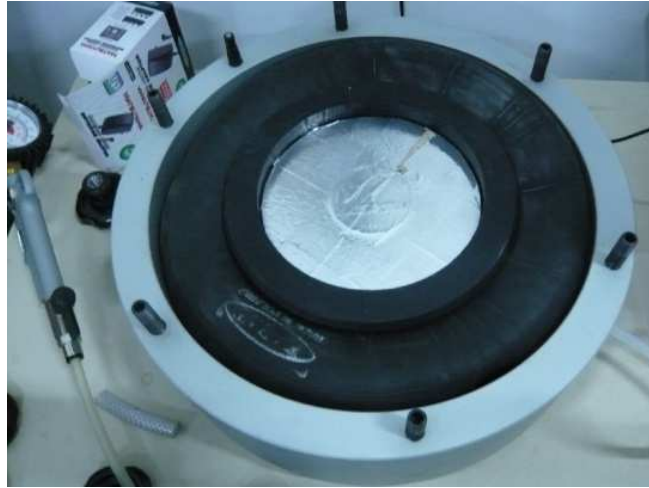
Fig. 1. Permeability cell accommodating the mortar coated with adhesive aluminum foil
586 except at the micro-crack (pressure arrival side), the other side having undergone
587 treatment by bioprecipitation was not covered with adhesive aluminum.

171 Pressurization of the micro-crack treated by bioprecipitation was carried out using a
172 CEMBURO permeabilimeter equipped with digital flowmeters (Fig. 1), since it was not
173 possible to use the permeabilimeter specifically designed for the annular mortar fitted with
174 their steel core to achieve pressures greater than 100 kPa.

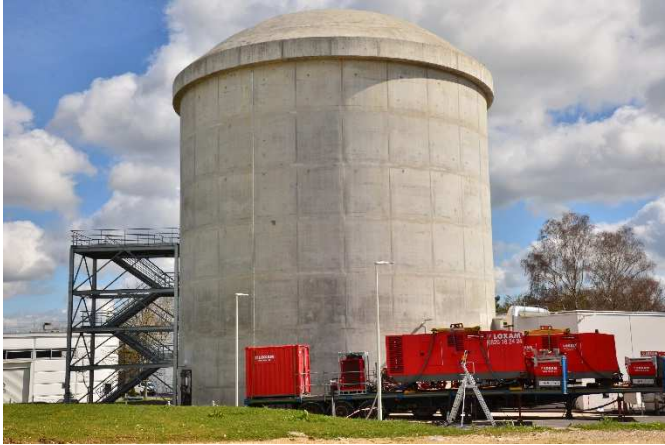
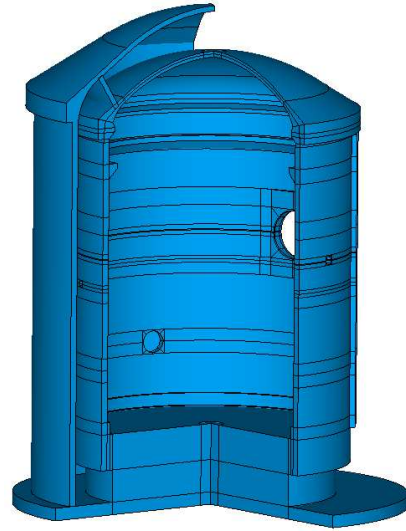
190 VeRCoRs is a replica at 1/3 scale of a 1300 MW nuclear reactor enclosure, which was
191 built at EDF Lab - Les Renardières (France) (Fig. 2). This double-walled containment,
192 approximately 30 m high and 16 m diameter, has internal prestressed concrete walls 40 to
193 60 cm thick depending on the location. The prestressed reinforced concrete structure of
194 VeRCoRs is strongly reinforced to withstand mechanical stresses, especially during
195 pressurization. It is a research tool used to simulate the behavior of prestressed concretes
196 over time. In addition to the monitoring of the deformations of the building, VeRCoRs is
197 equipped with 700 sensors and 2 km of optical fibers. The evolution of its leak tightness is
198 quantified each year by the measurement of leaking during pressurization tests at 500
199 kPa (absolute pressure).

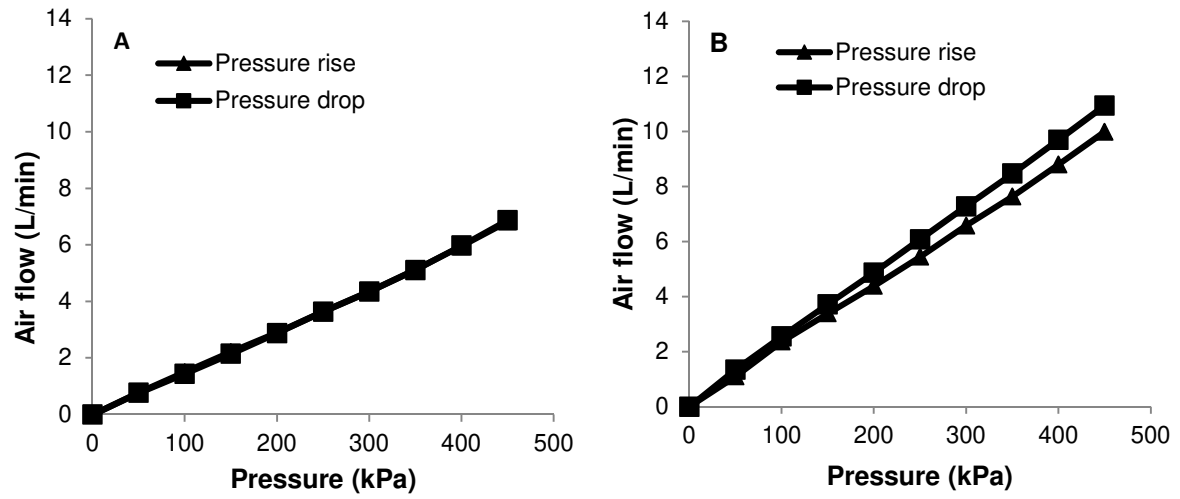
625 **Fig. 6.** Evolution of the air flow within the micro-crack of mortars A and B during
626 the pressure cycle.

309 For the two mortars tested, the air flow increased progressively when applying an
310 increasing pressure until reaching 450 kPa. Oppositely, the air flow decreased with a
311 decrease of the pressure (Figs 6A and 6B). A very good proportionality of the air flow as a
312 function of the pressure was observed for the two samples during both rising and

313 decreasing of the pressure in accordance with Darcy's law. Thus, the increase in pressure
314 did not seem to modify the apparent opening of the micro-crack since the slope of the
315 curve remained constant for both rising and decreasing parts of the pressure cycle (Figs
316 6A and 6B). Moreover, this slope was identical for the rise and the descent in pressure for
317 the mortar A. Thus, the pressure bearing at 450 kPa did not modify the apparent opening
318 of the micro-crack of the mortar A. The mortar B behaved differently since the air flow
319 increased slightly from 9.99 to 10.94 L/min in relation to a probable increase in the
320 apparent opening of the micro-crack. However, the estimate of the apparent opening of
321 the micro-crack using the air permeability cell specifically made to accommodate the
322 mortar rings (Section 2.2.3) indicated a decrease in the apparent opening of 2 and 5 μm

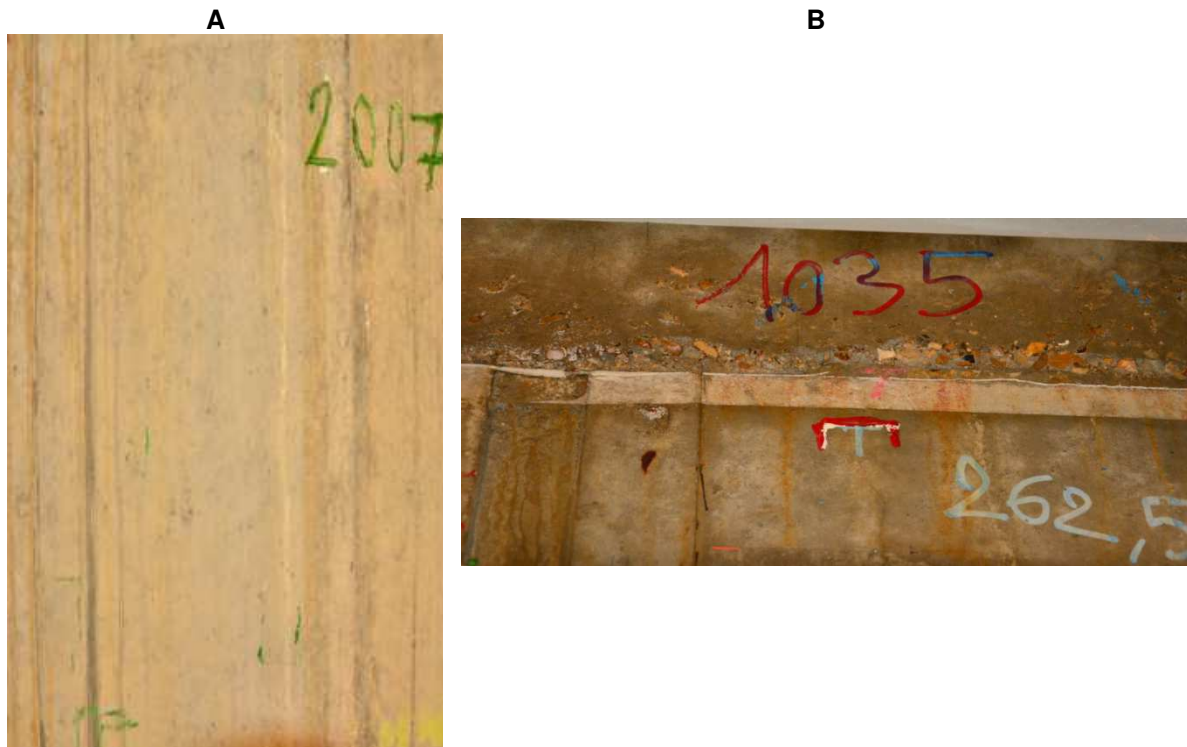
Fig. 9. Zone 1 (A) and zone 2 (B) after bioprecipitation treatment.

438 The two concrete surfaces, having been treated with the procedure previously described,
439 had a pale yellow color, which is related to the formation of the calcium carbonate - biofilm
440 composite (Fig. 9). Consequently, the bioprecipitation treatment procedure specifically
441 defined for VeRCoRs was successful. The observed robustness may also be related to
442 the involvement of bacterial populations present in the concrete walls in addition to *B.*
443 *pseudofirmus* brought by bioprecipitation treatment. Indeed, some strains of the
444 indigenous microflora, which were in a latent state on the concrete walls, may be activated
445 during the bioprecipitation treatment that brings nutriment and water. Thus, after a first
446 bioprecipitation treatment, the potential of bioprecipitation should remain and could be
