## Bioprecipitation of a calcium carbonate – Biofilm composite on the surface of concrete for the maintenance of nuclear reactor enclosures

C. Lors, Denis Damidot, Laurent Petit, A. Legrix, N.C. Tran, B. Masson

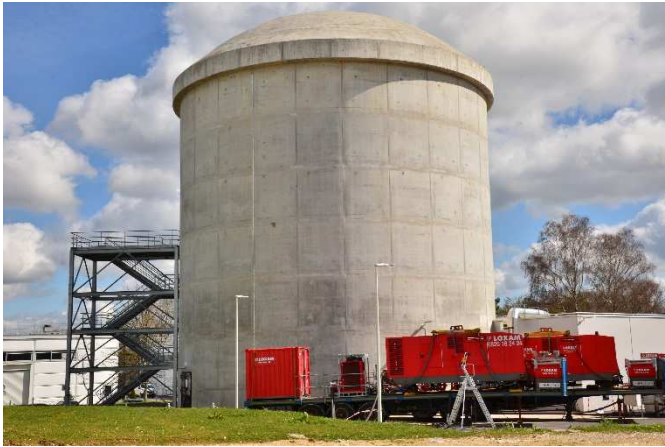
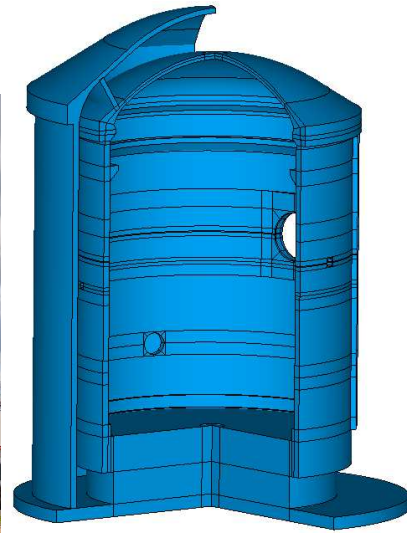
190 VeRCoRs is a replica at 1/3 scale of a 1300 MW nuclear reactor enclosure, which was  
191 built at EDF Lab - Les Renardières (France) (Fig. 2). This double-walled containment,  
192 approximately 30 m high and 16 m diameter, has internal prestressed concrete walls 40 to  
193 60 cm thick depending on the location. The prestressed reinforced concrete structure of  
194 VeRCoRs is strongly reinforced to withstand mechanical stresses, especially during  
195 pressurization. It is a research tool used to simulate the behavior of prestressed concretes  
196 over time. In addition to the monitoring of the deformations of the building, VeRCoRs is  
197 equipped with 700 sensors and 2 km of optical fibers. The evolution of its leak tightness is  
198 quantified each year by the measurement of leaking during pressurization tests at 500  
199 kPa (absolute pressure).

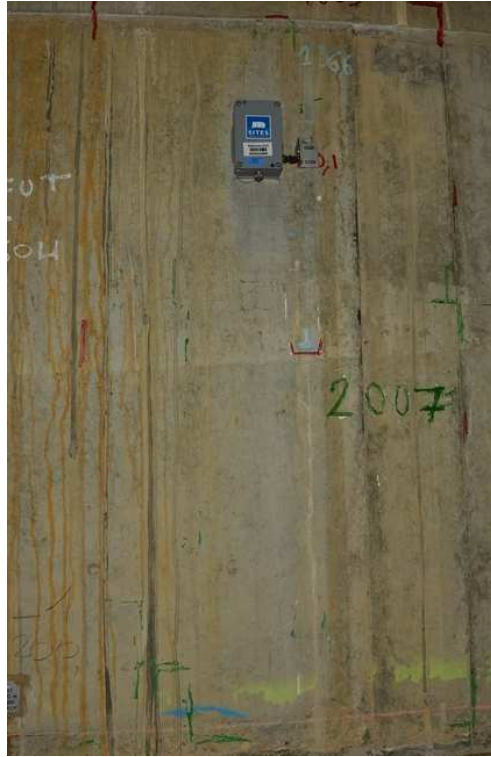
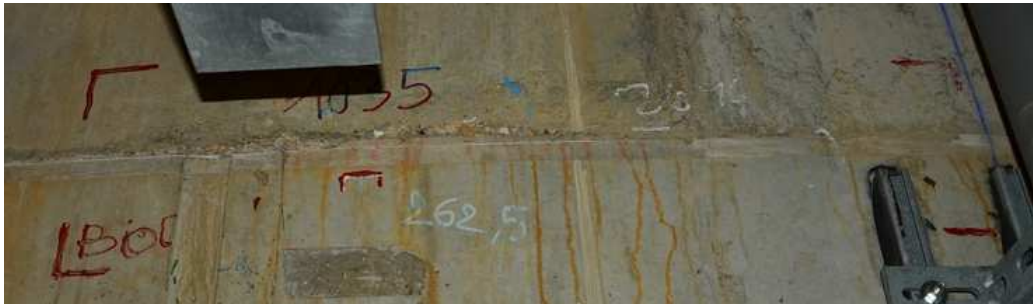
**Fig.3.** Zone 1 (A) and zone 2 (B) selected to perform bioprecipitation treatment.

200 Two zones with different types of micro-cracks were selected in interior concrete walls of  
201 VeRCoRs: a vertical zone in the middle of a vertical wall (named zone 1) and a horizontal  
202 zone corresponding to a vertical interface between two concrete batches (named zone 2)  
203 of respective dimensions equal to  $1.2 \times 0.5 \text{ m}^2$  and  $0.8 \times 0.25 \text{ m}^2$  (Fig. 3A and Fig. 3B  
204 respectively). These zones are instrumented to measure the leakage rate induced by the

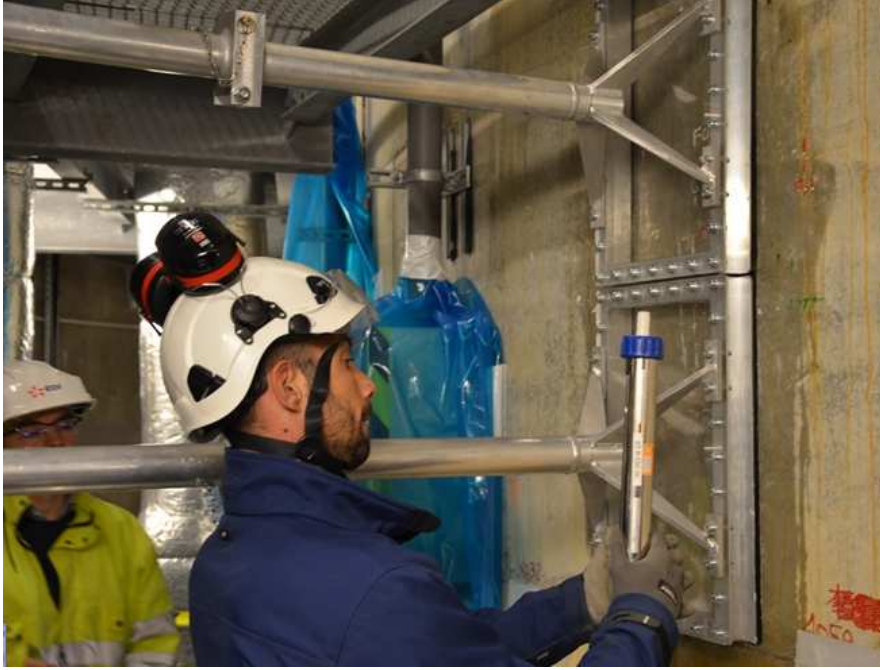
613 **Fig. 4.** Collecting box around the leakage zone.

205 micro-cracks during the pressurization test. The method of measuring the leakage flow  
206 consists in applying a collecting box around the leakage zone, ensuring the leak tightness  
207 of the device for measuring the leakage flow and thus comparing the evolution of this  
208 zone between two cycles of pressurization (Fig. 4).

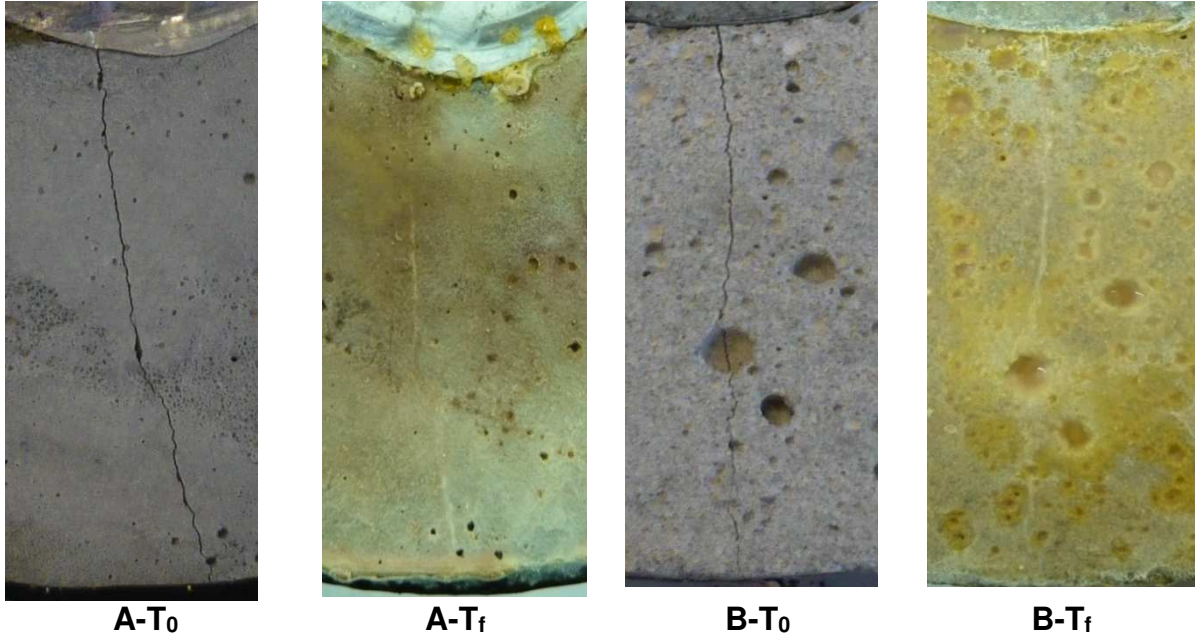
288 After 4 cycles of bioprecipitation treatment, a light yellow-colored calcium carbonate -  
289 biofilm composite layer was clearly visible on the surface of the two samples used in this  
290 study (referred to as mortars A and B), but also in defects such as the air bubbles and at  
291 the micro-crack that looked to be sealed at that scale (Fig. 5).

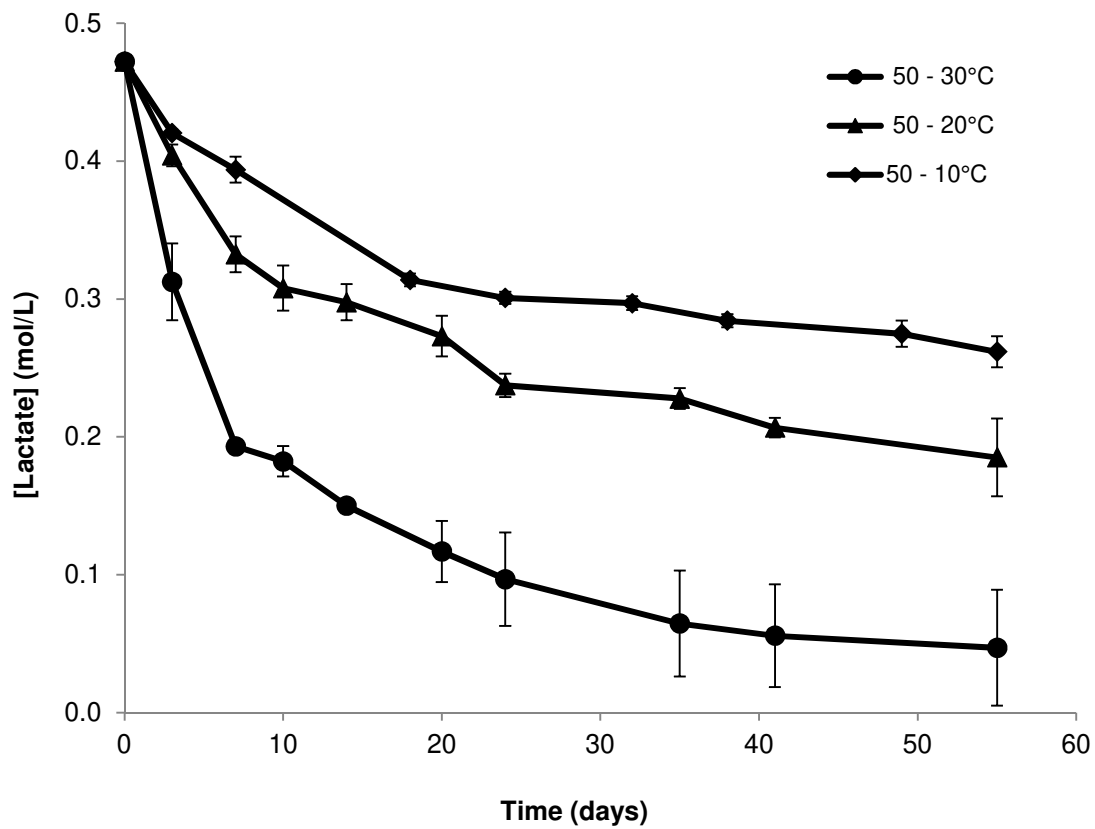
631 **Fig. 7.** Evolution of lactate concentration in growth tests of *Bacillus pseudofirmus*

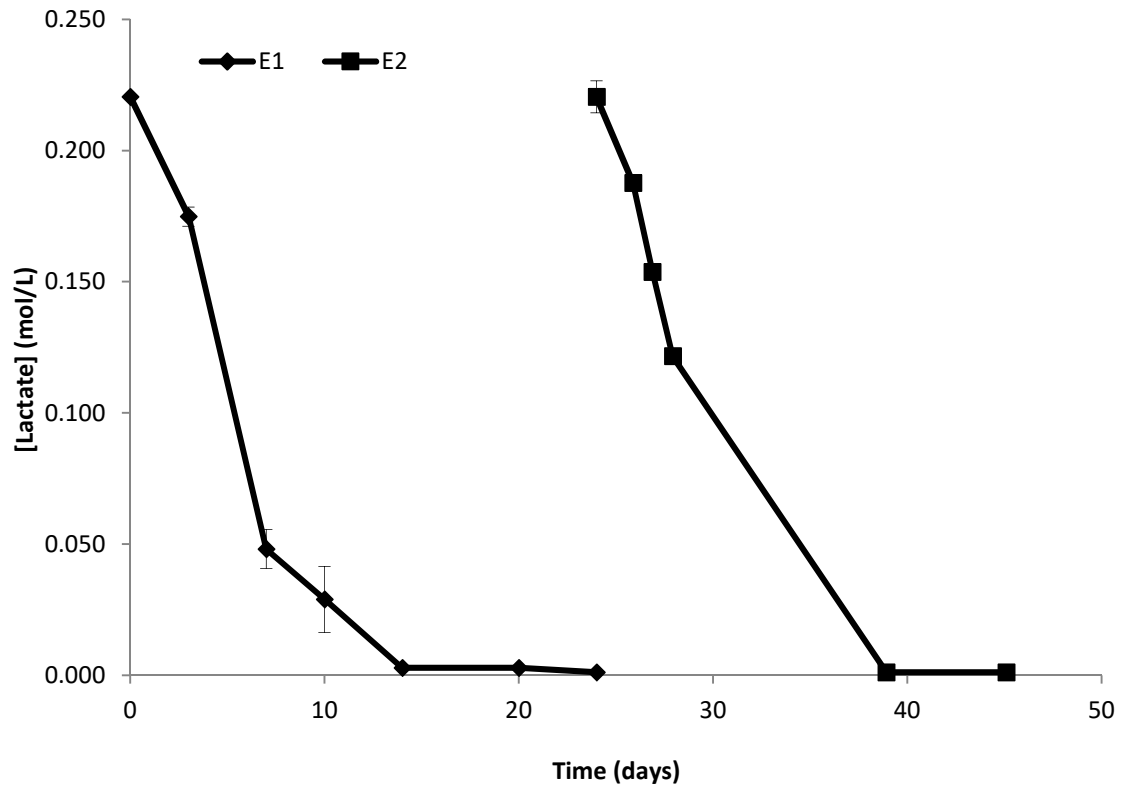
637 **Fig. 8.** Evolution of lactate concentration during a first bacterial growth at 30 °C with a  
638 bacterial inoculum of *Bacillus pseudofirmus* in the presence of 25 g/L of calcium lactate  
639 (E1 curve) followed by a second bacterial growth of the mature bacterial suspension  
640 (starting at 24 days) in the presence of 25 g/L of calcium lactate thanks to the addition of  
641 calcium lactate to the bacterial suspension (E2 curve).

394 days of culture (E2 curve on Fig. 8). Thus, the rate of lactate consumption starting with a  
395 mature bacterial suspension (E2 curve on Fig. 8) is comparable than the one observed  
396 during the first bacterial growth starting with a bacterial inoculum (E1 curve on Fig. 8)  
397 containing 266 times fewer bacterial cells. This result validates an experimental protocol  
398 based on bioprecipitation cycles with sprays of a bacterial suspension at the beginning,  
399 and then sprays of nutrient medium at longer times once a bacterial colonization is well  
400 established on the support.

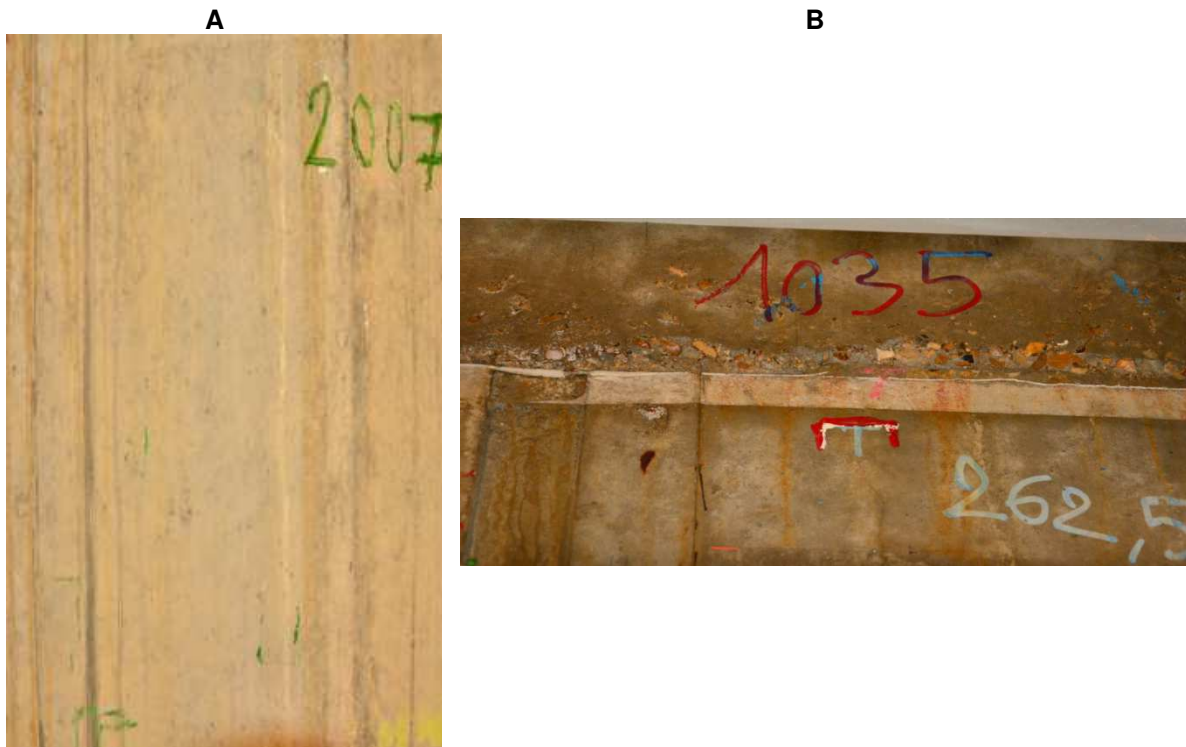
**Fig. 9.** Zone 1 (A) and zone 2 (B) after bioprecipitation treatment.

438 The two concrete surfaces, having been treated with the procedure previously described,  
439 had a pale yellow color, which is related to the formation of the calcium carbonate - biofilm  
440 composite (Fig. 9). Consequently, the bioprecipitation treatment procedure specifically  
441 defined for VeRCoRs was successful. The observed robustness may also be related to  
442 the involvement of bacterial populations present in the concrete walls in addition to *B.*  
443 *pseudofirmus* brought by bioprecipitation treatment. Indeed, some strains of the  
444 indigenous microflora, which were in a latent state on the concrete walls, may be activated  
445 during the bioprecipitation treatment that brings nutriment and water. Thus, after a first  
446 bioprecipitation treatment, the potential of bioprecipitation should remain and could be
