## Quantifying 450 years of limestone weathering induced by salt crystallization on fortifications in Malta and Gozo

Erwan Roussel, Franck Vautier, Olivier Voltaire, Marie-Françoise André, Joann Cassar, et al.. Quantifying 450 years of limestone weathering induced by salt crystallization on fortifications in Malta and Gozo. *Geomorphology*, 2021, 378, pp.107614. 10.1016/j.geomorph.2021.107614 . hal-03113888

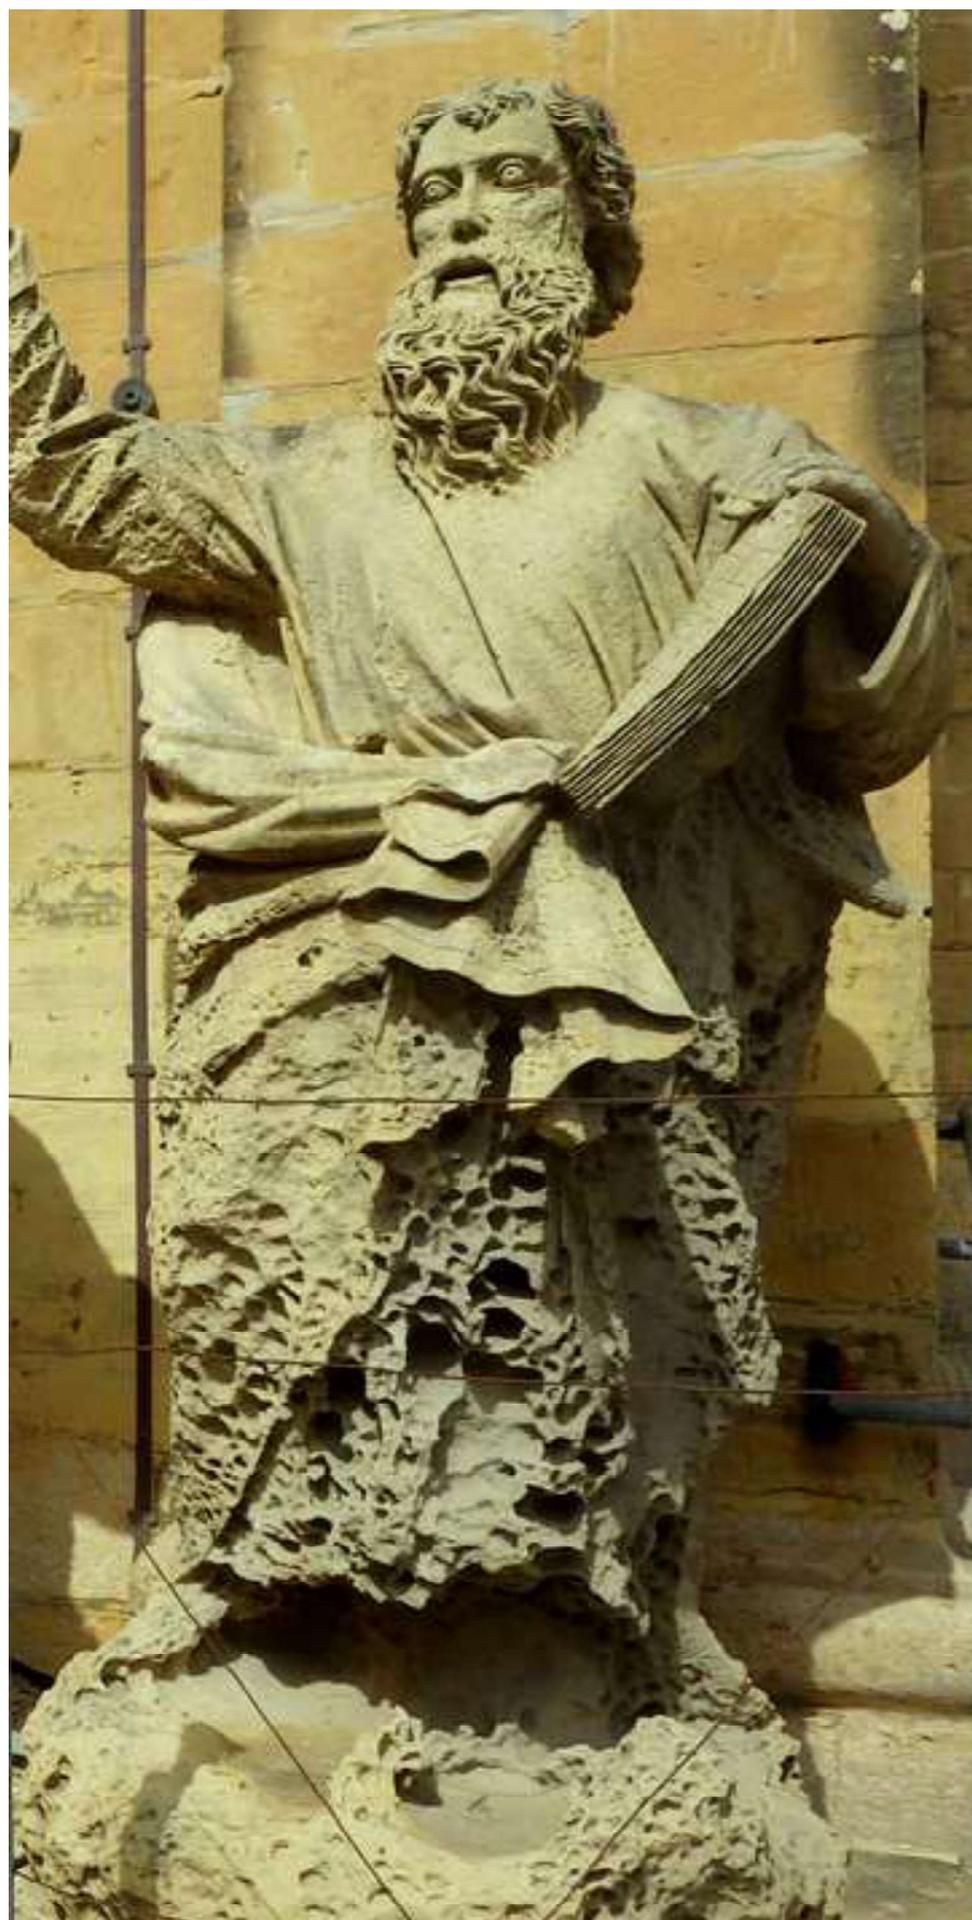
Fig. 2. External wall of Inquisitor's Palace in Vittoriosa showing individual blocks of Globigerina Limestone at different stages of alveolar weathering, from almost sound stone to totally backweathered stone (Photo M.F. André). Numbers indicate the phases of the damage model: 1 - non-weathered stone surface; 2 – local backweathering; 3 - cavities formation and salt accumulation behind the crust; 4 - cavities coalescence and formation of larger and deeper alveoli; 5 - pronounced backweathering results in the development of a more or less plain surface and the rounding of block edges.

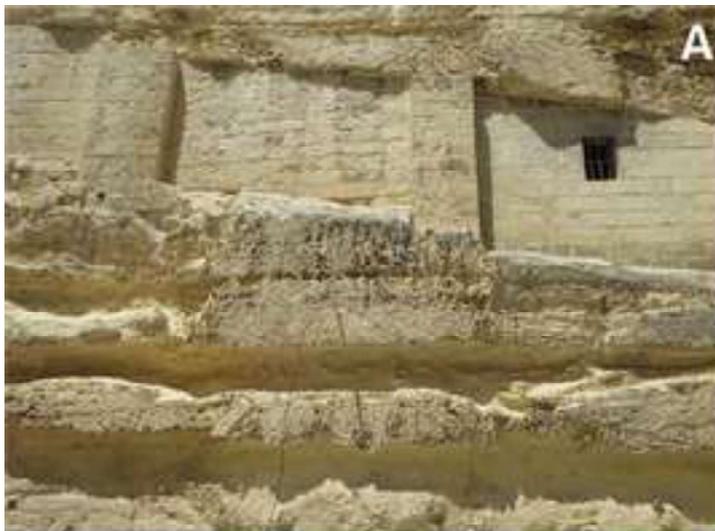
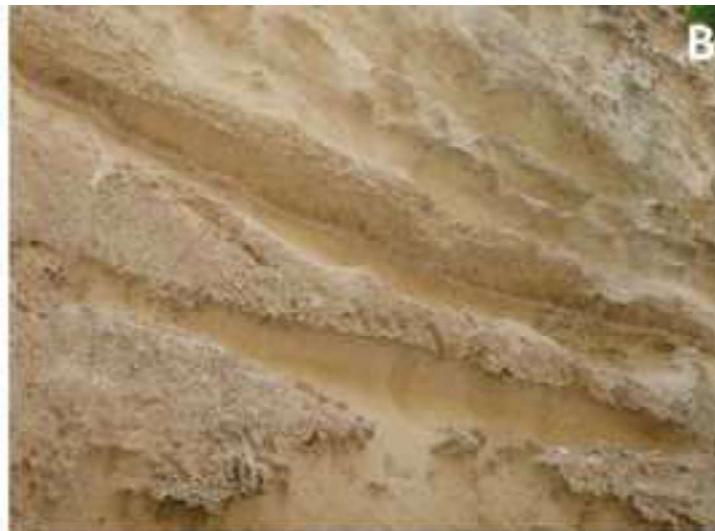
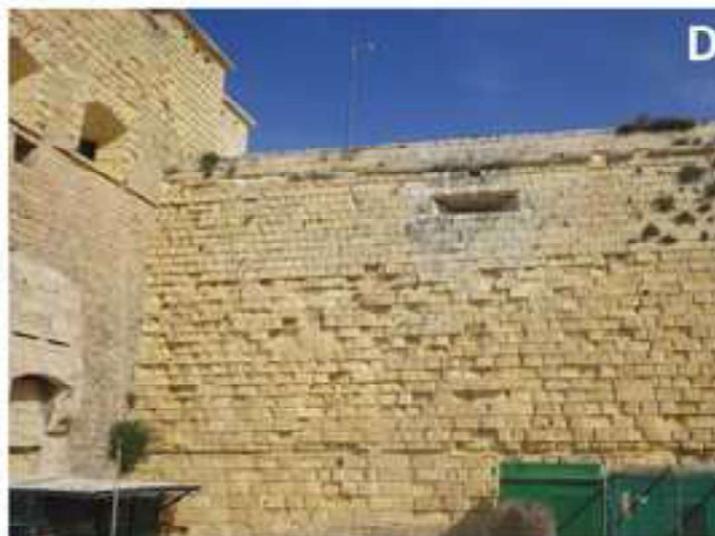
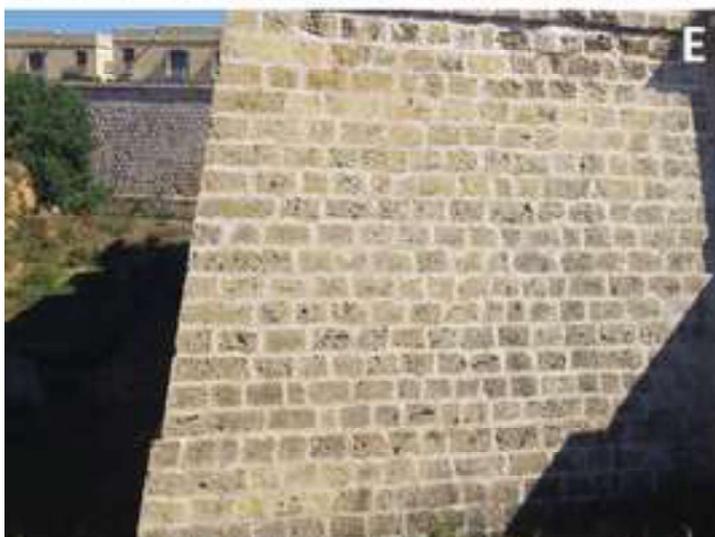
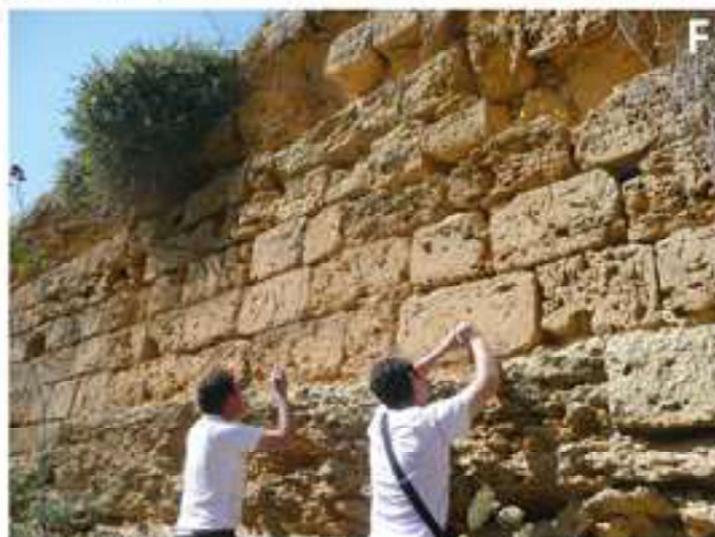
148 The first study area is located in the Valletta defensive ditch (Fig. 4A and 5A-B), in the SW part  
149 of the Valletta fortified city. This walled city was designed by the Papal engineer Francesco  
150 Laparelli, and built in Globigerina Limestone between 1566 and 1570, just after the Great Siege  
151 of 1565 (Spiteri, 2001). The site for measuring limestone loss was selected in a non-restored  
152 part of the ditch, of particular interest because of its alternating *Franka* and *Soll* layers  
153 (determined visually), and of the remarkable preservation of original tooling marks in places.  
154 This part of the ditch wall faces the east. To make the comparison between stone materials  
155 easier, sections of the investigated photogrammetric imagery in *Franka* have been  
156 denominated Site 1 and sections in *Soll* appear as Site 2.

158 Site 3 is located in Abercrombie's Curtain. It is part of Fort St Elmo which is located at the NE  
159 tip of the Valletta fortified city (Fig. 4 and 5 C). The investigated section of fortifications faces  
160 the south-east direction and belongs to the external Carafa bastioned Enceinte designed by  
161 Don Carlos de Grunenbergh and built in 1687-89 on the foreshore surrounding the Fort to  
162 secure it (Spiteri, 2001). This curtain wall consists of Coralline Limestone. The lime mortar  
163 between ashlar blocks is barely visible for it has been eroded from the surface. No repointing  
164 of mortar joints had been done at the time of the study.

166 Site 4 is located in the NE part of the French Curtain, beneath Fort St Elmo (Fig. 4A and 5D).

188 a lower quality Globigerina Limestone (*Soll*), more prone to honeycomb weathering, was used  
189 for the counterguard (site 6 facing the south-west, Fig. 5F). In both places, the surface of a  
190 number of stones has retained tooling marks. The original mortar has been partly eroded in

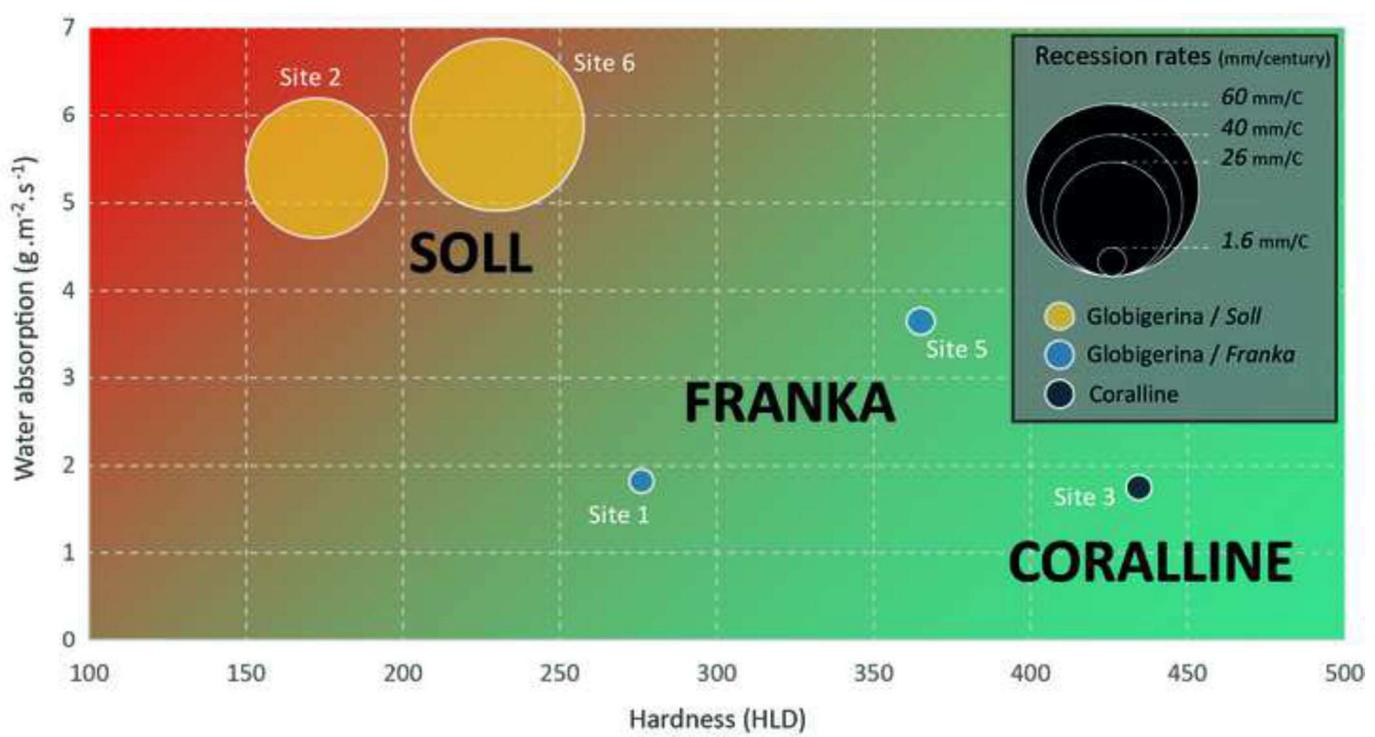
Figure 12

847 Fig. 12. Limestone durability scale obtained from data collected at 5 sites investigated in the  
848 Valletta Ditch, Fort St Elmo (in Malta) and Fort Chambray (in Gozo)

490 As expressed in Fig. 12, the results of the on-site behaviour of the investigated limestones  
491 (water absorption and hardness), as well as their microscopic structure, shed some light on  
492 the controlling factors of their contrasted durabilities. *Soll*, which has yielded the fastest  
493 weathering rates is the least mechanically resistant material (median surface hardness below  
494 230 HLD) and has the highest on-site water uptake capacity (median over 4.9 g.m<sup>-2</sup>.s<sup>-1</sup>).  
495 Moreover, microscopic observations indicate that it is a non-cohesive, poorly cemented or
