Quantifying 450 years of limestone weathering induced by salt crystallization on fortifications in Malta and Gozo

Erwan Roussel, Franck Vautier, Olivier Voltaire, Marie-Françoise André, Joann Cassar, Gilles Fronteau, Bruno Phalip, Céline Thomachot-Schneider, Jean-Pierre Toumazet

Erwan Roussel, Franck Vautier, Olivier Voltaire, Marie-Françoise André, Joann Cassar, et al.. Quantifying 450 years of limestone weathering induced by salt crystallization on fortifications in Malta and Gozo. *Geomorphology*, 2021, 378, pp.107614. 10.1016/j.geomorph.2021.107614 . hal-03113888

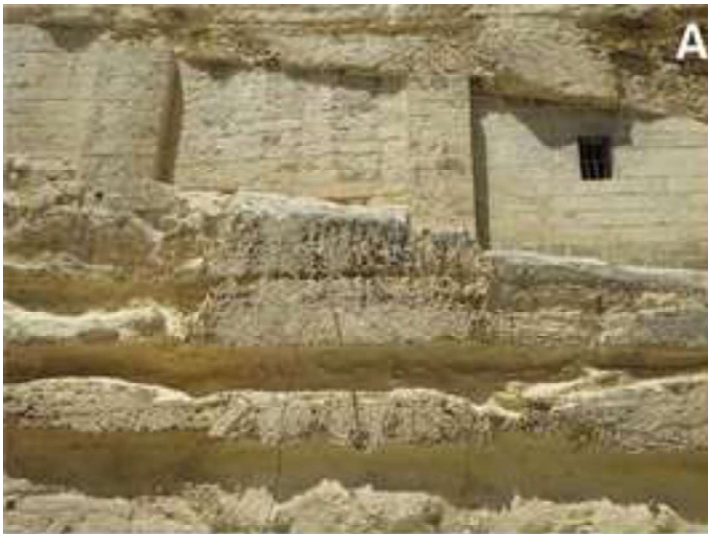
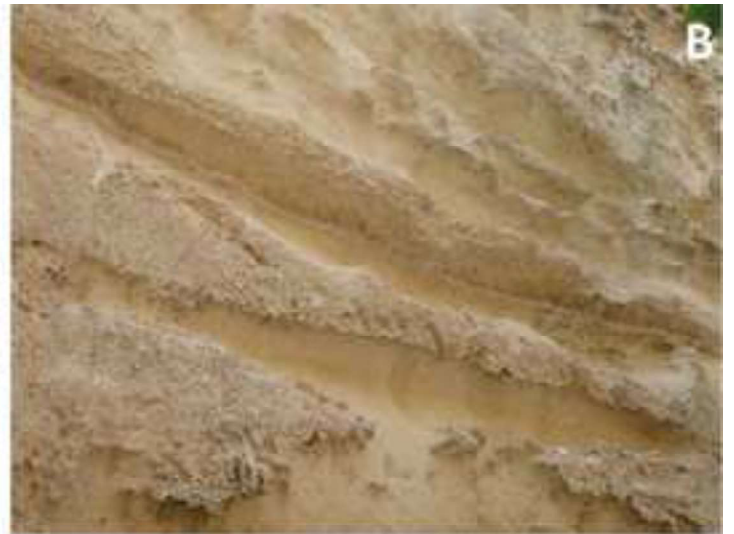
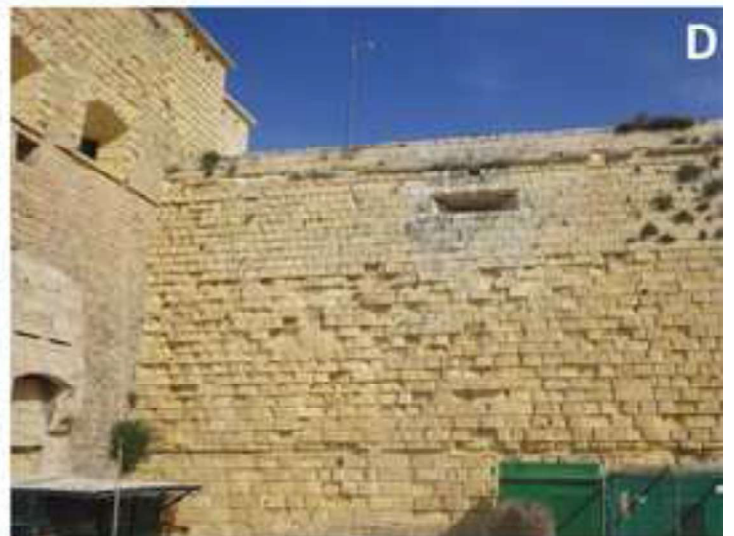
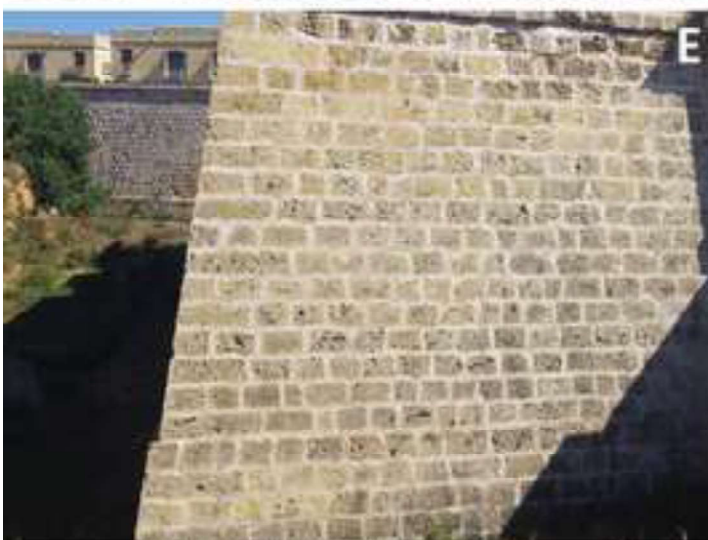
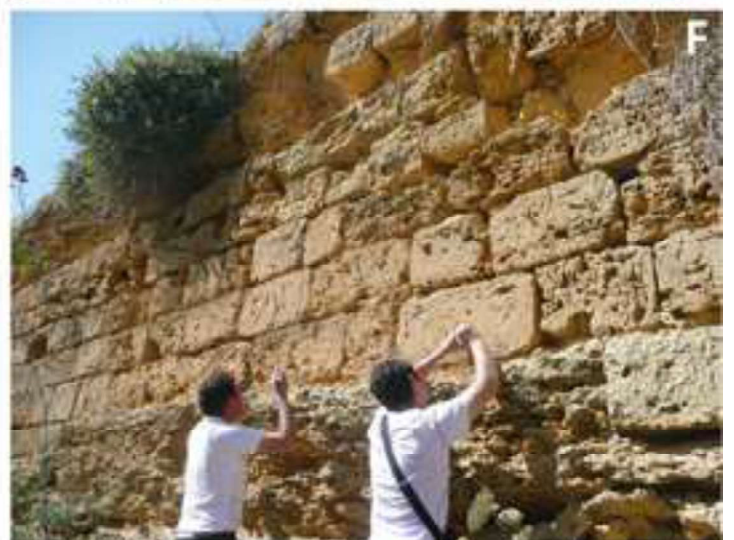
148 The first study area is located in the Valletta defensive ditch (Fig. 4A and 5A-B), in the SW part
149 of the Valletta fortified city. This walled city was designed by the Papal engineer Francesco
150 Laparelli, and built in Globigerina Limestone between 1566 and 1570, just after the Great Siege
151 of 1565 (Spiteri, 2001). The site for measuring limestone loss was selected in a non-restored
152 part of the ditch, of particular interest because of its alternating *Franka* and *Soll* layers
153 (determined visually), and of the remarkable preservation of original tooling marks in places.
154 This part of the ditch wall faces the east. To make the comparison between stone materials
155 easier, sections of the investigated photogrammetric imagery in *Franka* have been
156 denominated Site 1 and sections in *Soll* appear as Site 2.

158 Site 3 is located in Abercrombie's Curtain. It is part of Fort St Elmo which is located at the NE
159 tip of the Valletta fortified city (Fig. 4 and 5 C). The investigated section of fortifications faces
160 the south-east direction and belongs to the external Carafa bastioned Enceinte designed by
161 Don Carlos de Grunenbergh and built in 1687-89 on the foreshore surrounding the Fort to
162 secure it (Spiteri, 2001). This curtain wall consists of Coralline Limestone. The lime mortar
163 between ashlar blocks is barely visible for it has been eroded from the surface. No repointing
164 of mortar joints had been done at the time of the study.

166 Site 4 is located in the NE part of the French Curtain, beneath Fort St Elmo (Fig. 4A and 5D).

178 Sites 5 and 6 were selected at Fort Chambray, in the eastern part of the Island of Gozo (Fig. 4).
179 The construction of this fortress overlooking Mgarr harbour has been retraced by Buhagiar
180 and Cassar (2003) based on historic sources. Fort Chambray was designed in 1716 by the
181 French military engineer Louis François d'Aubigné de Tigné, but due to a lack of funding, its
182 construction was postponed until 1749. At that time, Jacques-François de Chambray,
183 Governor of Gozo, financed the construction and preliminary excavations started based on
184 Tigné's original design modified by Francesco Marandon. Work on the Fort itself began in 1752
185 and was completed by 1760. Stone quality was adjusted to strength requirements in the
186 different parts of the Fortress: on the exposed external wall of the right ravelin (site 5 facing
187 the north-west, Fig. 5E), a high quality Globigerina Limestone (*Franka*) was selected, whereas

188 a lower quality Globigerina Limestone (*Soll*), more prone to honeycomb weathering, was used
189 for the counterguard (site 6 facing the south-west, Fig. 5F). In both places, the surface of a
190 number of stones has retained tooling marks. The original mortar has been partly eroded in

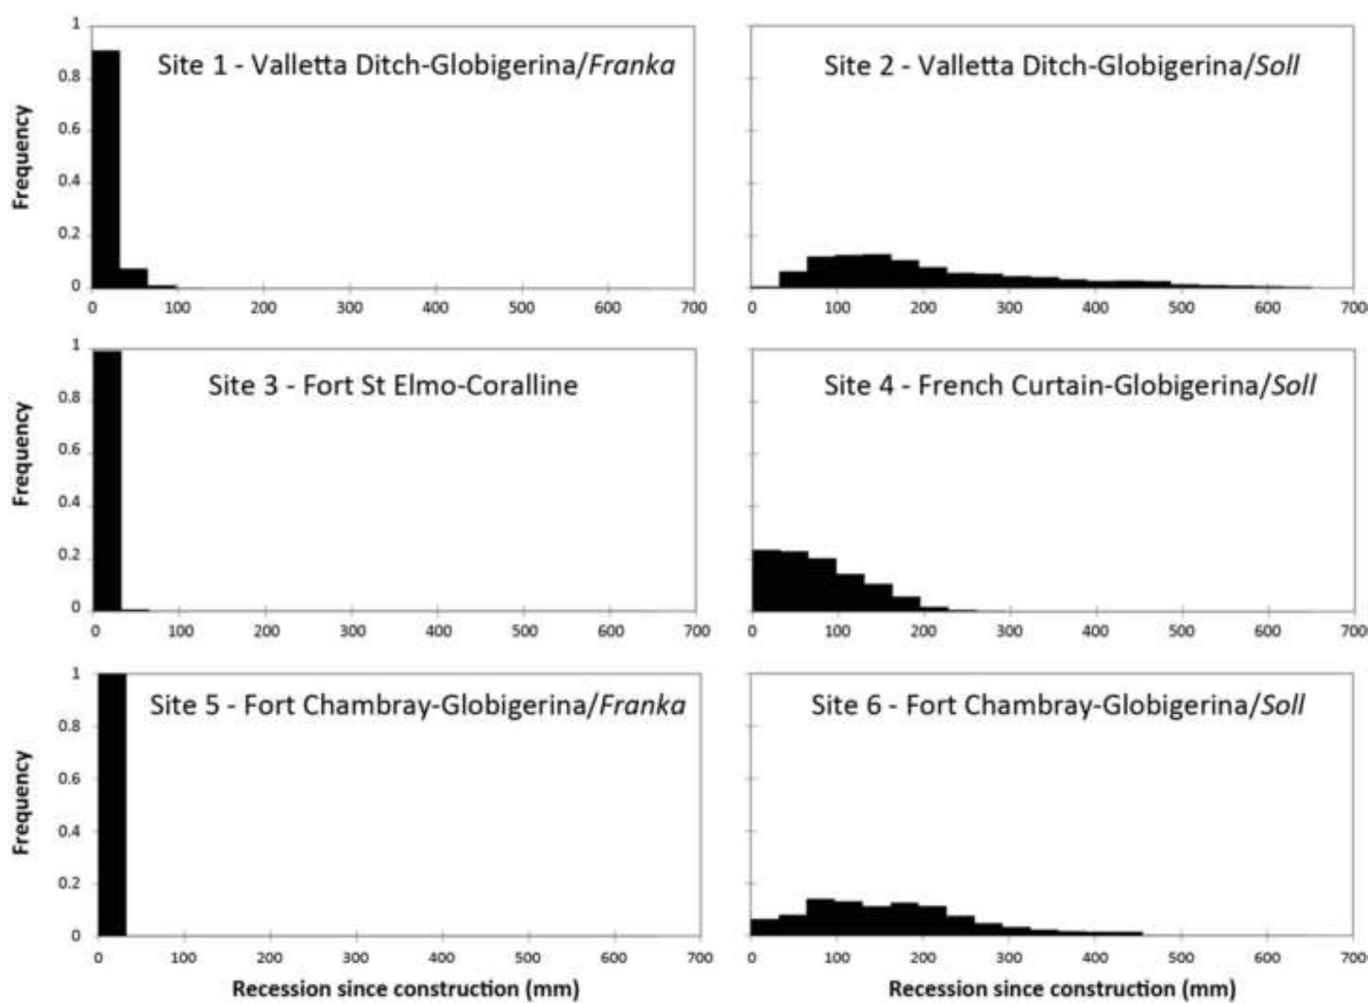
Figure 8

353 4.1 mm to 179.8 mm (Table 3). Distributions of stone recession values exhibit two contrasting
354 shapes (Fig. 8). The harder limestone types (Coralline Limestone and *Franka* facies of
355 Globigerina Limestone) of sites 1, 3 and 5 show concentrated low values and a very low
356 positive skewness of stone recession distributions ($MAD < 4$). On the contrary, the softer *Soll*
357 facies of Globigerina Limestone of sites 2, 4 and 6 exhibit highly dispersed values (MAD ranging
358 from 38.8 to 81.4) with a strong positive skewness.
