**State of knowledge and identification of research
priorities for the scientific validation of disaster resistant
building cultures of the Himalayan regions of Nepal :
Research report**

State of knowledge and identification of research priorities for the
scientific validation of disaster resistant building cultures of the
Himalayan regions of Nepal

Research report

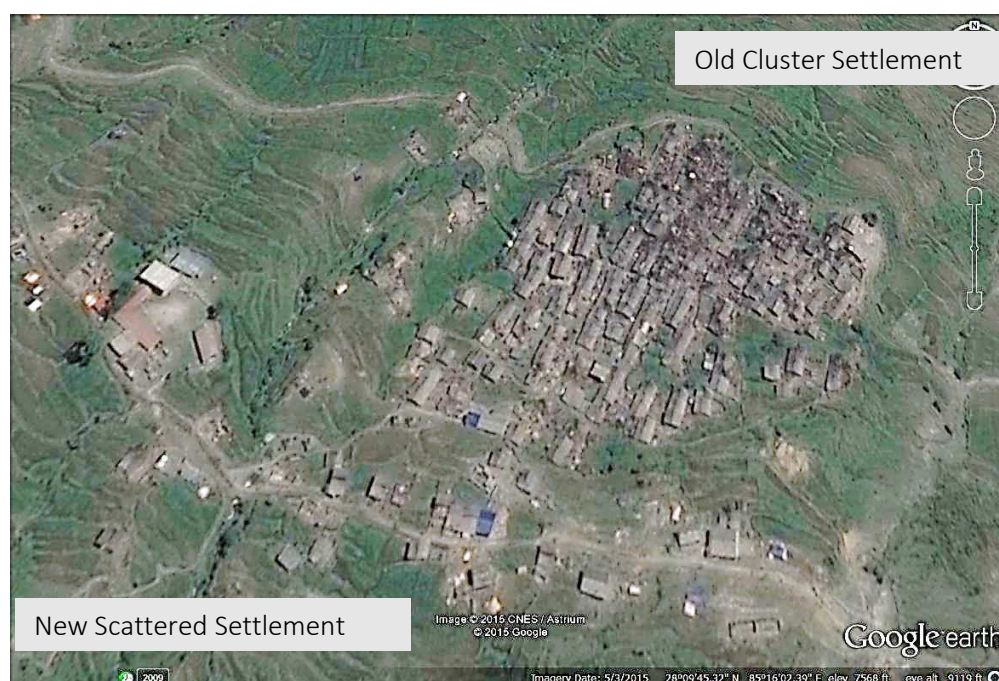
Fig.6) Top view of the village of Gatlang after 2015 EQ. (Source ASF Nepal report)

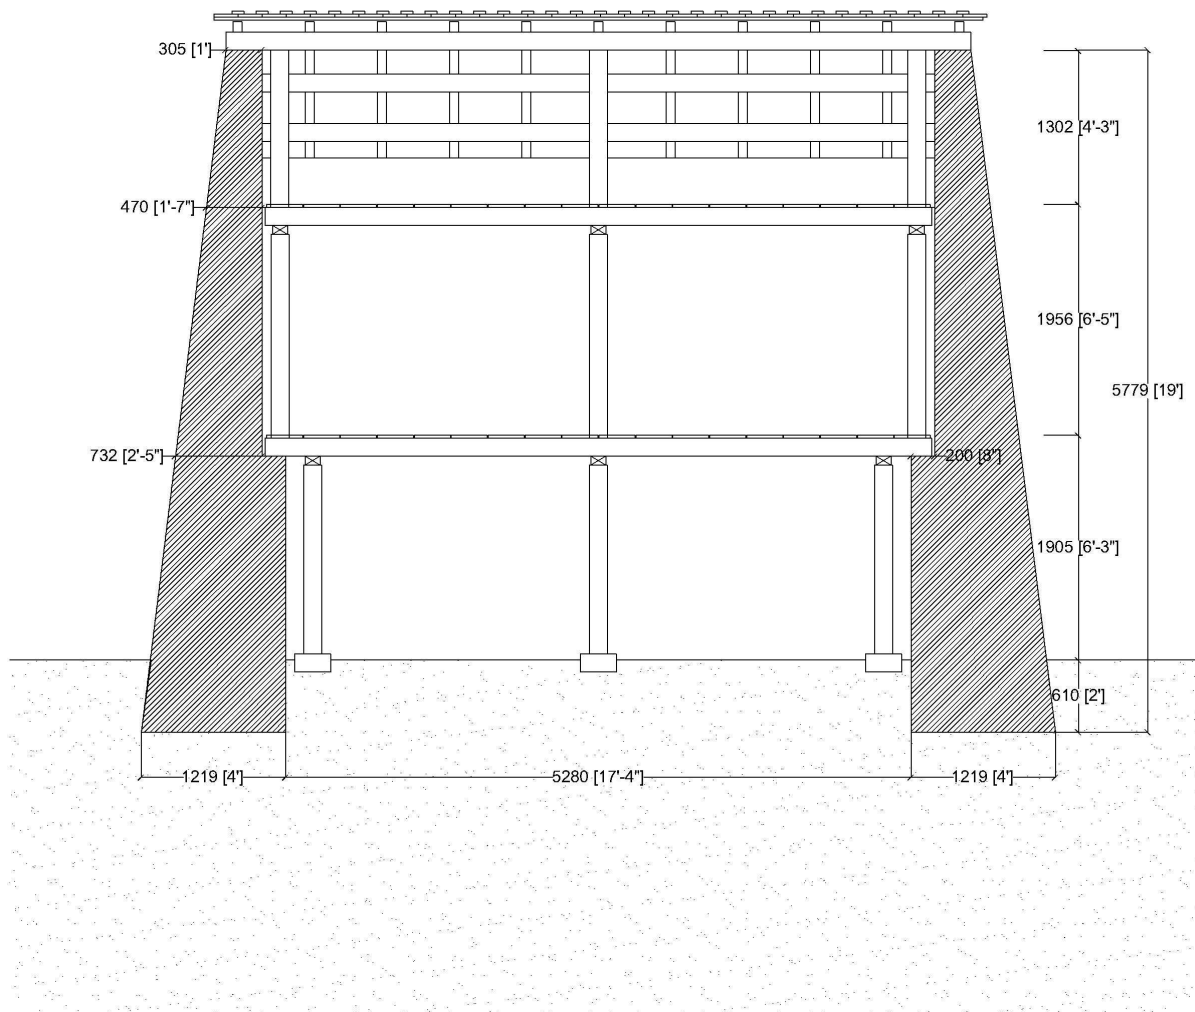
GATLANG VERNACULAR HOUSE TYPE 1 Existing drawings - dry stone Masonry		section BB'	échelle 1:50	format A4	date 01.04.2020
CRAtterre J.Hosta	<input type="checkbox"/>	<input type="checkbox"/>	0 0.5 1 2.5m

Fig. 17) Sample of house unit / Section.

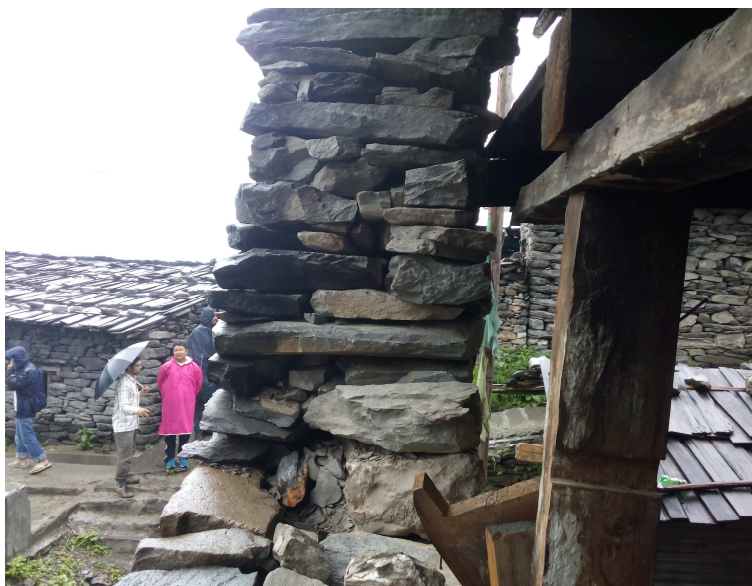
Fig. 25) Partial collapse of wall / standing wooden structure inside. Gatlang (ASF Nepal)

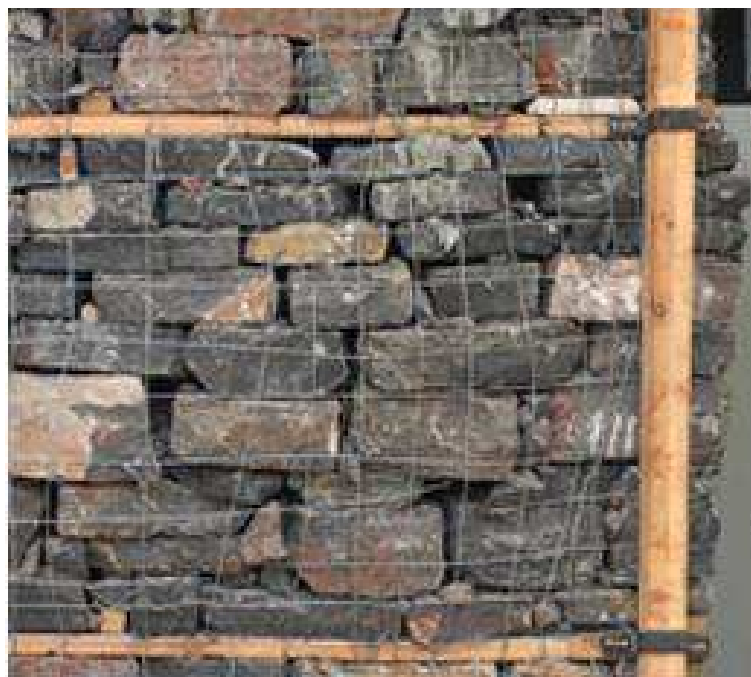
Fig. 36) Retrofitted wall sample with built-in wooden bandages with wooden posts combined with gabion wire jacketing¹⁹
