**State of knowledge and identification of research  
priorities for the scientific validation of disaster resistant  
building cultures of the Himalayan regions of Nepal :  
Research report**

State of knowledge and identification of research priorities for the  
scientific validation of disaster resistant building cultures of the  
Himalayan regions of Nepal

Research report

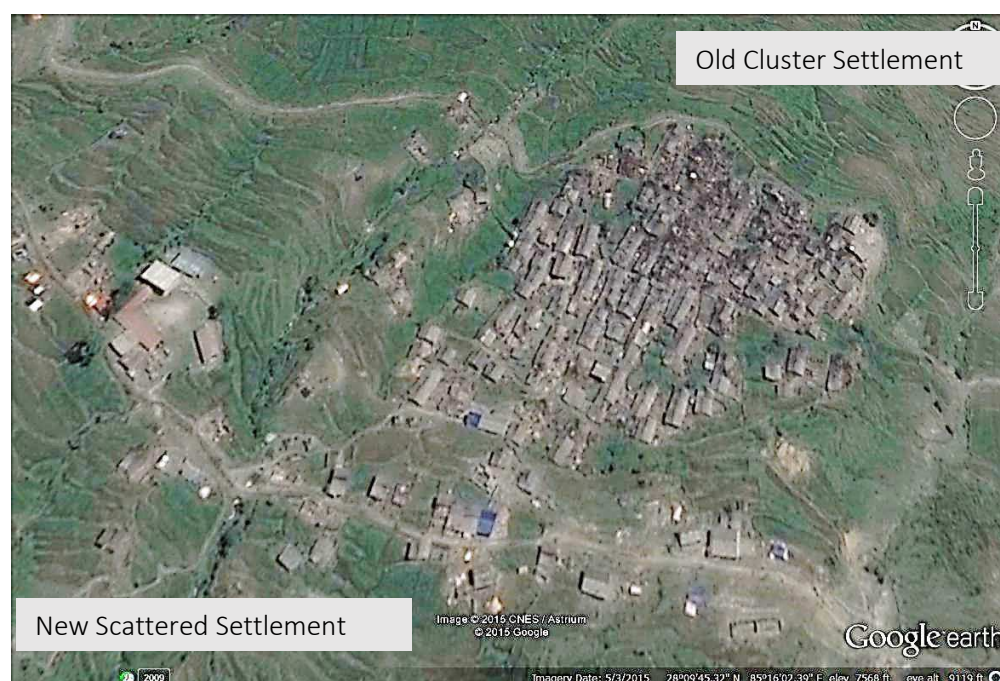
Fig.6) Top view of the village of Gatlang after 2015 EQ. (Source ASF Nepal report)

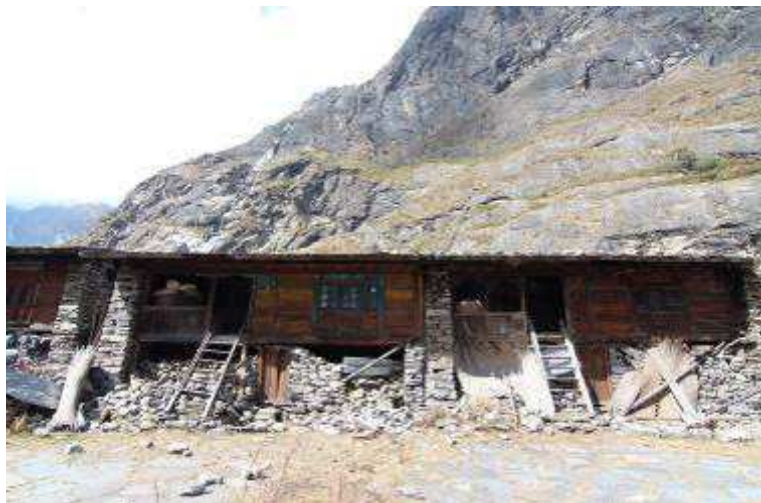
Fig.7) Row houses in Langtang Valley after the avalanches due to the 2015 Gorkha EQ.

- Single units: the house is isolated from other constructions.
- Row houses: the houses share a common wall.
  - Row houses parallel to the level lines
  - Row houses in the slope. In this case the level differences of the roofs induce extra complexity in connexion of the adjacent units

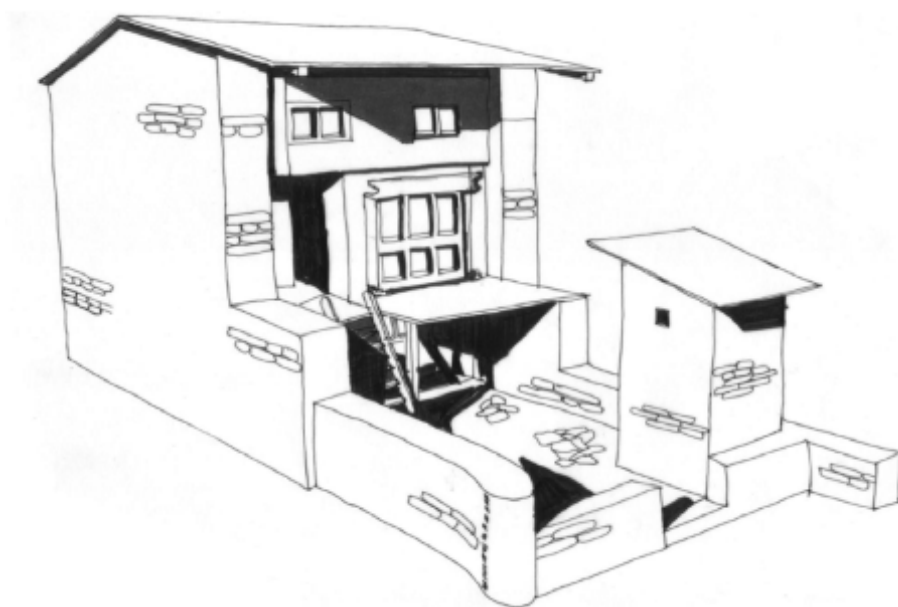
Fig. 11) House unite in Gatlang, in Final Report on Healthy Home Project, Rasuwa. (source ASF Nepal)

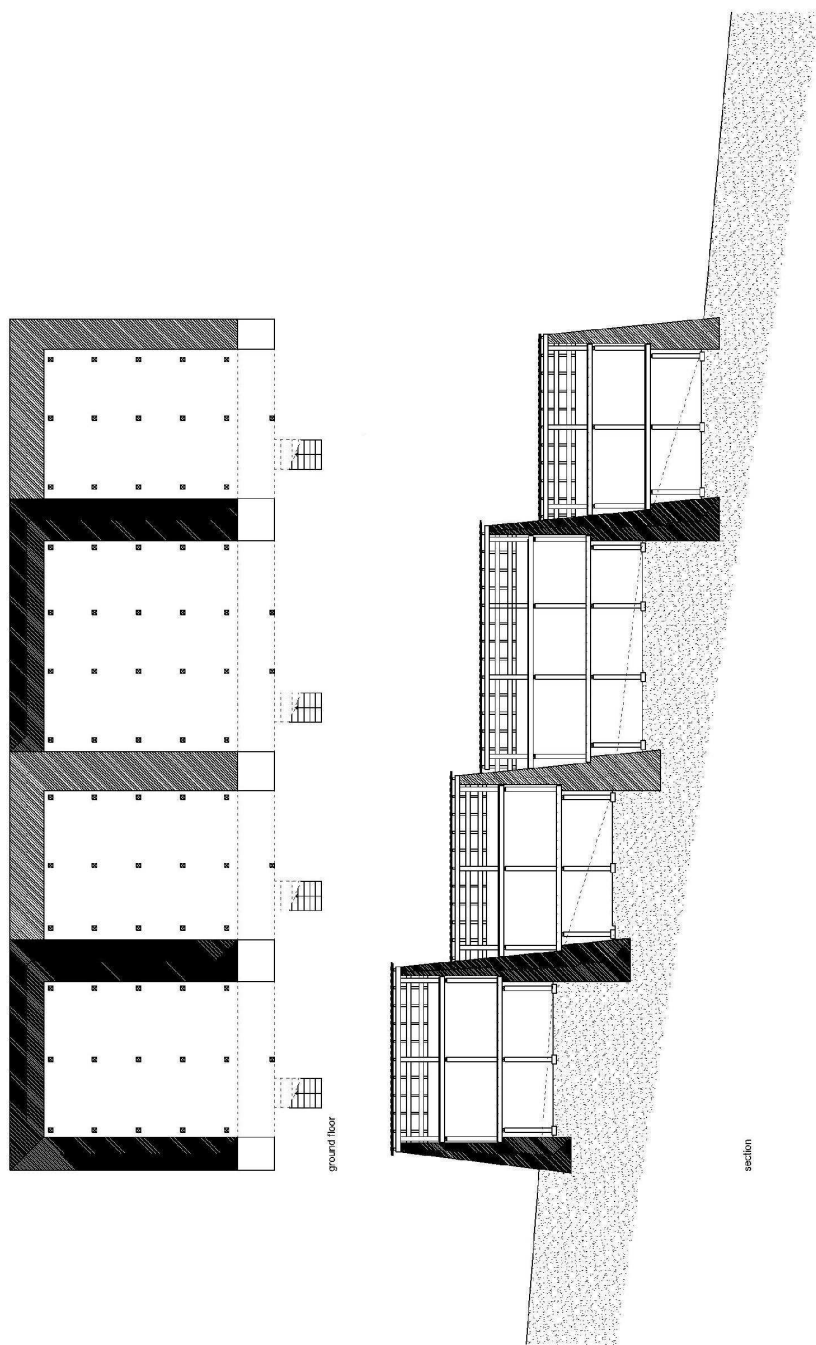
Fig. 12) Row of houses / Plan & section

<b>GATLANG VERNACULAR HOUSE TYPE 1</b> Existing drawings - dry stone Masonry CRAterre J. Hosta		Row houses_plan		échelle 1:200		format A4		date 01.04.2020	
		0 1 2 3m		0 1 2 3m		0 1 2 3m		0 1 2 3m

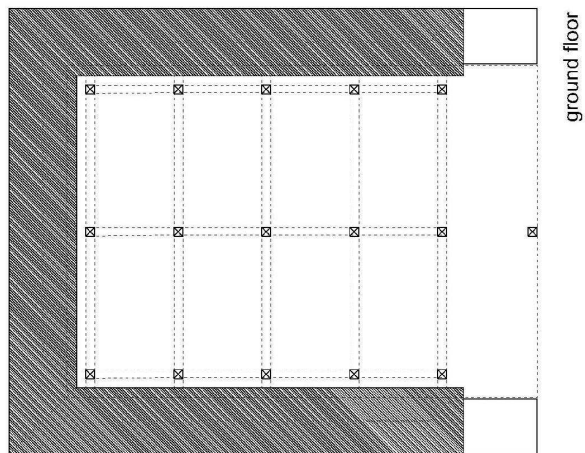
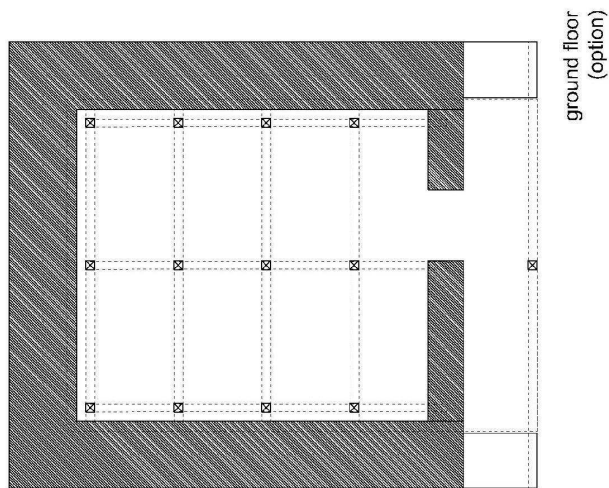
<b>GATLANG VERNACULAR HOUSE TYPE 1</b> Existing drawings - dry stone Masonry	Row houses_plan	échelle 1:100	format A4	date 01.04.2020		
					0	1
CRAterre J.Hosta

Fig. 13) Variants of house unit / Ground floor Plan

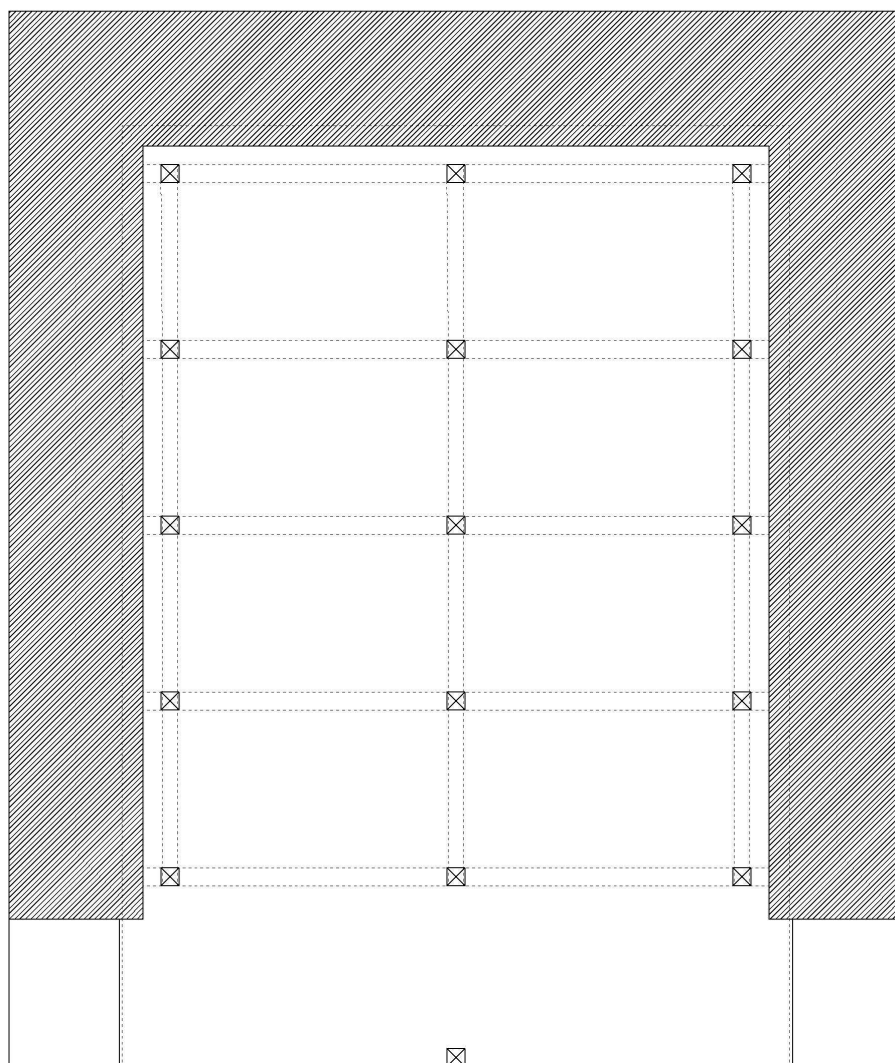
<b>GATLANG VERNACULAR HOUSE TYPE 1</b> Existing drawings - dry stone Masonry		plan_ Ground floor	échelle 1:150	format A4	date 01.04.2020	
CRAterre J.Hosta	<input type="checkbox"/> <input type="checkbox"/>

Fig.14) Sample of house unit / Ground floor

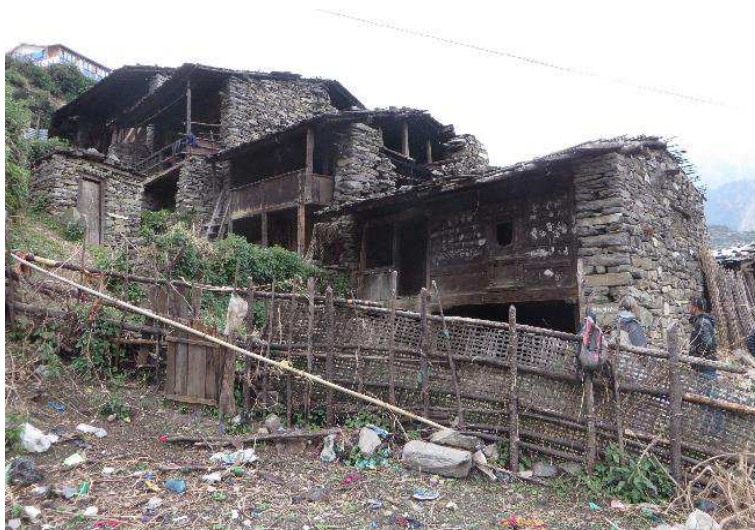
Fig. 22) Damages on gables walls on a row of Houses. Gatlang (CRAterre)

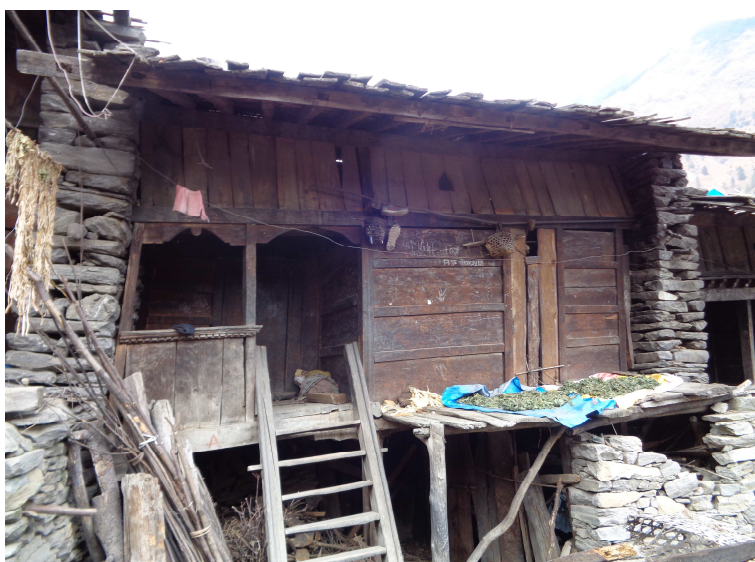
Fig. 23) Stone masonry wall distortion. Gatlang (ASF Nepal)

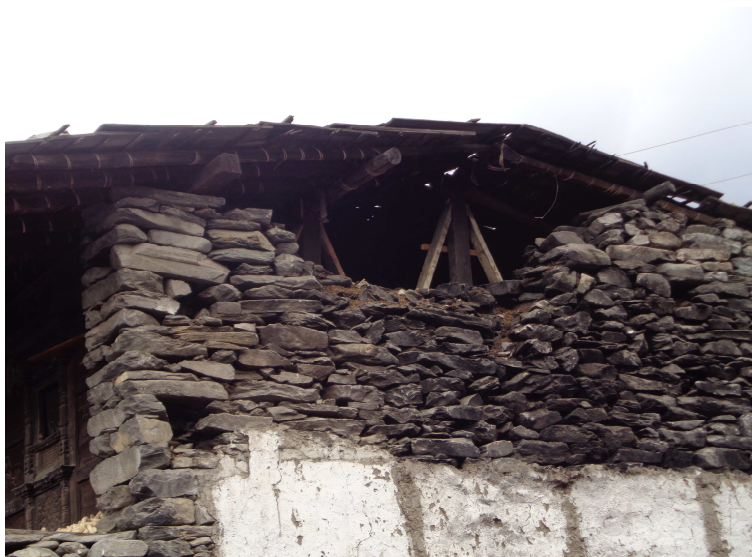
Fig. 24) Partial collapse of gable wall. Gatlang (ASF Nepal)

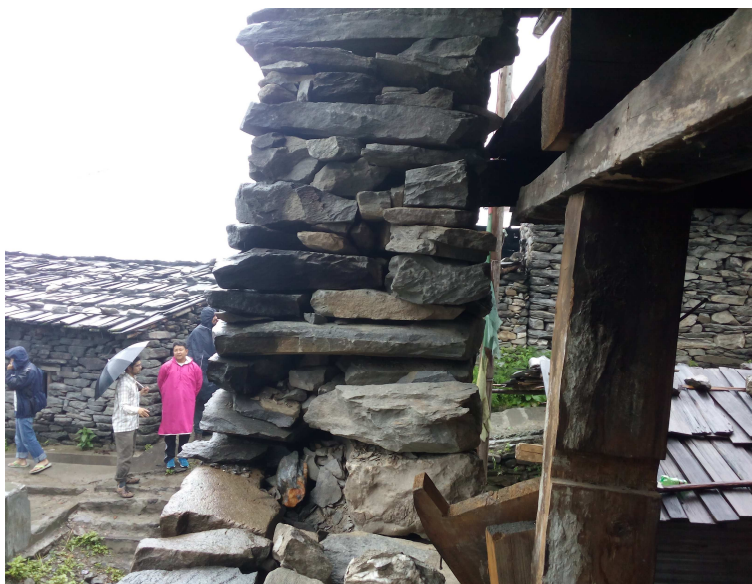
Fig. 25) Partial collapse of wall / standing wooden structure inside. Gatlang (ASF Nepal)

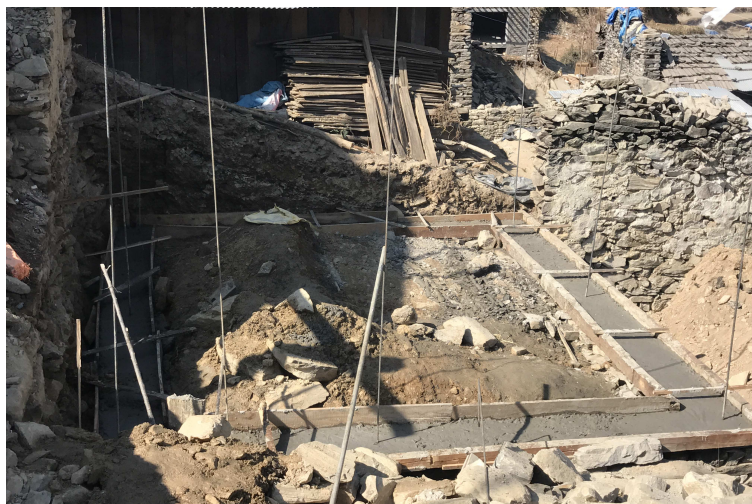
Fig.27) New house under construction beside an existing house in a row. (CRAterre)

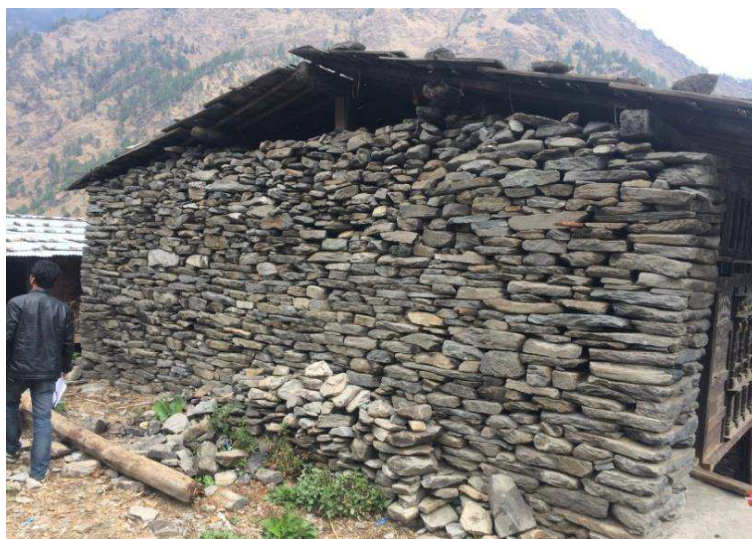
Fig. 28) partially repaired house, showing evidence of vulnerability, see gable wall (CRAterre)

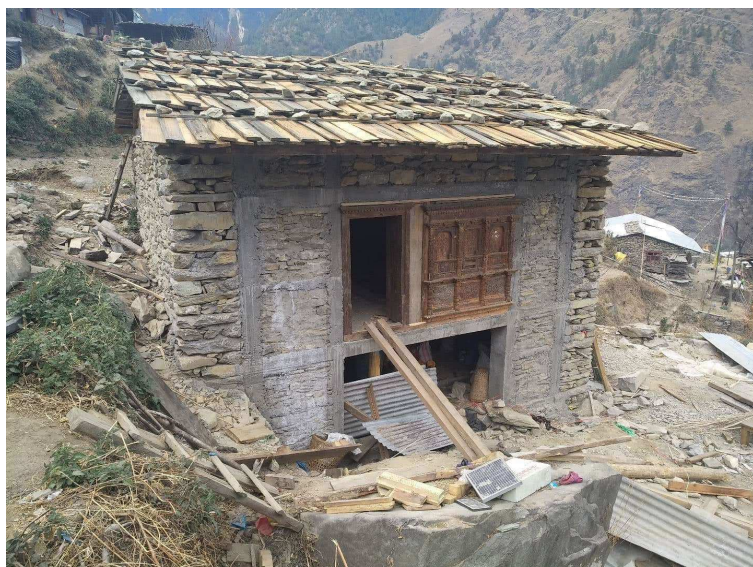
Fig. 31) Gatlang, retrofitted house using “strong back” approach<sup>16</sup>

The RC splint bandage helps to prevent global failure of the structure whereas GI wire jacketing applied on the remaining portion helps in preventing local failure. During the application, RC splint bandage is applied around the opening, corner and T-junction to improve the resistance towards seismic loading. The GI wire is properly anchored to the wall for its effectiveness.

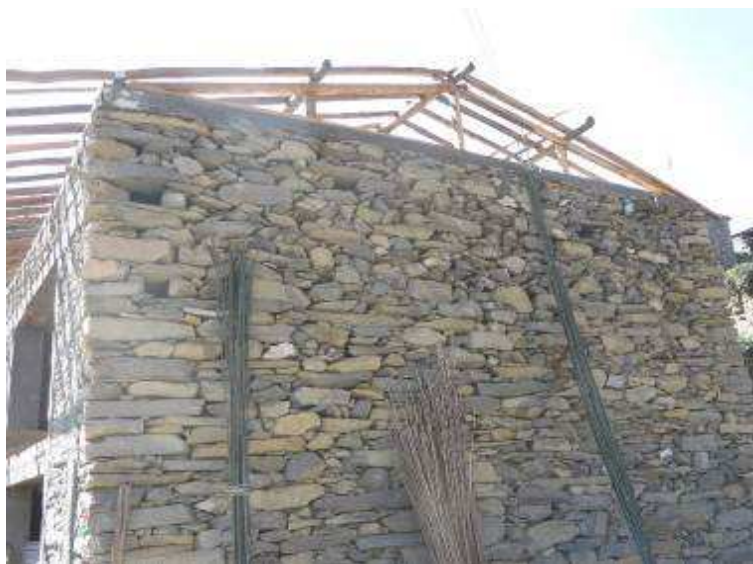
Fig. 32) Gatlang, retrofitted house using “strong back” approach<sup>17</sup>

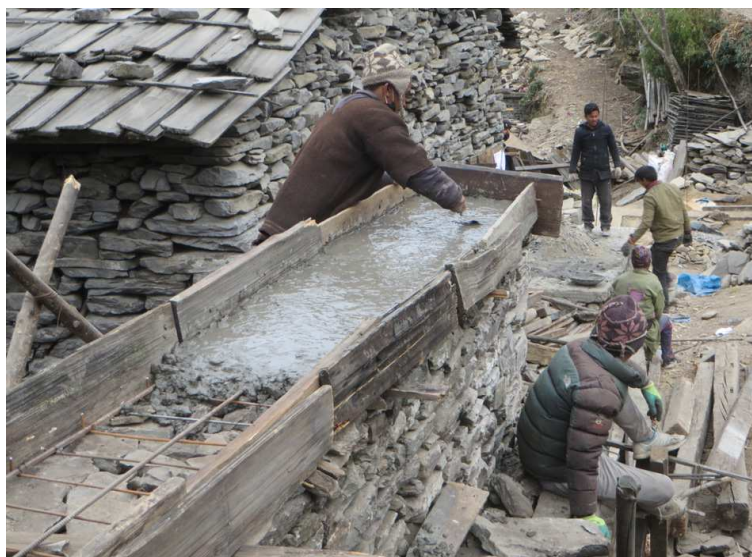
Fig. 33) Repairs and reconstruction of gable wall (confined) in Gatlang, ASF Nepal /CRAterre 2017

The seismic band is a particular member that is used for providing seismic resistance to the low strength masonry structures at different horizontal level using various material: timber, bamboo or concrete. Such band could be continuous at plinth, lintel, and roof level and discontinuous at the opening location such as sill and stitch band. The proper application of such band helps to prevent chances of out-of-plane, in-plane and corner separation failure. The shear band at roof level also help in proper connection of roof with the wall and provide support during the seismic action (S. Yadav, 2017)

The following technic is not applicable in retrofitting since the bands are inserted in between masonry layers. But applicable for heavy repairs, with complete or partial dismantling of the dry-stone masonry walls.

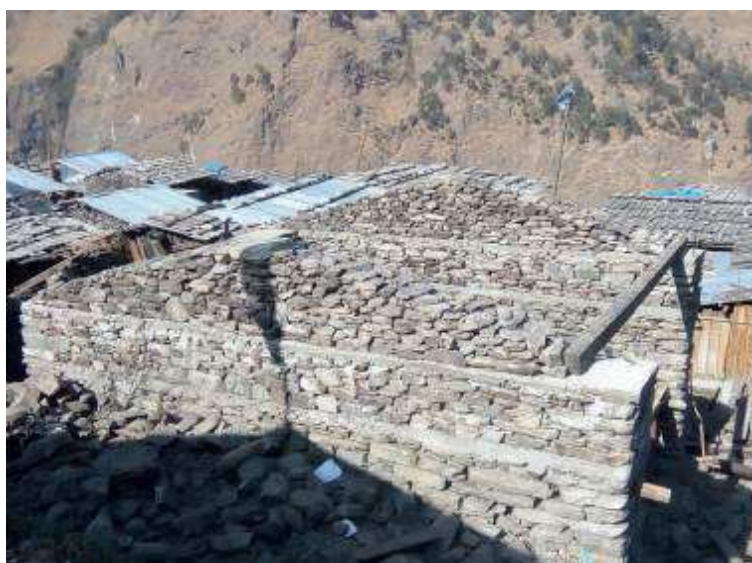
Fig. 34) Repairs and reconstruction of gable wall (confined) in Gatlang, ASF Nepal /CRAterre 2017

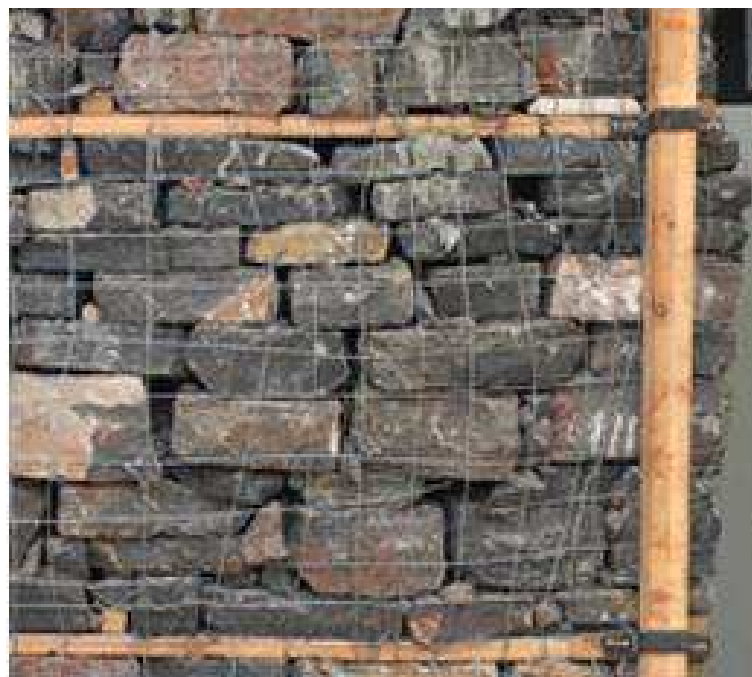
Fig. 36) Retrofitted wall sample with built-in wooden bandages with wooden posts combined with gabion wire jacketing<sup>19</sup>

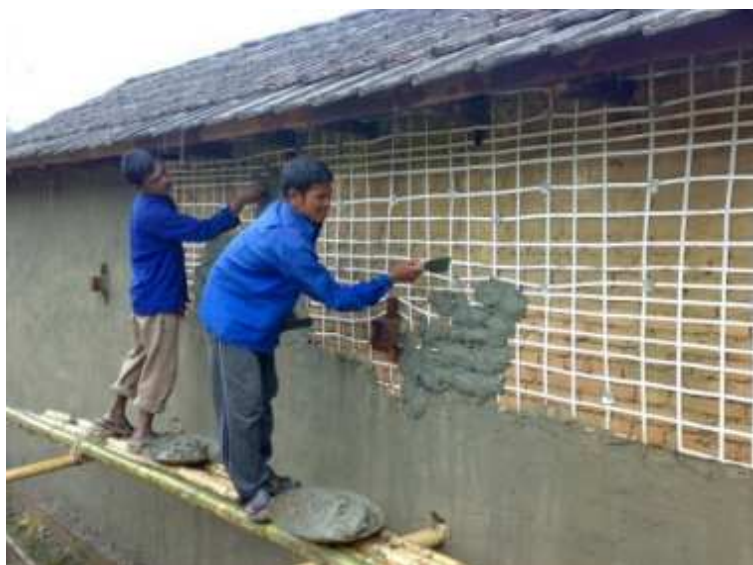
Polypropylene meshing uses common polypropylene packaging straps (pp-bands) to form a mesh which is used to encase masonry walls, preventing both collapse and the escape of debris during earthquakes. PP-bands are used for packaging all over the world and are therefore cheap and readily available while the retrofitting technique itself is simple enough to be suitable for local builders. PP meshing has been applied in Nepal, Pakistan and more recently in China. This method is most readily applicable in terms of low-cost upgrading of traditional structures to limit damage caused by normal earthquakes and give occupants a good chance of escape in a once-in-a-lifetime large earthquake.

Fig. 37) NSET, Implementation of PP band method of retrofitting in Kathmandu Valley<sup>21</sup>

To protect the Polypropylene from UV rays, mud plaster is used on the outside, providing adequate cover to ensure the durability of the material.<sup>20</sup>

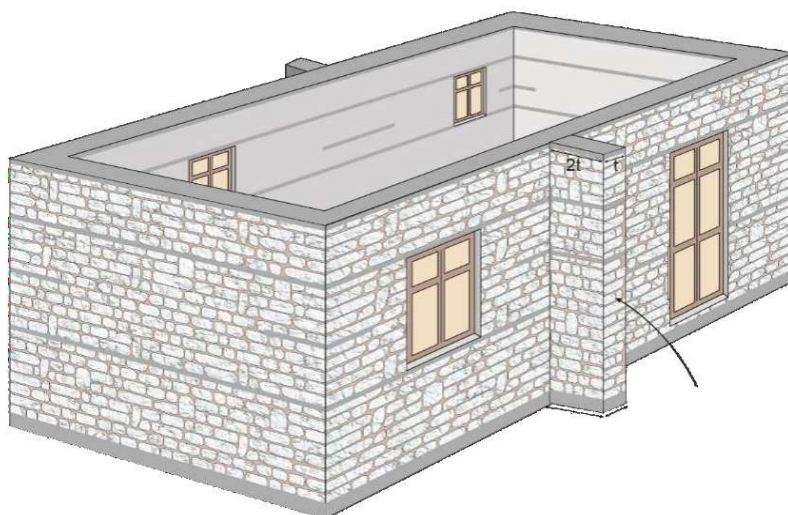
Fig. 38) Buttresses (outer face of wall)<sup>23</sup>

This might not be the case for common constructions observed). This option could be particularly appropriate for end-of-row houses, most exposed in case of EQ.

NB: The connection of such elements with existing walls is a key element.

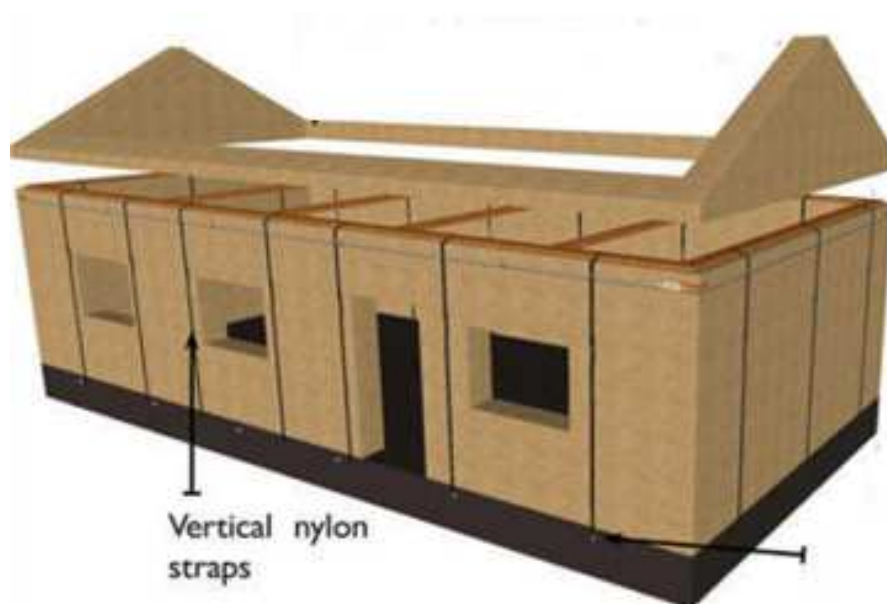
The use of nylon rods and straps in case of masonry structures helps to increase the ductility of the wall and also prevent out-of-plane failure.<sup>24</sup> The pre-tensioning of the straps is not required, however it should be tightened in order to eliminate slippage. This runs on both exterior and interior wall surface.

Fig. 39) Nylon straps on low strength masonry building (Michiels)
