**State of knowledge and identification of research  
priorities for the scientific validation of disaster resistant  
building cultures of the Himalayan regions of Nepal :  
Research report**

State of knowledge and identification of research priorities for the  
scientific validation of disaster resistant building cultures of the  
Himalayan regions of Nepal

Research report

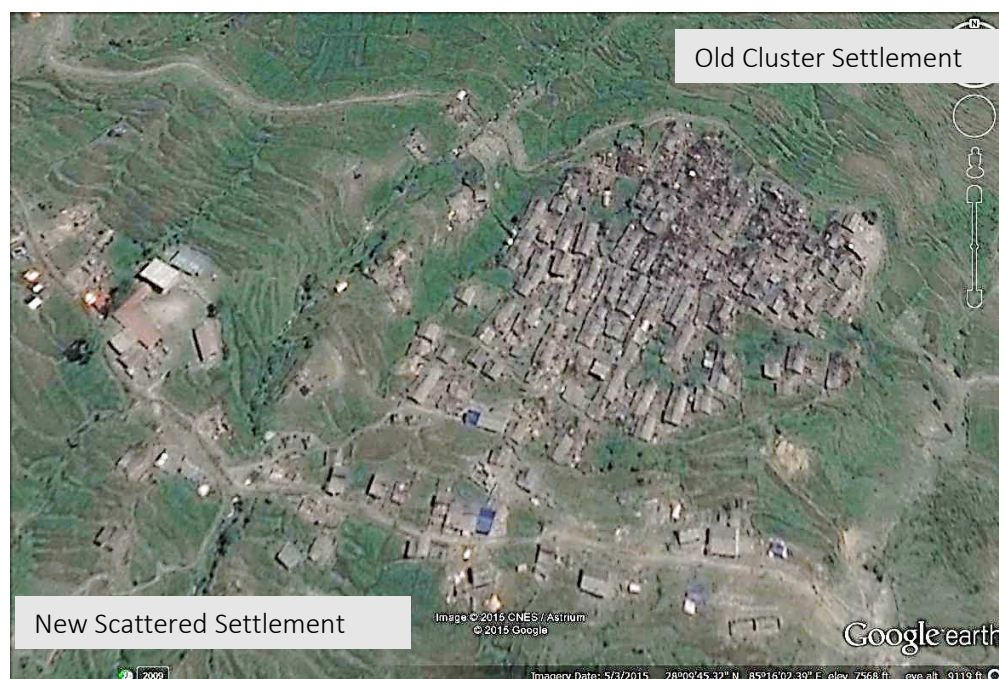
Fig.6) Top view of the village of Gatlang after 2015 EQ. (Source ASF Nepal report)

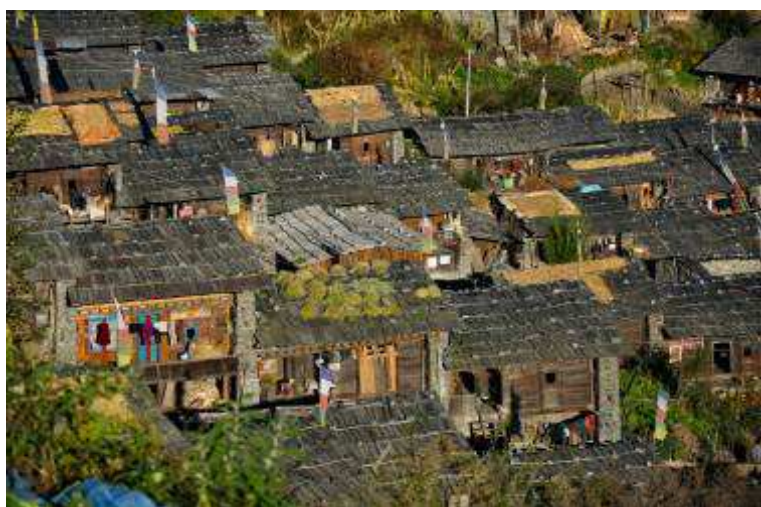
Fig.8) Row houses in Gatlang before Gorkha EQ

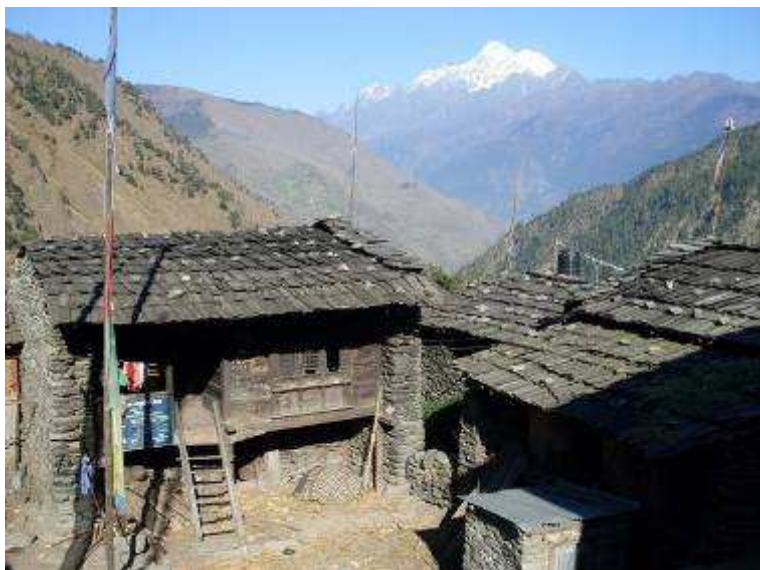
Fig.10) main façade of a house in Gatlang before Gorkha Earthquakes (source : ASF Nepal)

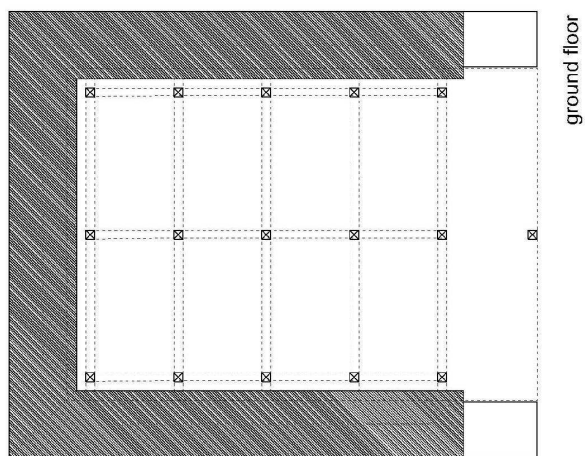
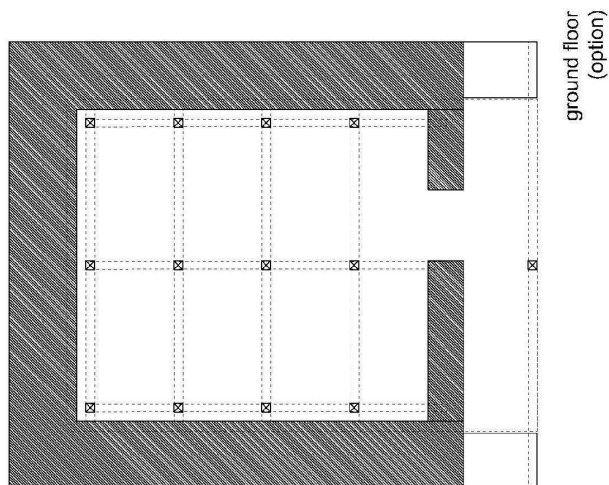
<b>GATLANG VERNACULAR HOUSE TYPE 1</b> Existing drawings - dry stone Masonry CRAterre J. Hosta	Row houses_plan	échelle 1:100	format A4	date 01.04.2020	0 1 2 5m

Fig. 13) Variants of house unit / Ground floor Plan

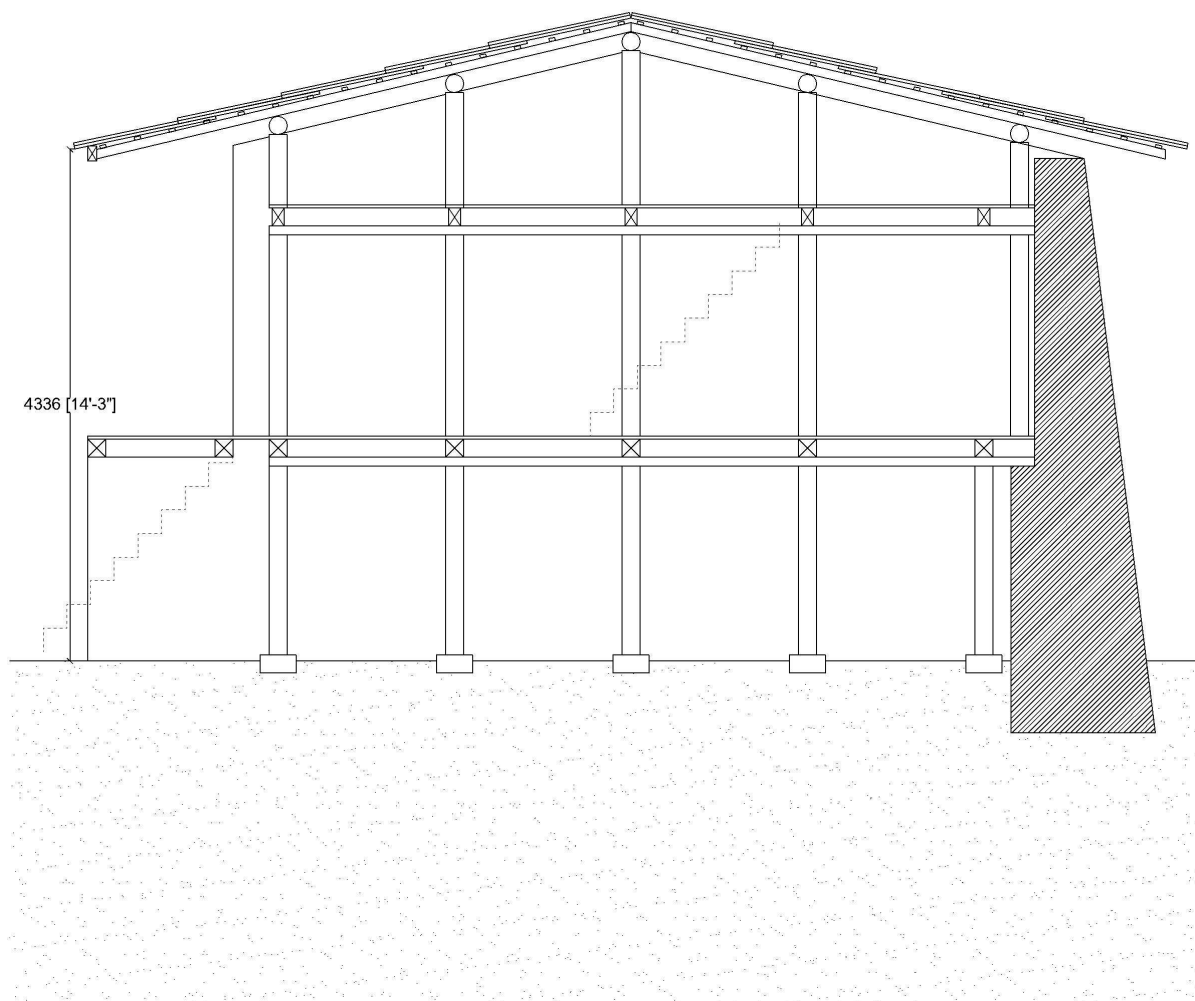
<b>GATLANG VERNACULAR HOUSE TYPE 1</b> Existing drawings - dry stone Masonry		section BB'	échelle 1:50	format A4	date 01.04.2020
CRAterre J.Hosta	<input type="checkbox"/> <input type="checkbox"/>	0    0.5    1    2.5m

Fig. 16) Sample of house unit / Section.

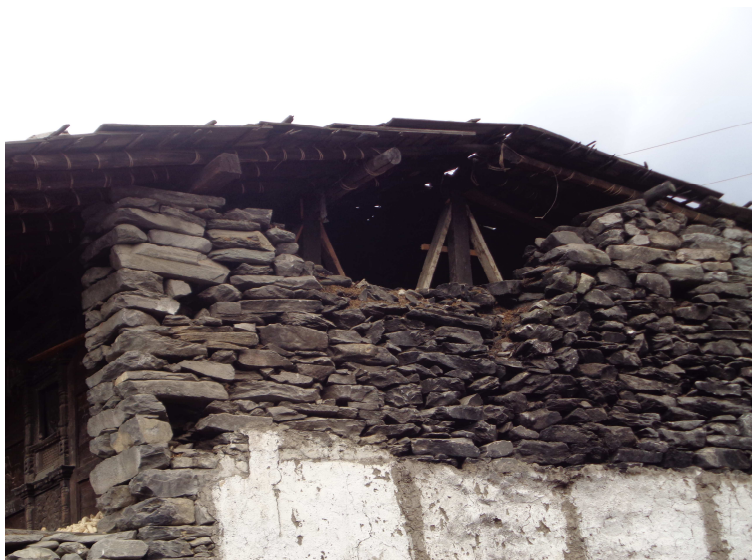
Fig. 24) Partial collapse of gable wall. Gatlang (ASF Nepal)

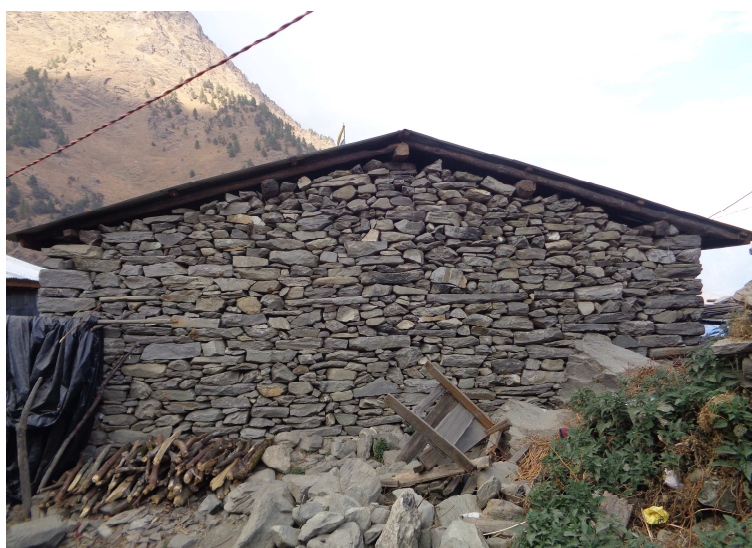
Fig. 29) partially repaired house, with addition of retrofitting component, see gable wall (CRAterre)
