Effects of Horizontal Seismic Band on Seismic Response in Masonry Structure: Behaviour Depending upon the Material Used

Santosh Yadav, Hala Damerji, Reinold Keco, Yannick Sieffert, Eugénie Créte, F. Vieux-Champagne, Philippe Garnier, Yann Malecot

Effects of Horizontal Seismic Band on Seismic Response in Masonry Structure: Application of DIC technique

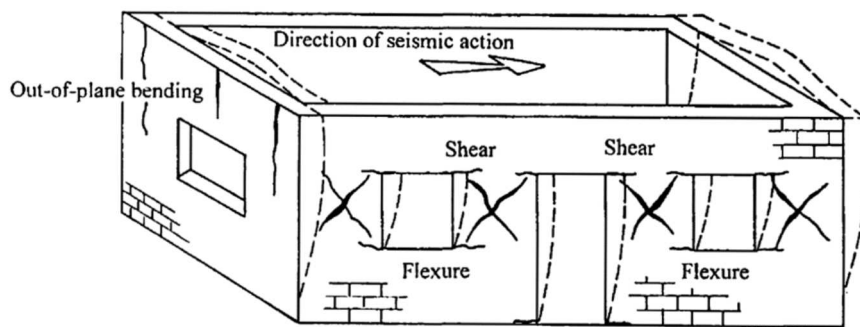
Fig. 1 Various failure mode in a masonry structure [30]

fault rupture, the distance between source to site, ground condition, and magnitude [29]. The structures' failure pattern can vary depending on the nature of the material used, bond strength, normal axial loading due to roof and other superstructure on the wall, placement of opening, and seismic loading. Fig. 1 shows the global failure mode in a masonry structure when submitted by seismic loading action. However, these entire failure modes are not necessarily occurring during any event. In the case of an out-of-plane wall, the failure can be due to flexural bending or corner separation or the wall's delamination. For the in-plane wall, it could be due to diagonal shear crack, shear sliding, or flexural bending/rocking. Suppose the crack formation and propagation can be limited by any means. In that case, the structural damage can be minimized and, most importantly, save the people's lives during a seismic disaster event. One such technique is the use of the horizontal seismic band.

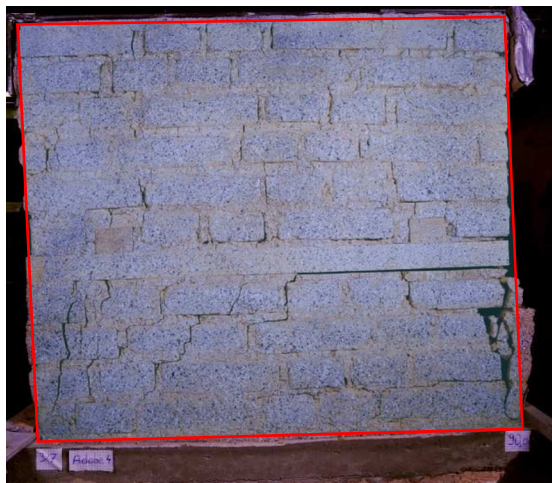
Fig. 14 Wall with timber band at 4560 seconds of loading at peak displacement towards left

During the third cycle (Fig. 13), the behavior of the wall with the band is still the same, and the orange line follows the same trend as in Fig. 11 and Fig. 12. This means that integrity is preserved in a wall with the seismic band until the end of the third cycle of displacements. The same cannot be said about the behavior of the wall without any band. The blue line shows that the crack surface area seldom decreases in value. Older cracks expand, and new cracks in the wall's inner parts are created whenever the imposed force is at its highest. Another interesting thing to notice, in the case of the wall with a band, is that while force switches directions, the crack surface area remains almost constant. This happens because both the upper and lower part of the wall has been disconnected at the band level, so instead of expanding, cracks simply shapeshift from rectangles into parallelograms (when pushed or pulled from the initial location) while covering the same surface as shown in Fig. 14 and Fig. 15.

The failure occurred through the mortar joints and propagated along the horizontal and header joint. Some of the bricks were fragmented during the crack propagation, as seen in Fig. 14 and Fig. 15.
