# Effects of Horizontal Seismic Band on Seismic Response in Masonry Structure: Behaviour Depending upon the Material Used

Santosh Yadav, Hala Damerji, Reinold Keco, Yannick Sieffert, Eugénie Créte, F. Vieux-Champagne, Philippe Garnier, Yann Malecot

# Effects of Horizontal Seismic Band on Seismic Response in Masonry Structure: Application of DIC technique

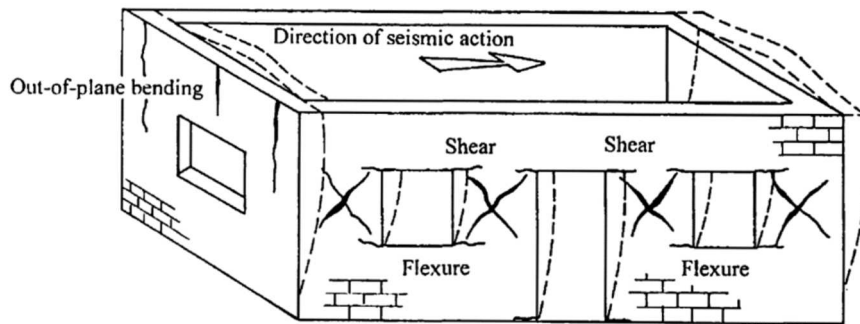
*Fig. 1 Various failure mode in a masonry structure [30]*

Usually, the interface is the weak bond between mortar and units in masonries. This low tensile strength creates a key reason for most of the damage [28]. Damage in the structure is directly influenced by the seismic event, which has its characteristics. Each seismic event is characterized by its horizontal and vertical ground motion components, which are influenced by the nature of

fault rupture, the distance between source to site, ground condition, and magnitude [29]. The structures' failure pattern can vary depending on the nature of the material used, bond strength, normal axial loading due to roof and other superstructure on the wall, placement of opening, and seismic loading. Fig. 1 shows the global failure mode in a masonry structure when submitted by seismic loading action. However, these entire failure modes are not necessarily occurring during any event. In the case of an out-of-plane wall, the failure can be due to flexural bending or corner separation or the wall's delamination. For the in-plane wall, it could be due to diagonal shear crack, shear sliding, or flexural bending/rocking. Suppose the crack formation and propagation can be limited by any means. In that case, the structural damage can be minimized and, most importantly, save the people's lives during a seismic disaster event. One such technique is the use of the horizontal seismic band.

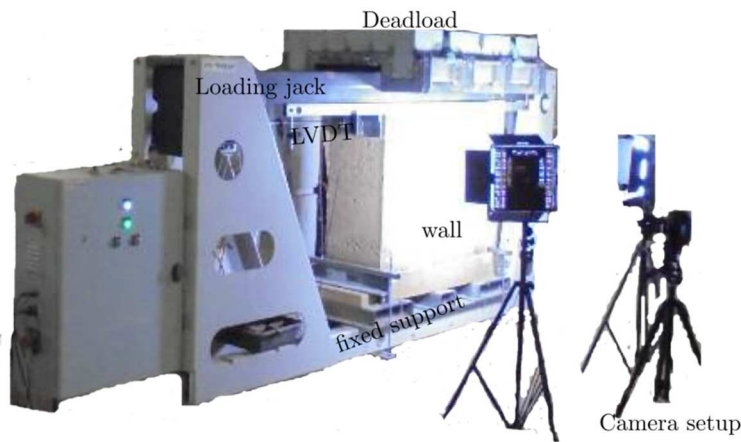
Fig. 2 General experimental set up for the quasi-static test

static cyclic loading test is used to determine the influence of a horizontal seismic band in a masonry wall. The shear resistance of the wall can be obtained by applying the in-plane loading [36], but for this study, we have compared the crack surface area with the corresponding force rather than the classical hysteresis curve. The loading pattern was selected based on the recommendation of [37] for the quasi-static loading cycle. The general experimental setup is shown in Fig. 2, where the loading actuator/jack, camera setup, and specimen location are indicated. With the help of a C-shaped metallic connected to the actuator (graphically indicated in Fig. 3), it is possible to apply cyclic loading by changing the loading direction. Two masonry walls (dimension 0.91 m in length, 0.86m in height, and thickness of 0.32m) are built with and without a seismic band. Timber was used as a seismic band with a cross-section dimension of 70 mm x 50 mm and arranged in the form of the ladder as shown in Fig. 4 using nail connection. Earth (adobe) bricks are used to construct the walls using mud mortar with a thickness of 20 mm. A reinforced concrete stud is cast around the first brick bed, and a metallic strip is added to the ends, which is fixed using nuts and bolts. The compressive strength of brick-and-mortar ranges from 1.2 MPa to 1.4 MPa when tested individually, and with the compression test on the wallet, the average compressive strength of about 1 MPa was obtained. These values are necessary for determining the loading conditions for the test. A speckle pattern on the wall surface, which is needed for carrying out digital image correlation (DIC), is created using black and white aerosol spray paint. DIC was quite useful in the past few decades to get information at the local level without the use of any sensor on the specimen. The digital image correlation technique allows for a continuous record of cracks formation all along the displacement cycle.

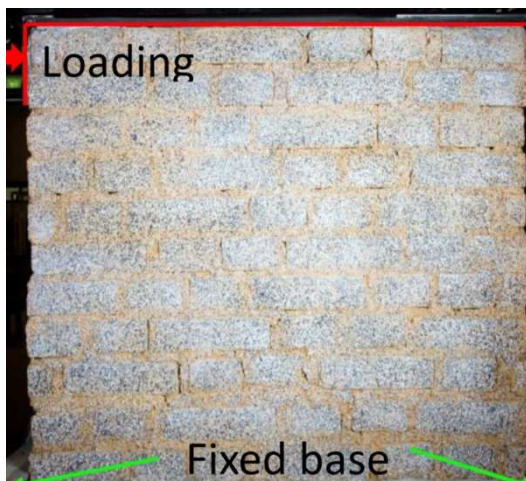
Fig. 3 Masonry wall without a band (left) and with timber seismic band (right)

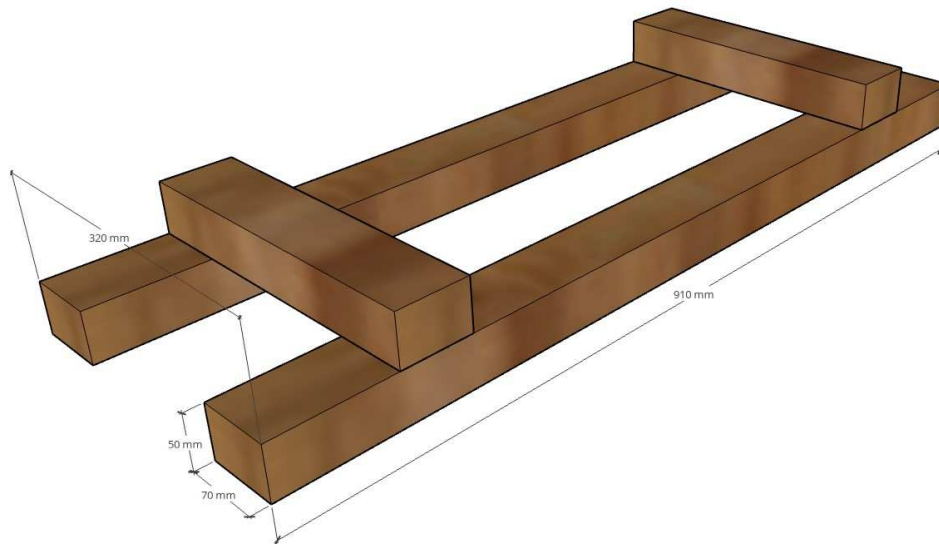
Fig. 4 Dimension of timber seismic band used

A dead load of 9.8 kN is added on the top of the wall, representing that of a roof and any other structure supported by the wall. This dead mass is uniformly applied on the wall creating normal axial stress of 0.03 MPa. A cyclic displacement until a maximum amplitude of 80 mm is applied on the wall, as shown in Fig. 5, at a variable rate of displacement (see Fig. 6).

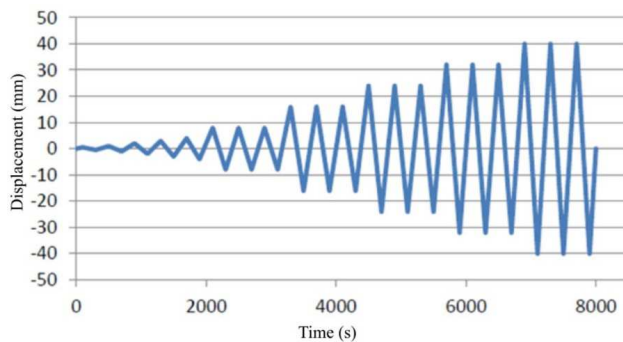
Fig. 5 Displacement sequence for the quasi-static cyclic tests applied to the jack

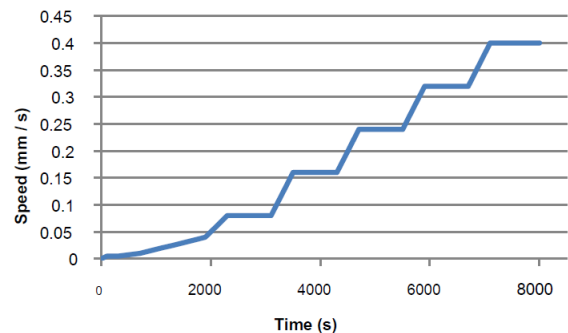
Fig. 6 Displacement loading rate

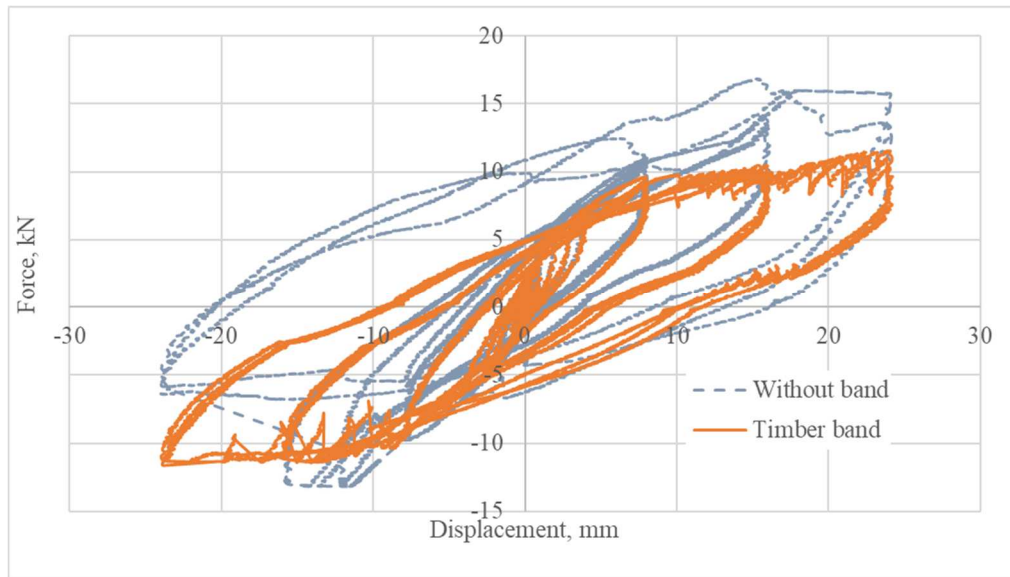
Fig. 7 force-displacement hysteresis curve

Two masonry walls are quasi-statically loaded. The measurement of force recorded from the sensor associated with the jack and displacement recorded using the LVDT sensor at the top of the wall are used to generate a hysteresis curve, as shown in Fig. 7. From this plot, we observe that both walls' behavior is similar until 5 mm horizontal displacement, after which we notice changes in the nature of the curve. For the wall without the seismic band, the peak force value is increased more than the one with a timber band. However, the maximum displacement of the wall with the band is higher due to the wall's sliding behavior at the interface between the seismic band and the adobe brick.

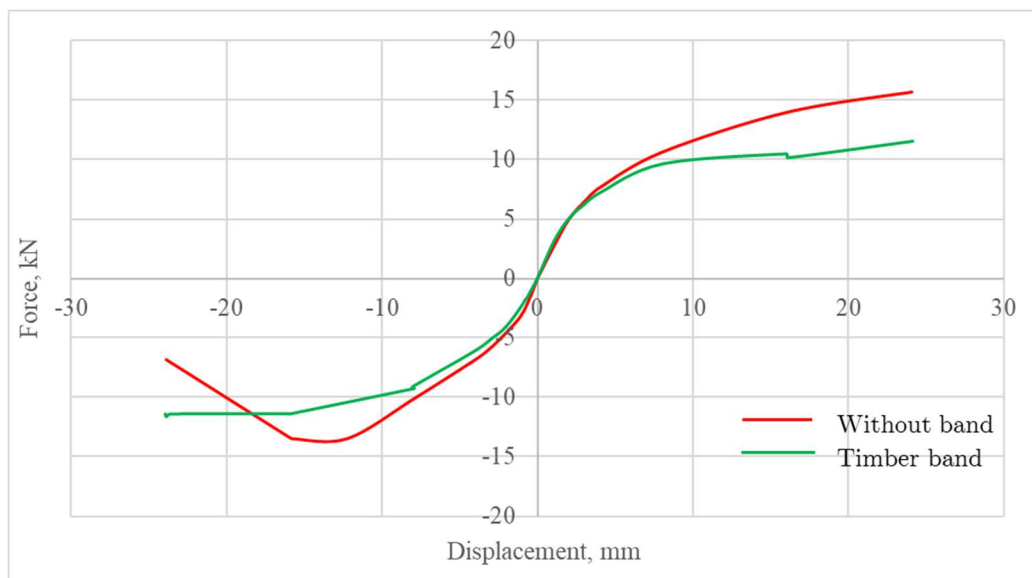
Fig. 8 Envelope curve for two wall samples

Fig. 8 shows the same tests' envelope curves, which are constructed by taking the ultimate force values during the first cycle of targeted amplitude cycles and their corresponding displacement point. From this plot, we observe that the force value increases in both loading directions for the wall without band because the changing direction develops new crack/fissures in the sample. Whereas, for the wall with timber band, the force is higher during the first cycle with an increasing amplitude indicated by the negative force-displacement part of the curve. This phenomenon could be due to the sliding behavior at the interface of the band and brick joint.

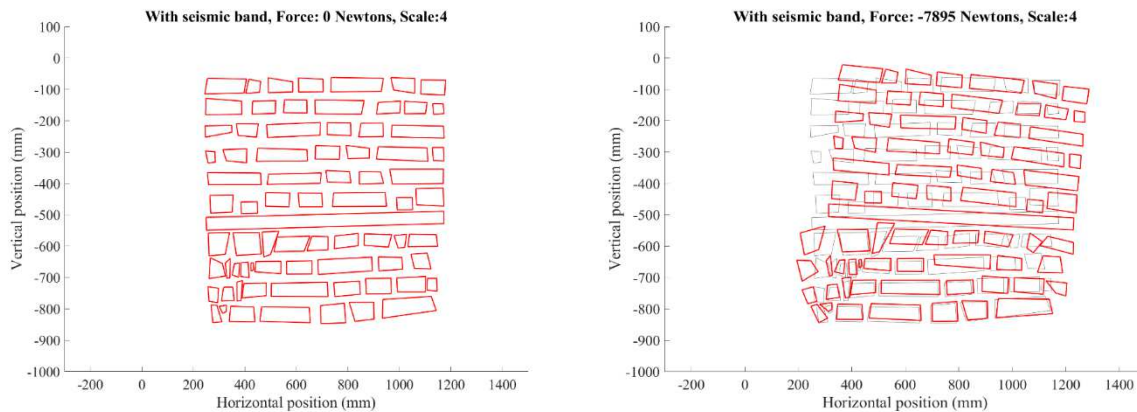
Fig. 9 DIC displacement output field for masonry wall with timber band at zero force (left) and 7.89 kN force (right)

The entire experiment is recorded with a high-resolution camera with images captured at an interval of 10 seconds. These images are later analyzed using the image-correlation software 'Tracker' [38]. The imaging was carried out for the only surface, but the crack propagation on both the surface was verified and observed uniformity regarding crack development. Each brick is associated with four points placed on its corners, forming quadrilateral, and the position of each brick is tracked image by image. The corner of the whole or fragmented brick was manually located by comparing the first image with the last one to avoid the error during DIC due to crack formation or missing part at the measurement point, which is the reason why the shape of the brick looks irregular, as seen in Fig. 9. The horizontal force's value applied on the wall at each stage is associated with the captured image in the analysis. Thus, results obtained with the two walls using DIC can be compared with the corresponding force applied at a particular instant. Fig. 9 shows the DIC output results plotted graphically using MATLAB.

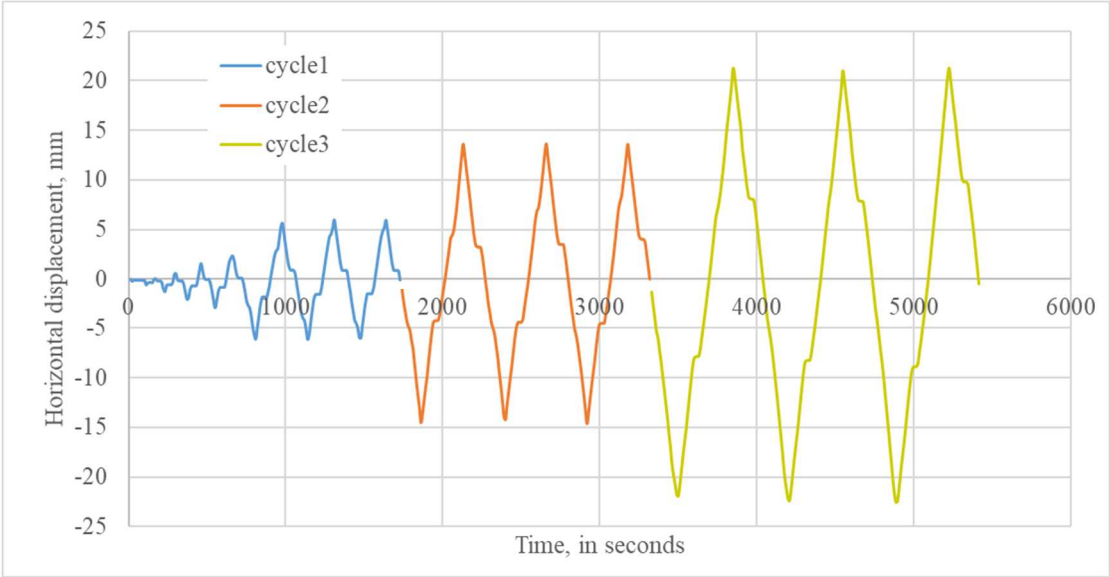
Fig. 10 Classification of displacement cycle for a wall with a band

The energy dissipation is calculated from the hysteresis curve, taking the area under the curve for three classified cycles (Fig. 10) and tabulated in Table 3. The values indicated here are the total energy dissipated by the global behavior of the wall. The value of energy dissipation by the wall without band is more because of the more force required to reach the targeted displacement and more permanent damage on the wall.

As the loading in the horizontal direction is applied, the crack opening at header joints (vertical fissures) increases significantly. A process is established to evaluate the pattern of vertical cracks. Each crack is viewed as a quadrilateral made of four points, two from each side of adjoining bricks. Coordinates are calculated to enlarge the cracks only when there is a difference in the displacement values between two bricks. This displacement obtained from DIC is multiplied with the head or bed joint's length to calculate the surface area of fissures in a vertical or horizontal direction, respectively. For comparing the results of the two cases, it is important to consider deformation stages. For that, three cycles were chosen with constant displacement amplitudes, as shown in Fig. 10. The following analysis is carried out for each cycle using cracks surface area total variation in square millimeters extending upwards in the y-axis direction, dependent on the force value in the x-axis direction. The x-axis consists of the force applied by the loading actuator. The positive part indicates pulling force

(represented with positive force and displacement when the wall is moved toward the left), and the negative part indicated the pushing force (represented with negative force and displacement when the wall moves toward the right).

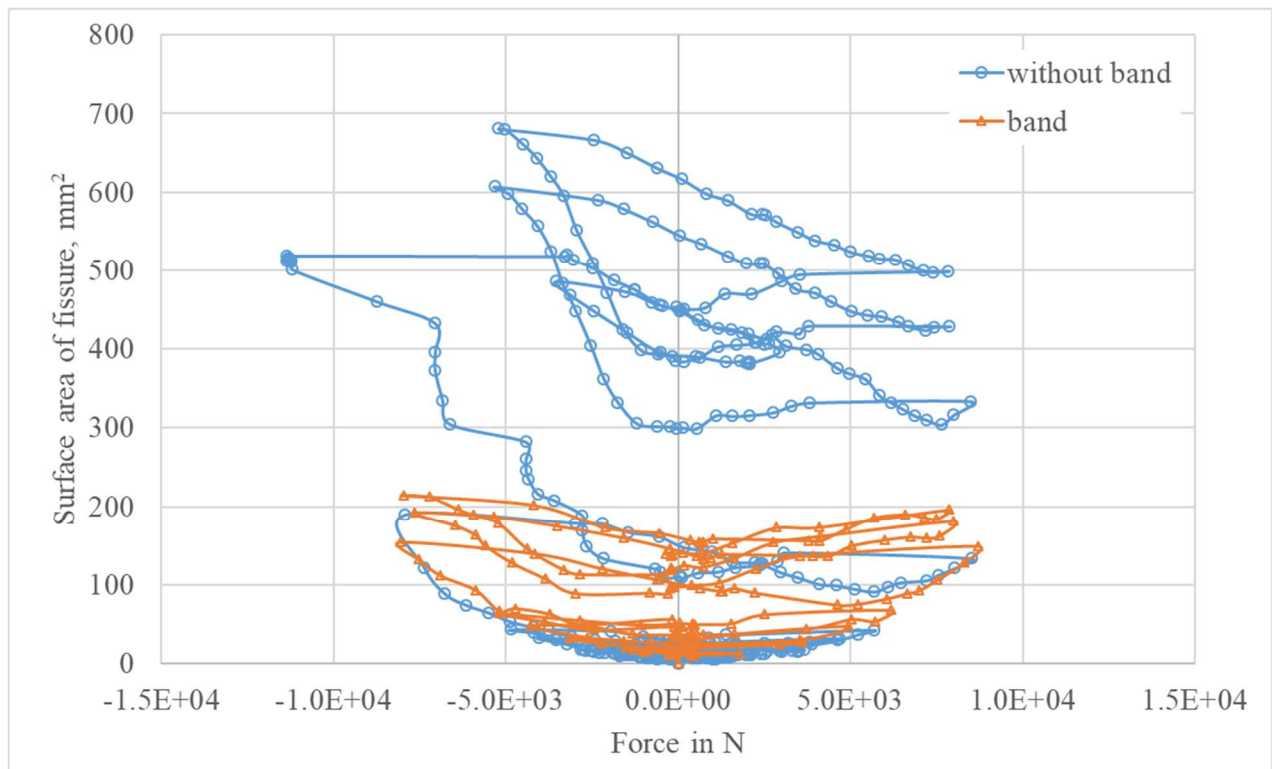
Fig. 11 Vertical fissure area in relation to the applied force during the first cycle

Four main observations can be done throughout the first loading cycle that is shown in Fig. 11. Here, the cycles are classified by the peak horizontal displacement applied to the walls, and each cycle indicated has three periods of oscillation. First, in the beginning, both walls have similar behaviors. Crack opening increases at a slow pace, and deformation is characterized by almost perfect elasticity. Bonding between bricks is still intact, so walls behave like an entire unit. Second, the wall with a horizontal band suffers 8-shaped fluctuations in the crack opening, which is due to cracks below the band that are enlarged and then closed again while slightly ripping and drifting towards permanent deformation. Third, when a force pushes the wall without a seismic band towards the right (force is negative in this case), we can see an obvious increase in the crack opening. It reveals the appearance of the first major diagonal crack in the wall without any band. We can observe sorts of steps, or a stair-like shape, while fissures jump from 100 mm<sup>2</sup> to around 520 mm<sup>2</sup>. These sharp increases are the result of abrupt disconnections between certain bricks. Fourth, at the end of the first cycle, due to the newly formed crack, not much (negative) force is needed to impose displacement in the right direction. Then, the semi-detached block of bricks smoothly glides at every displacement cycle of constant amplitude.

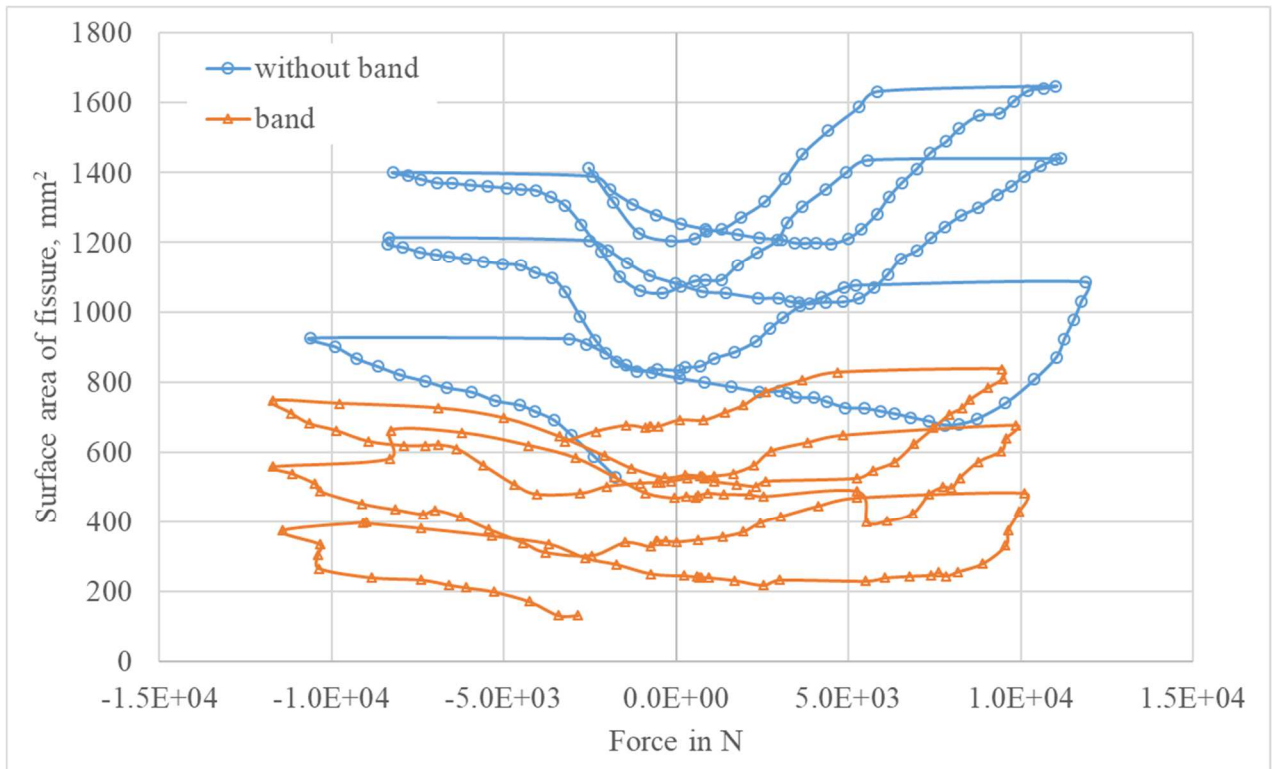
Fig. 12 Vertical fissure area in relation to the applied force during the second cycle

During the second cycle (Fig. 12), a more regular evolution pattern is observed. The phenomena previously described during the first cycle seem to predefine the behavior during the second cycle. The previous loading cycle remnants are immediately noted; the surface area is around 200 mm<sup>2</sup> for the wall equipped with a band and around 680 mm<sup>2</sup> for the wall without any band at the beginning of the second cycle. The orange curve is smoother and narrower than the blue one. This shows a very gradual and stable enlargement of cracks between the bricks. On the other hand, the blue curve shows a less stable pattern.

For both the wall, the surface area of cracks increases way faster at every round. Secondly, a steep decline in the surface area of crack is noticed in every direction change of the applied force. That is because separated blocks slide back to their initial positions. Since the first crack was seen on the right side of the wall when the force is negative, both increase and decrease of crack opening follow the same trend. However, when the force is positive, the wall is pushed on the left, the first left-side cracks appear on the wall without any band. Therefore, the blue curve on the top right side of the graph increases a lot more than the orange one. The maximum surface area of fissures obtained during the second cycle is approximately 800 mm<sup>2</sup> and 1620 mm<sup>2</sup> respectively, for the wall with a band and without a band.

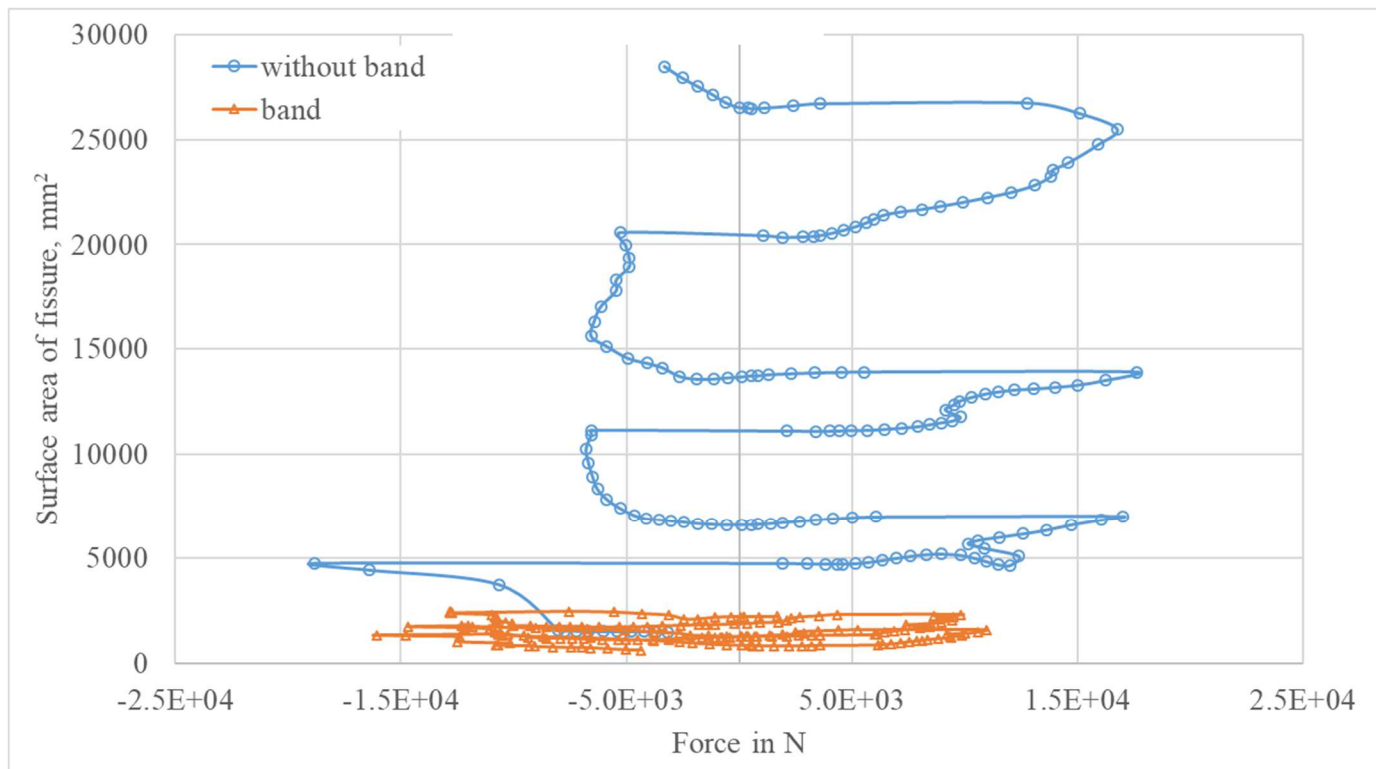
Fig. 13 Vertical fissure area in relation to the applied force during the third cycle

During the third cycle (Fig. 13), the behavior of the wall with the band is still the same, and the orange line follows the same trend as in Fig. 11 and Fig. 12. This means that integrity is preserved in a wall with the seismic band until the end of the third cycle of displacements. The same cannot be said about the behavior of the wall without any band. The blue line shows that the crack surface area seldom decreases in value. Older cracks expand, and new cracks in the wall's inner parts are created whenever the imposed force is at its highest. Another interesting thing to notice, in the case of the wall with a band, is that while force switches directions, the crack surface area remains almost constant. This happens because both the upper and lower part of the wall has been disconnected at the band level, so instead of expanding, cracks simply shapeshift from rectangles into parallelograms (when pushed or pulled from the initial location) while covering the same surface as shown in Fig. 14 and Fig. 15.

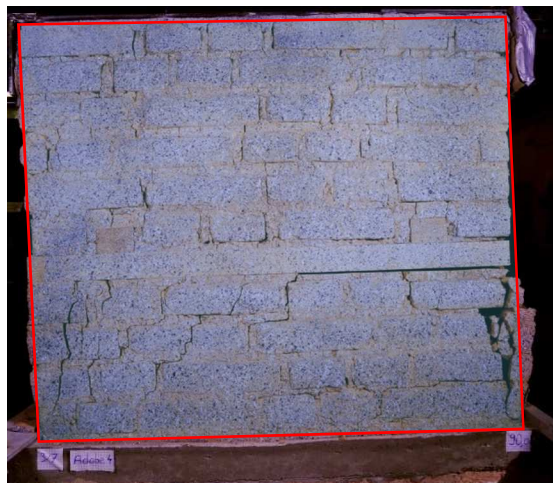
Fig. 14 Wall with timber band at 4560 seconds of loading at peak displacement towards left

The failure occurred through the mortar joints and propagated along the horizontal and header joint. Some of the bricks were fragmented during the crack propagation, as seen in Fig. 14 and Fig. 15.

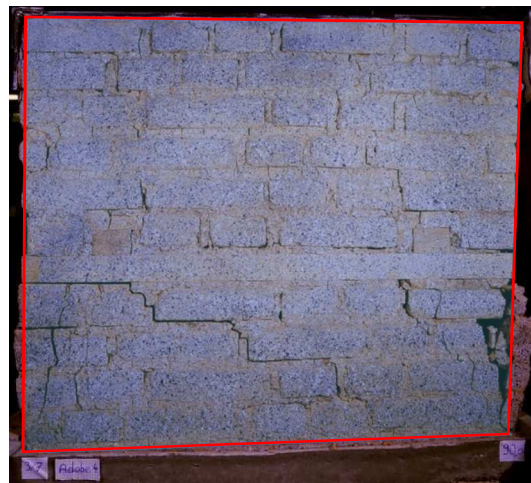
Fig. 15 Wall with timber band at 4880 seconds of loading at peak displacement towards the right
